## Door Weatherstrip Loose or Not Set

Year	Model	Trim Level
2018–23	Accord	ALL
2022–23	Civic	ALL

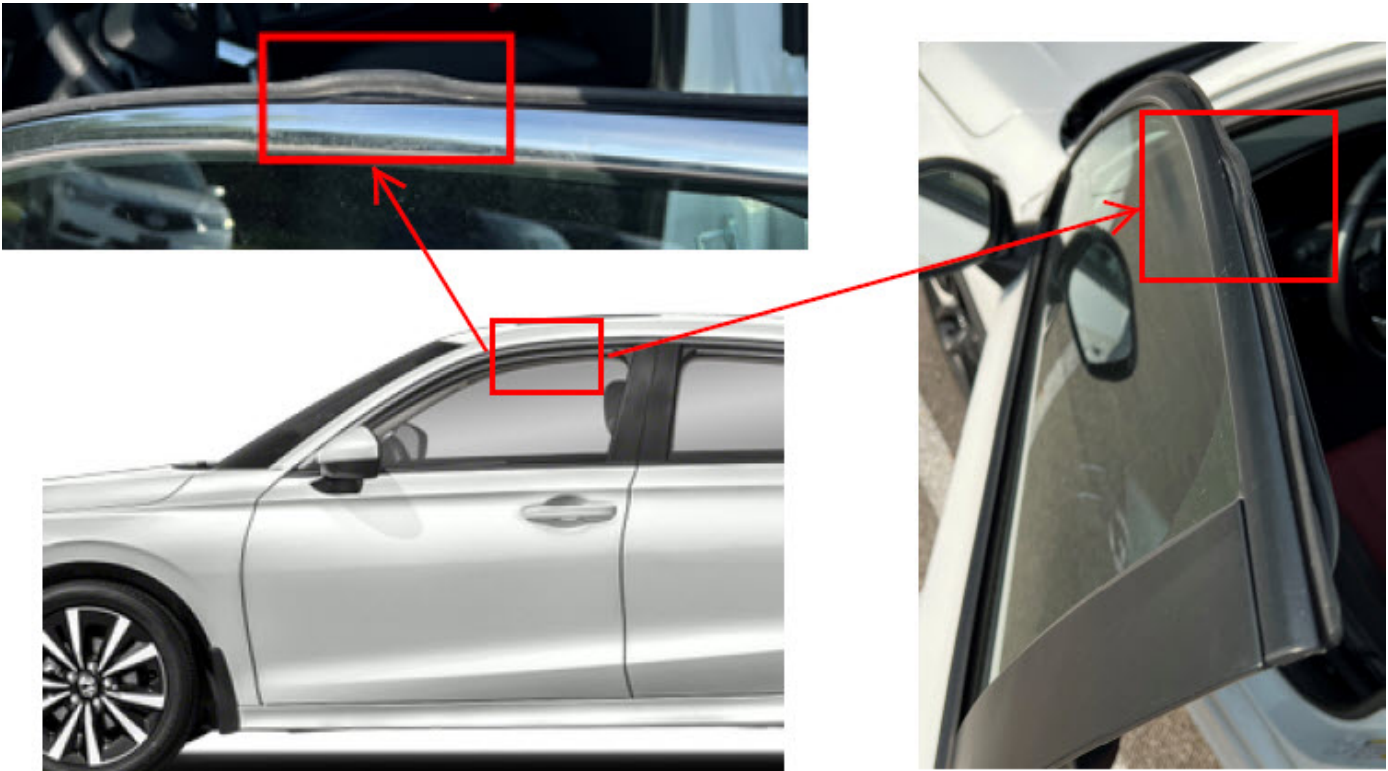
We have seen several claims where dealers state loose or unset weatherstrips at the door sash.

When a car comes in with this condition, you can successfully reinstall an undamaged weatherstrip back in place until permanent countermeasure parts are available.
