## ServiceNews Article

September 2023 B23090A Version 1

## **Door Weatherstrip Loose or Not Set**

Year	Model	Trim Level
2023-24	Integra	ALL

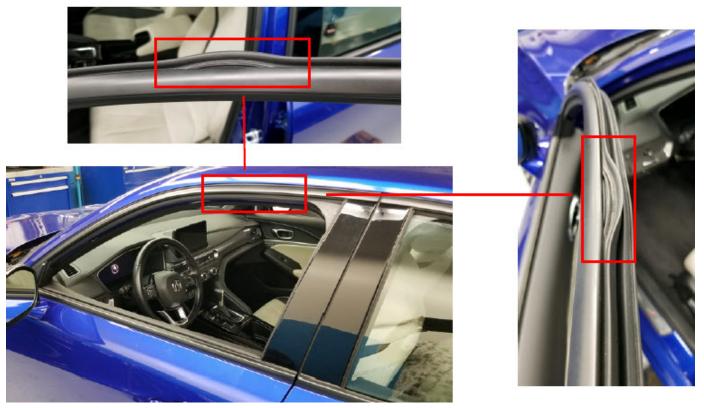
We have seen several claims where dealers state loose or unset weatherstrips at the door sash.

When a car comes in with this condition, you can successfully reinstall an undamaged weatherstrip back in place until permanent countermeasure parts are available.

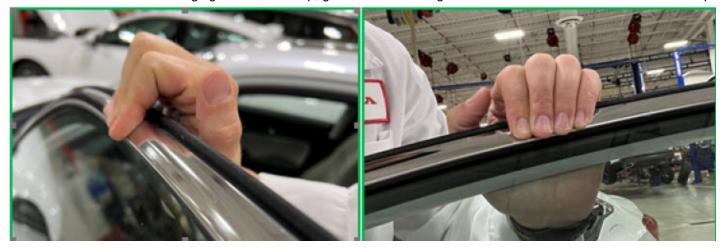
Once the weatherstrip is reattached, carefully suggest to your client that the seal may become dislodged from the door sash if used when exiting or entering the vehicle.

To reduce the chance of dislodging the weatherstrip, grab the outside edge of the door trim rather than the weatherstrip.
