SIB 52 01 21

2023-08-08

SEAT FAILS TO INITIALIZE DUE TO MISSING END STOP

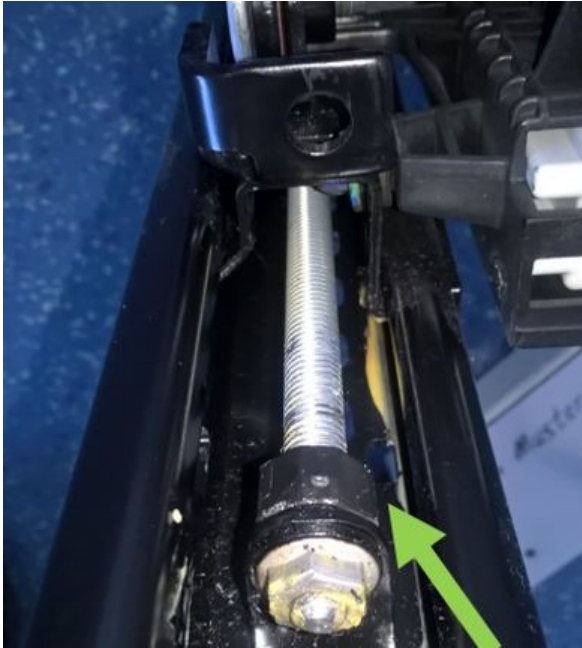
F90 G12 G30 spacer (arrow).

G30 only has a spacer installed on the passenger seat.

1. If this occurs after seat rail replacement, and the new rail **does NOT include the end stop**, then swap the end stop from the original rail.

2. If this occurs after seat rail replacement, and the new rail **does include the end stop**, then confirm the original rail did not have an end stop installed. Remove the end stop from new seat rail.
3. If this occurs after a customer has removed the end stop:
 - Request the customer supply the end stops for reinstallation if still available
 - Order end stop if available separately in ETK, see Parts section below.
 - If the end stop is not available separately in ETK then
 - it may only come with an entire seat rail assembly.
 - contact Parts Technical Support via a TTS TSARA case for support

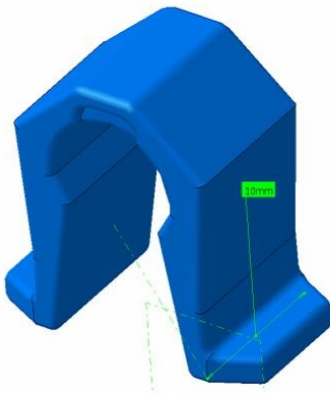
Illustration of the spacer

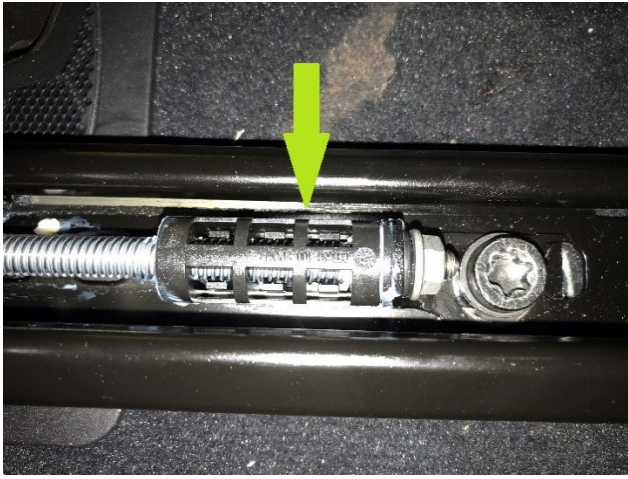
F95 F96 G05 G06 G07 spacer.

Top photo shows end stop (spacer) installed, lower photo shows rail minus the spacer.

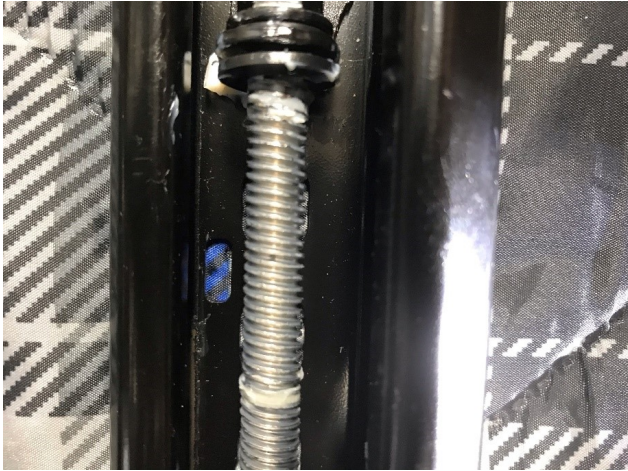
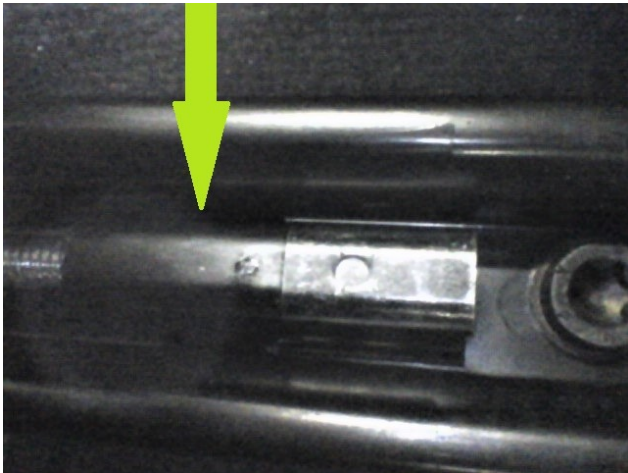
F44 spacer.

Top photo shows end stop (spacer) installed, lower photo shows rail minus the spacer.
