STAR ONLINE PUBLICATION

Case Number: S2305000001

Symptom/Vehicle Issue: Stop/Start Unavailable Message Displayed on Cluster. P258B Diagnostic Trouble Code (DTC) Present.

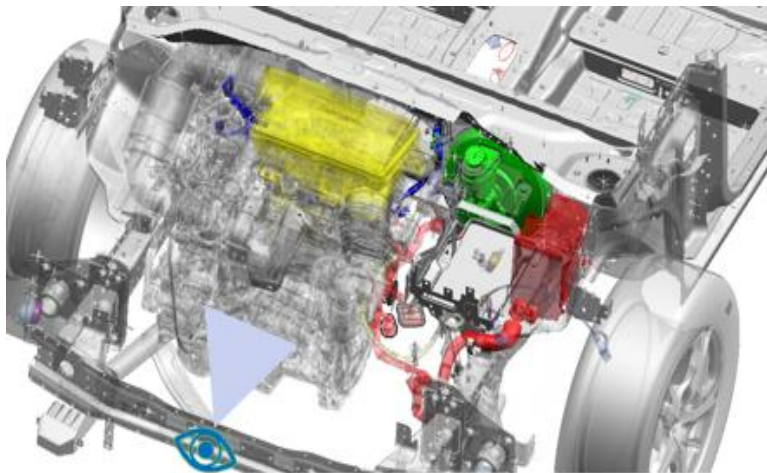
Vacuum Assist system

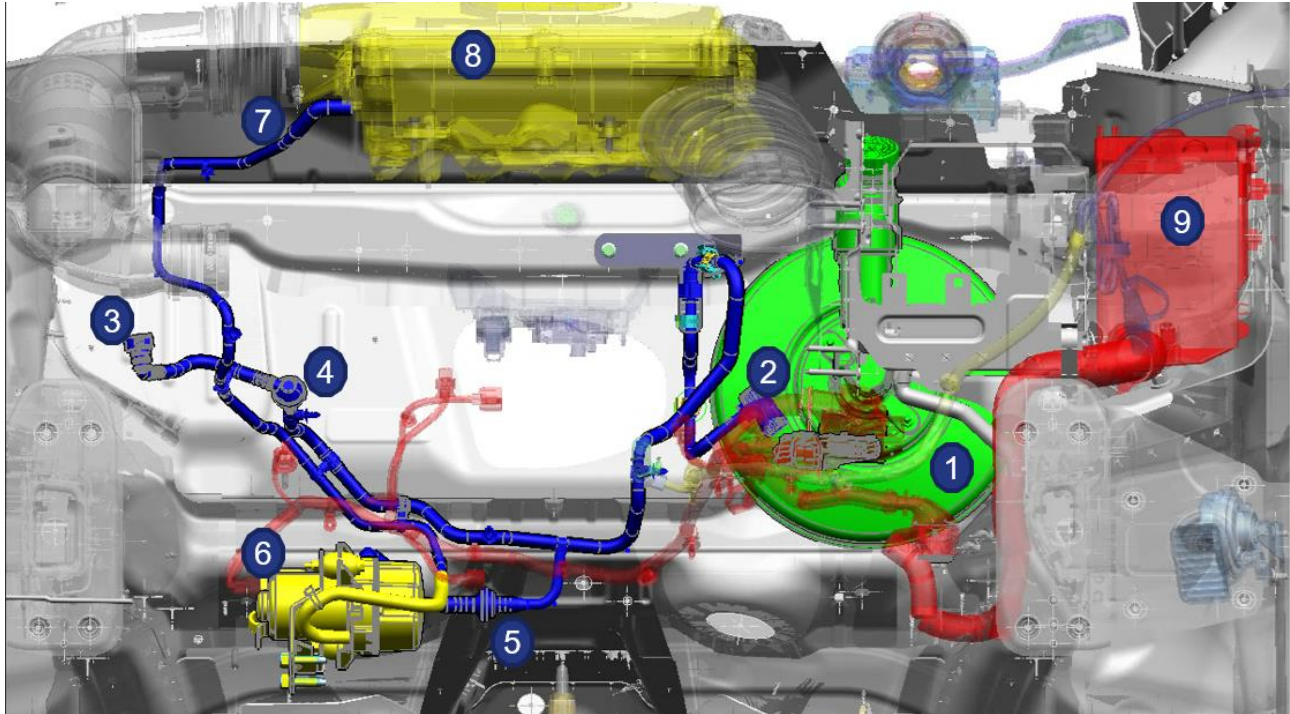
Individual Parts Of The Vacuum Assist System.

1. Brake booster	2. Check valve/ vacuum pressure sensor	3. Engine connection
4. Check valve- Engine path	5. Check Valve -EVP path	6. Electric Vacuum Pump
7. Exhaust air	8. Air Filter	9. PDC box

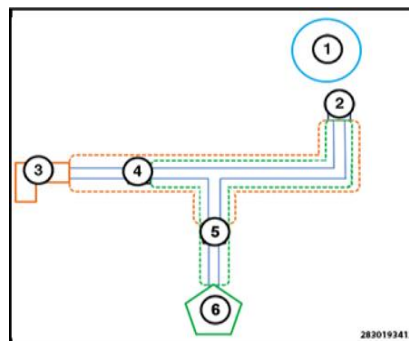
- A. check for leakage in the engine check valve and all the vacuum hose assembly inside the green dashed line (4).
- B. Inspect for Leakage in the EVP connection check valve and all the vacuum hose inside the orange dashed line (5).
- C. Inspect for leakage in the sensor check valve (2).

- If any of the above checks fail, the vacuum hose assembly should be replaced as an assembly.
- If the above vacuum checks pass, continue to CHECKING THE BRAKE BOOSTER SIDE FOR A LEAK.

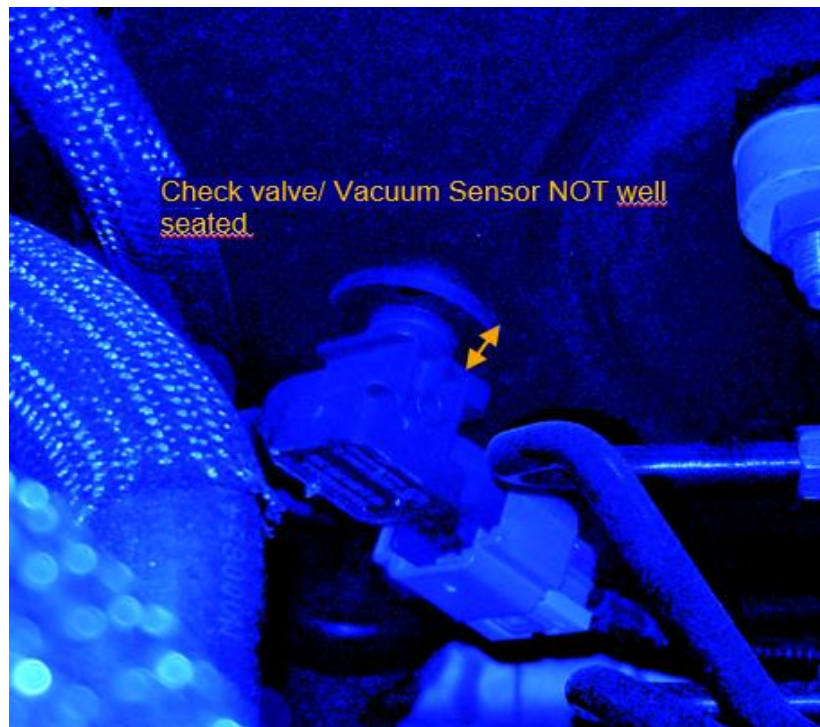
Verify vacuum sensor is seated and seal is not rolled.

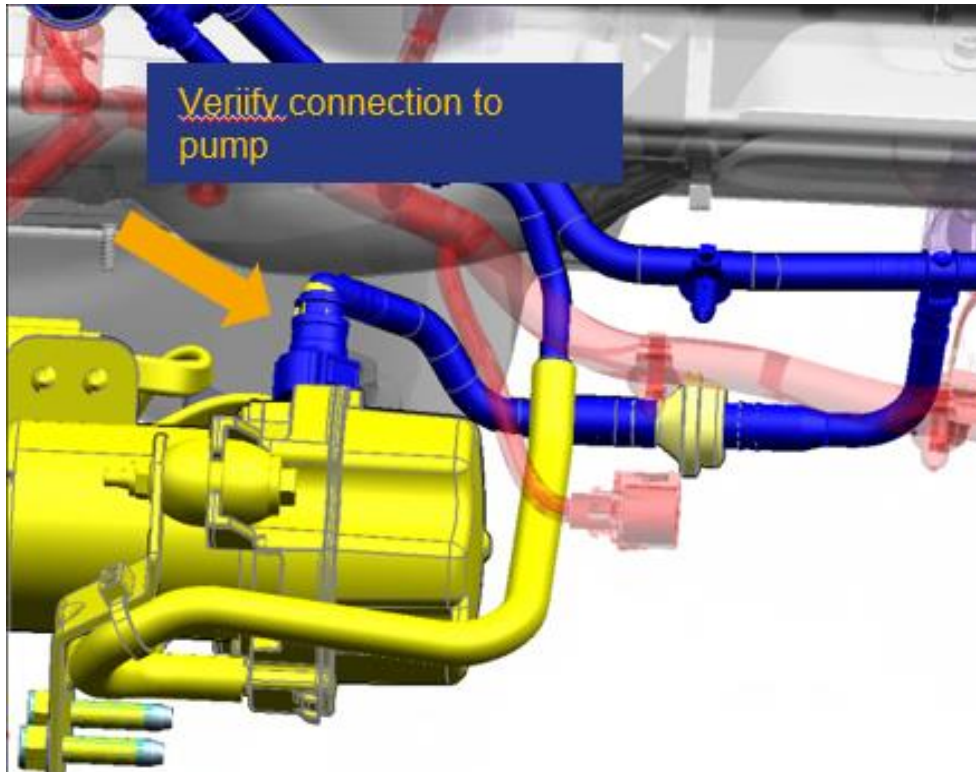
Inspect vacuum hose inlet for factory plug. Remove plug if found.

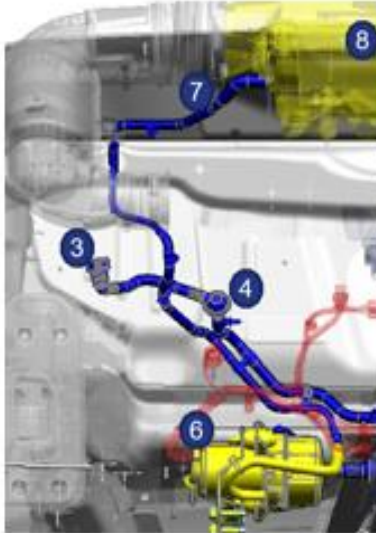
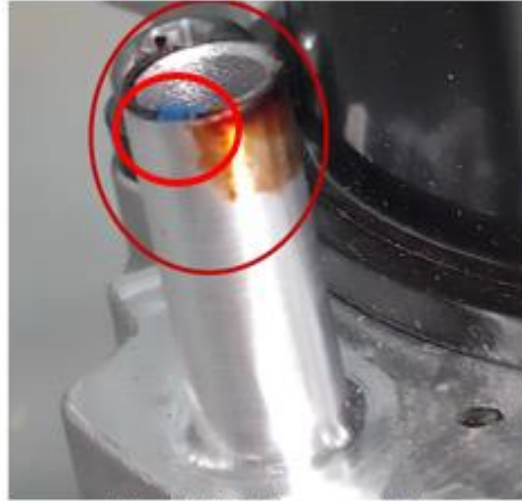
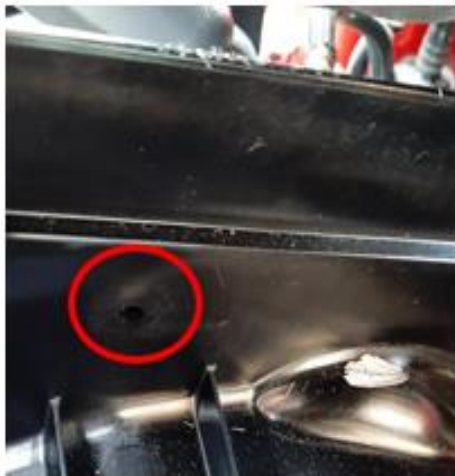
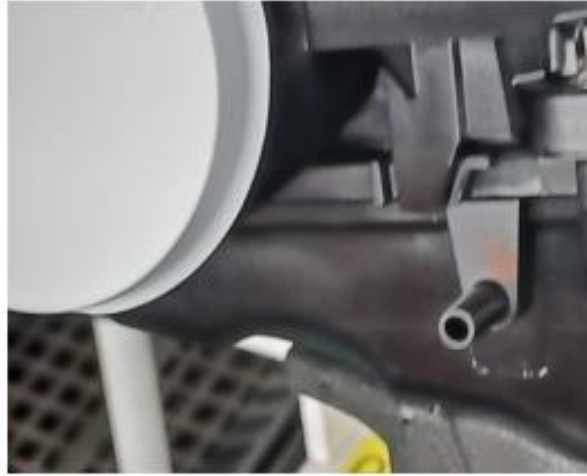
Photo 7: Residue on outlet.

Inspect exhaust hose and connections for contamination and debris. Replace as needed.

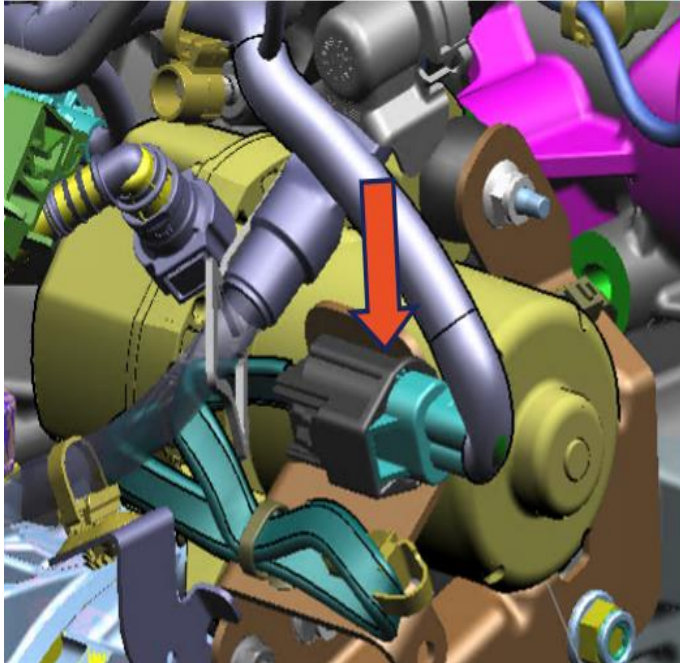
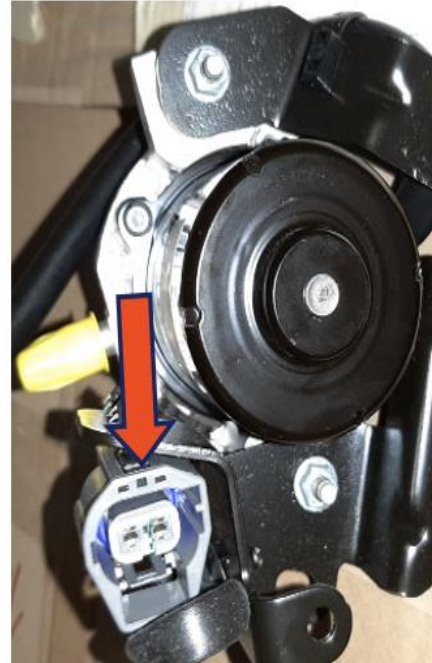
Inspect connections at EVP for pin issues, pin backout, expanded pins.

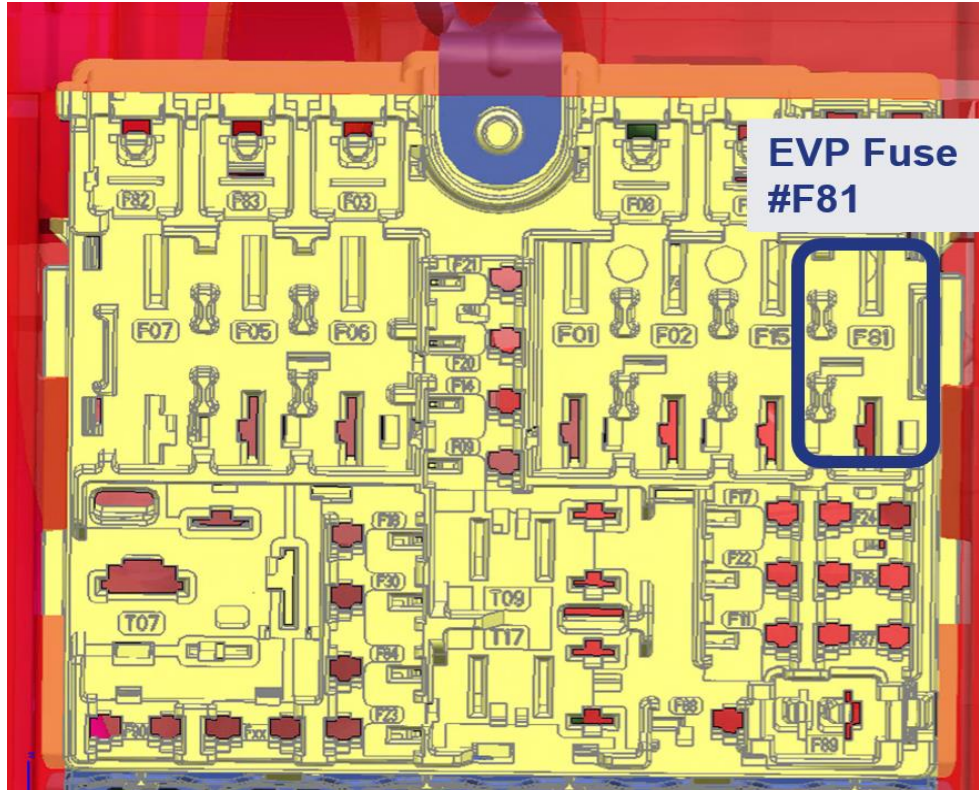
EVP does not operate. Verify fuse condition. If blown, test for shorts or failed EVP.

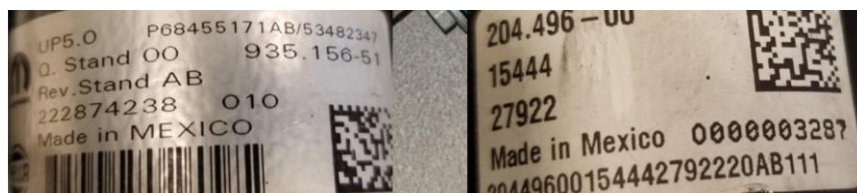
Yellowed or bubbled label is an indication of a possibly overheated pump.
