REFERENCE:	TSB: 23-082-23 GROUP 23 - Body	Date:	July 11, 2023	REVISION:	-
VEHICLES AFFECTED:	2023 (WD) Dodge Durango This bulletin applies to vehicles built on or after March 01, 2023 (MDH 0301XX) on or before March 14, 2023 (MDH 0314XX).	MARKET APPLICABILITY:			
CUSTOMER SYMPTOM:	Door B-pillar applique loose or peeling off door (Fig. 1) .				
CAUSE:	Appliques not properly glued down.

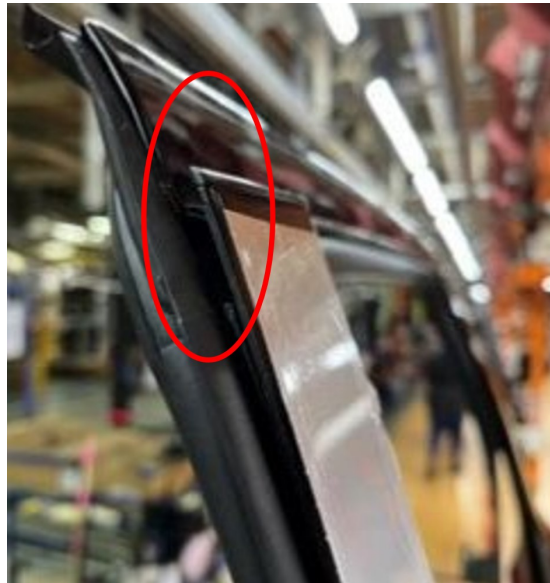
Fig. 1

Door B-Pillar Applique Loose Or Peeling Off

1. Inspect all B-pillar door appliques.
2. Were any door B-pillar appliques loose or peeling off the doors (Fig. 1) ?
 - YES>>> Proceed to [Step 1](#) of the Repair Procedure.
 - NO>>> This bulletin has been completed. Use inspect LOP (23-05-11-99) to close the active RSU.

This bulletin involves inspecting all four door B-pillar appliques and possibly replacing any B-pillar appliques that are loose or peeling off.

1. Replace the door B-pillar appliques as required. Refer to the detailed service procedures available in DealerCONNECT> Service Library under: Service Info>23 - Body / Doors - Rear / Applique / Removal and Installation.
