Technical Service Bulletin

35 Gearbox warning comes on, various DTC memory entries in TCM

35 23 44 2070217/1 September 15, 2023.

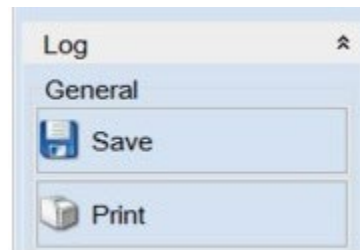
Figure 3. Save Diagnosis Log.

4. It is only possible to deliver the correct control unit if 89 values are read out and transmitted in the global variables under the address DA0002 at the start of the diagnostic session. To check this, save the diagnostic protocol (Figure 3) to the desktop of the scan tool and open it

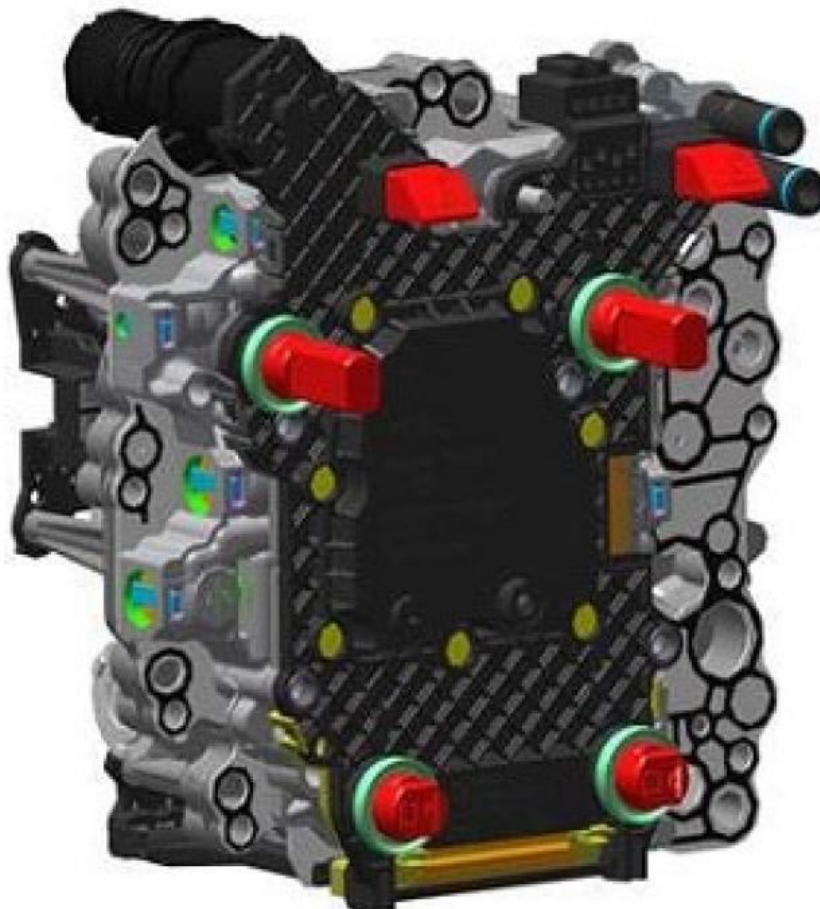
Figure 9. Mechatronics Sensors

**Tip:** The immobilizer must be readapted after replacing the control unit. For this purpose, it is essential that all vehicle keys are present at the time of the repair.
 13. After receiving the required genuine parts, remove mechatronics unit from gearbox according to the repair manual.
 14. The sensors are on the back of the mechatronics unit and must not be touched/damaged. The mechatronic unit must not be placed down on its sensors (Figure 9, red markings).

Touch a suitable earthed object (VAS 6613 ESD Work Surface) before working on electrical components of mechatronic unit. Do not touch the contacts or electronic components directly

You must ensure the highest levels of cleanliness for all work on the mechatronic unit. Even the smallest dirt particles or hairs in the system can lead to restricted functions and ultimately to failure of the mechatronic unit.

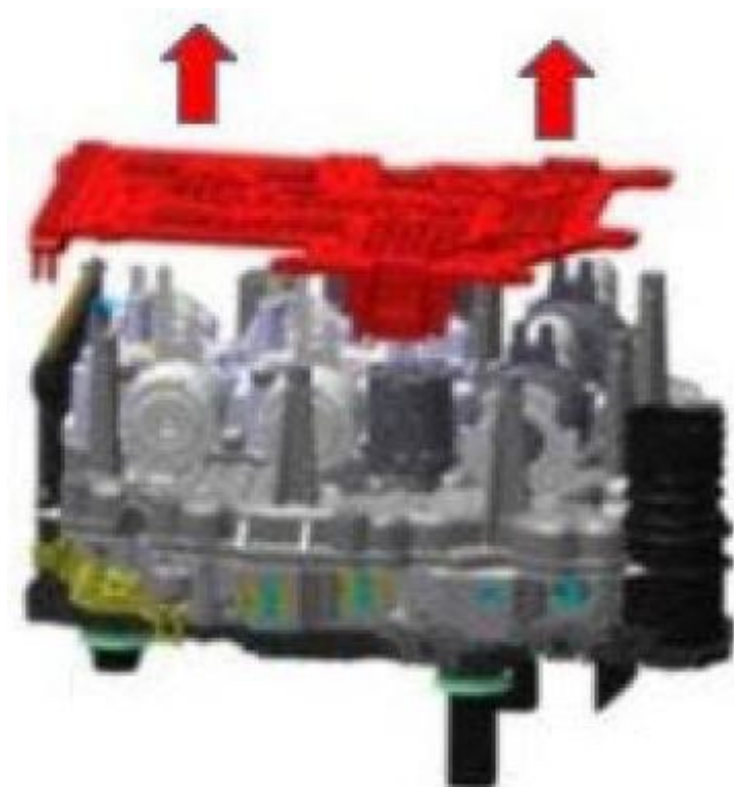
Figure 13. Removing contact plate.

17. Starting at the top corners, detach the contact plate (figure 13, red marking) carefully and evenly (without levering it upwards) from the mechatronic unit. It is essential to ensure that the contacts on the valves are not bent or damaged.
