Technical Service Bulletin

35 Gearbox Malfunction warning on, DTC P17F900 is stored in the TCM

35 23 45 2064312/4 September 20, 2023. Supersedes Technical Service Bulletin Group 35 number 22-42 dated January 14, 2022, for reasons listed below.

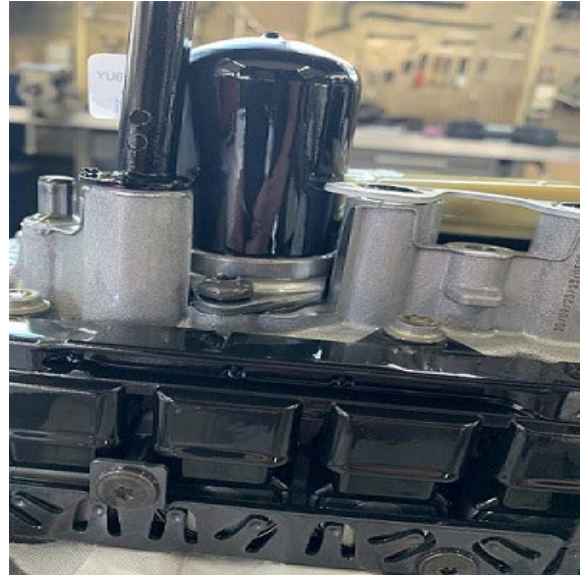
Figure 4. Loose bolts.

One or more bolts are loose (Figure 4).

You may also see the securing ring is not flush to the valve body which would mean the bolts are loose.

If the bolts are loose, replace pressure filter 2 along with the bolts as described in the Workshop Manual. Claim Option 1 in the Warranty Table below.

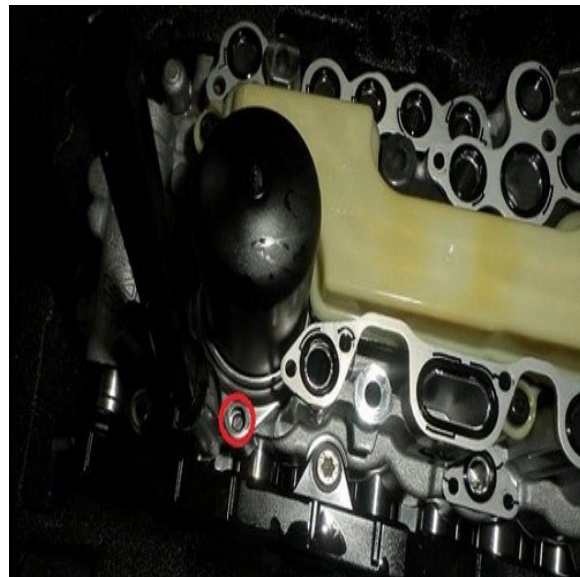
Figure 5. The bolt head is missing.

One or more bolt heads are broken off or missing (Figure 5).

If any of the bolts are broken, replace the Valve Body and reuse the Transmission Control Module per the Elsa Repair Manual. (If no valve body is available for your vehicle replace the Mechatronics unit and note this on the repair order). Claim Option 2 in the Warranty Table below.
