STAR ONLINE PUBLICATION

Case Number: S2023000037 Rev.C

Symptom/Vehicle Issue: Wind Whistle Noise From Dash A Pillar Area While Driving

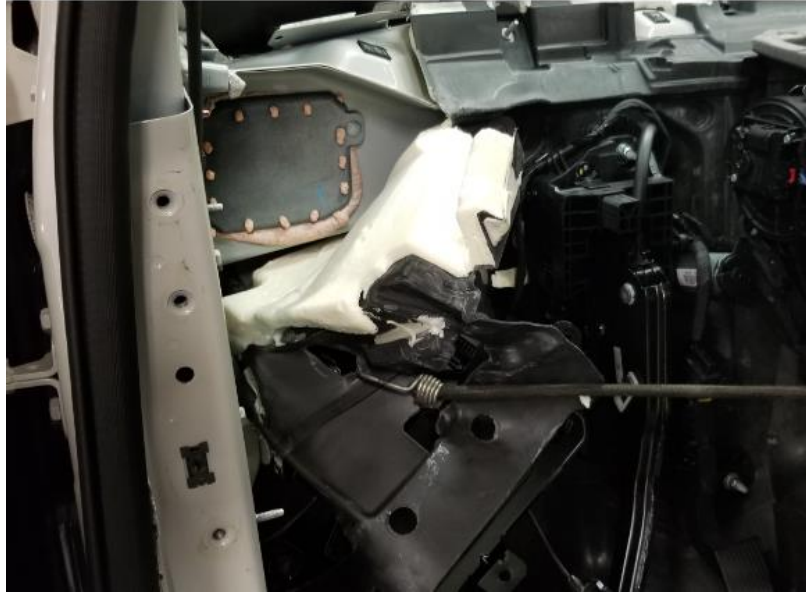
IP rolled back and deadener pad moved to provide access on WS

NOTE>> Images below have the dash removed for clarity. On WS vehicles the Instrument Panel (IP) will have to be “rolled” to access the area due to a sound deadener pad installed.

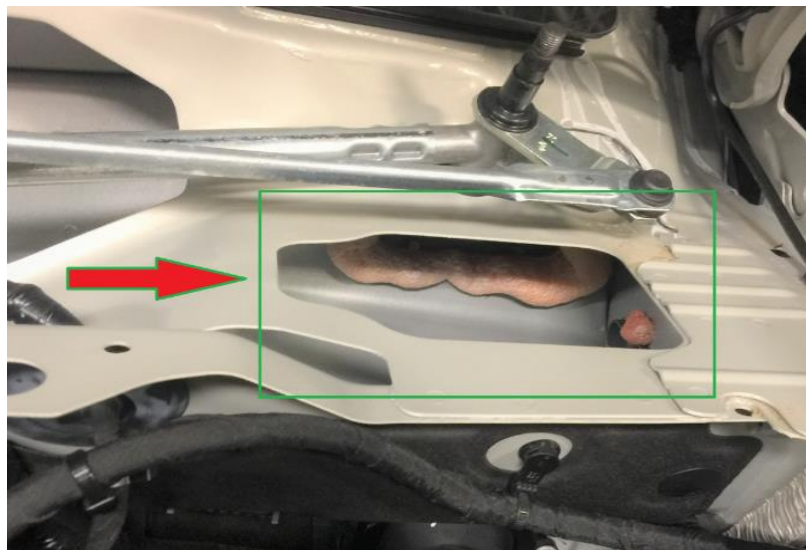
Direct compressed air into the cowl corners while soapy water testing from the interior

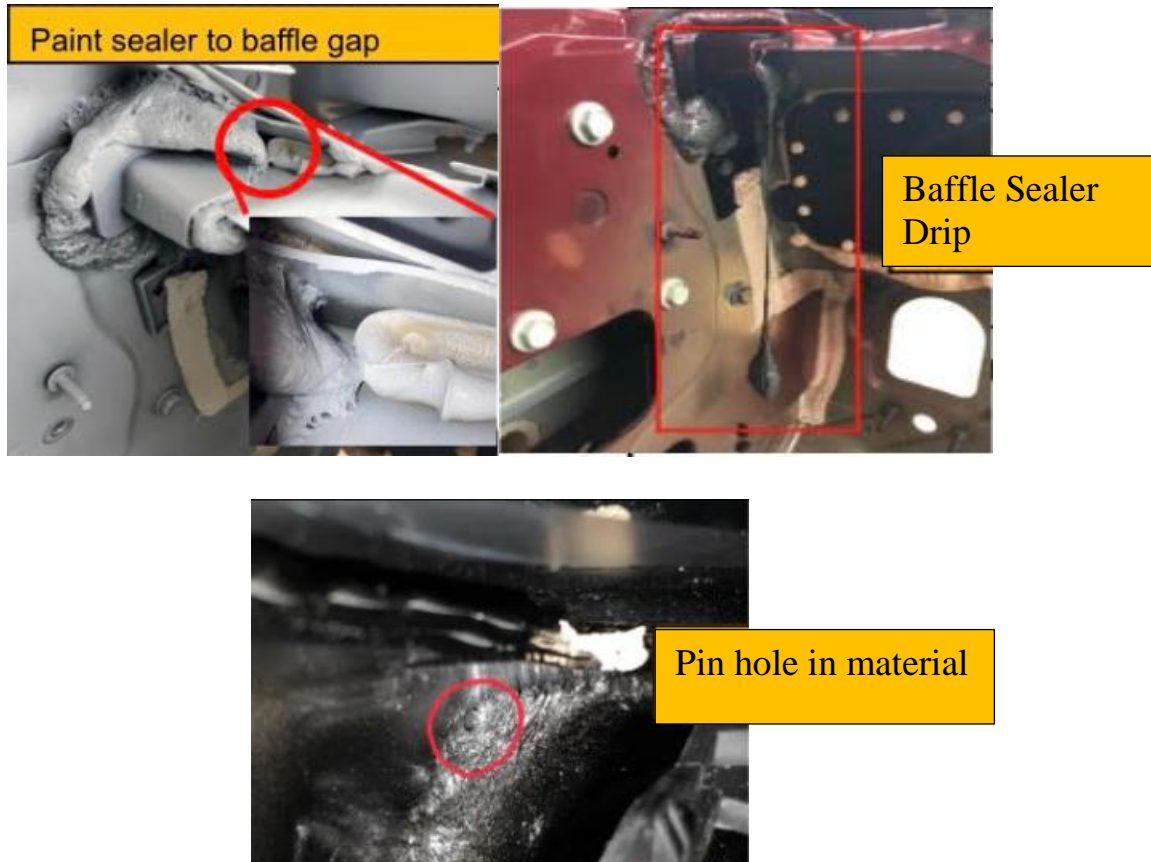
Dash cowl area at base of windshield A-pillar
