STAR ONLINE PUBLICATION

Case Number: S2324000012

Symptom/Vehicle Issue: Customer Indicates Whistle Noise Coming From The Rear Of The Vehicle.

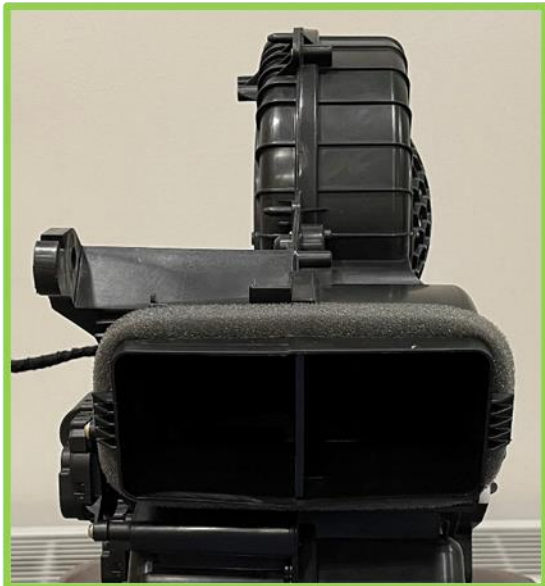
Correct HVAC Module Outlet Seal

Discussion: Remove foam seal from rear HVAC housing outlet and replace the seal with a new seal. Ensure it is properly seated prior to HVAC outlet installation.

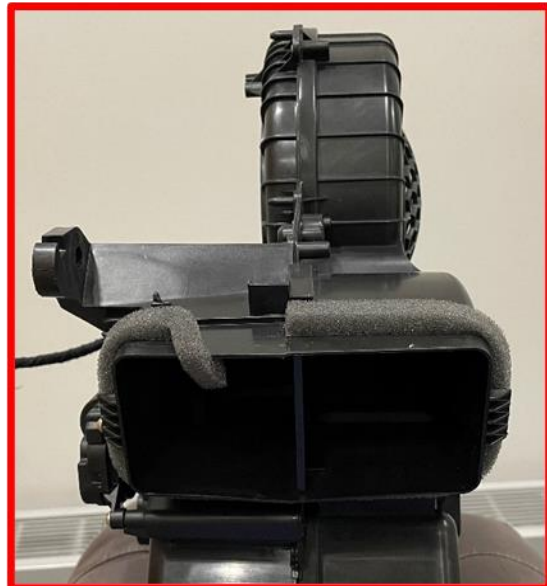
Customer Complaint/Technician Observation: Piece of the foam seal around the rear HVAC outlet is out of place.

Incorrect HVAC Module Outlet Seal
