STAR ONLINE PUBLICATION

Case Number: S2308000104

Symptom/Vehicle Issue: Passenger Front Door Speaker Is Inoperative. B1404-1A Front Right Audio Speaker Output-Circuit Resistance Below Threshold Set In The Radio

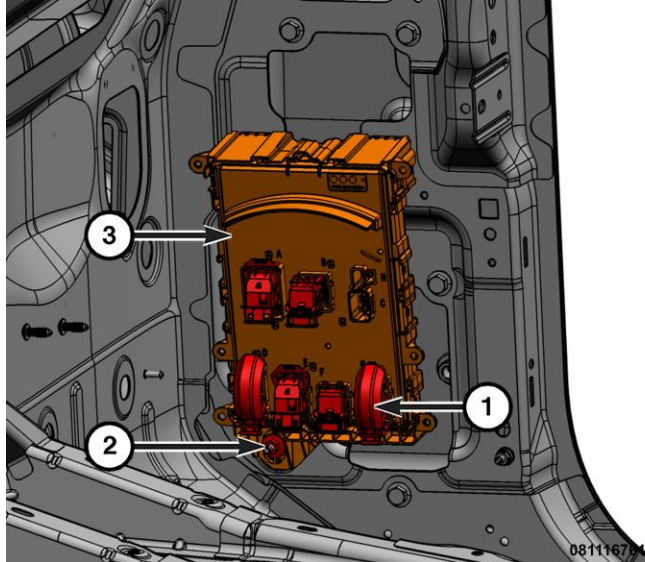
This concern could be caused by the passenger front door speaker wiring, circuits X154 and/or X156 being pinched behind the BCM.

View Off BCM Mounting On Passenger Footwell/A-Pillar

Repair: If you find that the speaker wiring is damaged, remedy using standard wiring repair methods. Ensure the body harness is fully secured by the clip behind/near the BCM.

Reinstall the BCM back in position while verifying it will no longer cause damage to the harness.

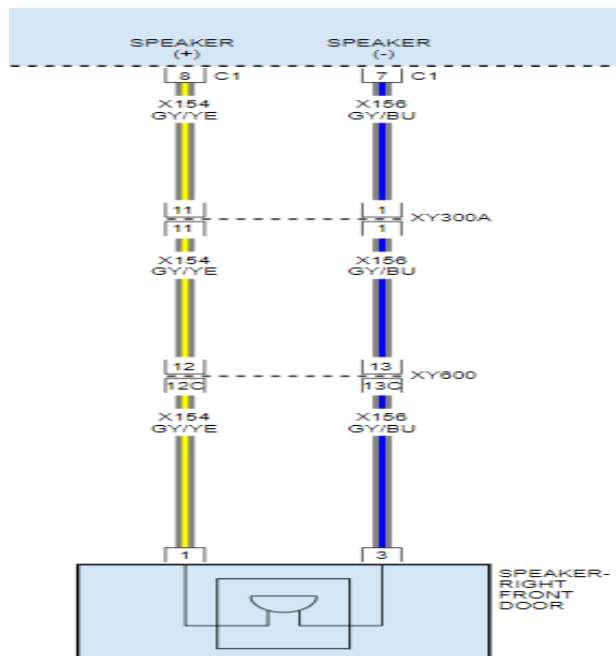
Passenger Front Door Speaker Circuits X154 and X156
