STAR ONLINE PUBLICATION

Case Number: S2324000013

Symptom/Vehicle Issue: Customer Indicates A/C Blows Warm

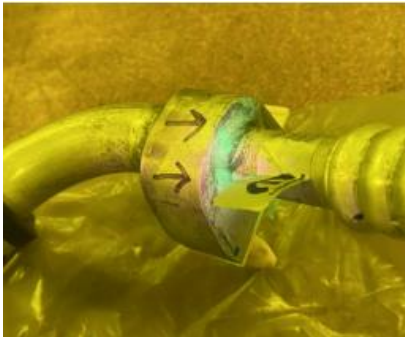
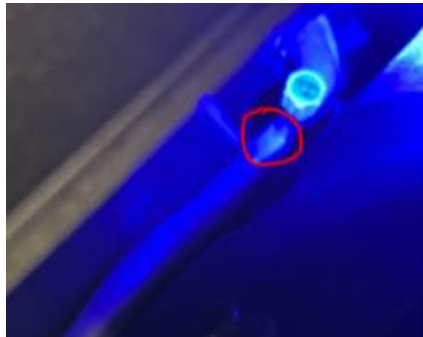
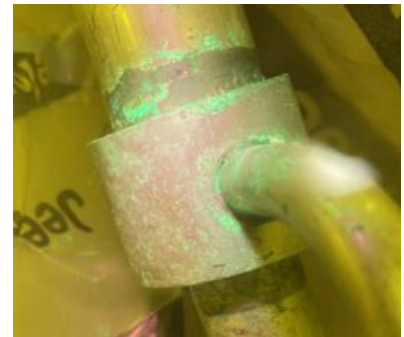
Suspect locations are joint leaks and braze welds.

Example of leak locations below.

Discussion: Using a UV light source and eyeglasses it is necessary to isolate and determine the source of the leak. On any vehicle that has less than 500 miles it may be necessary to add dye, operate the vehicle and retest to locate and isolate leak locations.
