# CUSTOMER SATISFACTION NOTIFICATION

## Right Rear Axle Shaft

Reference: 26A

2021 – 2022 (JT) Jeep Gladiator

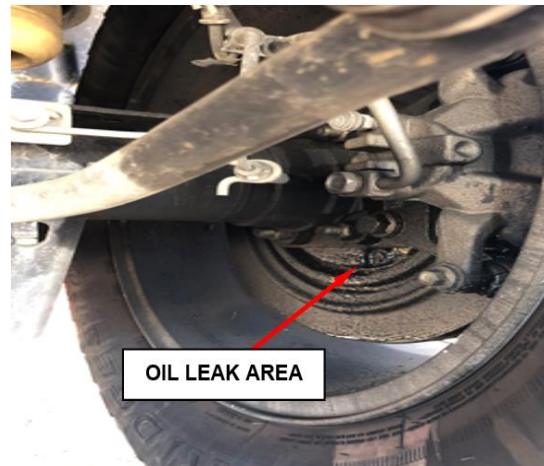
Figure 1 – Right Rear Axle

1. Raise vehicle on hoist.
2. Visually inspect right side axle shaft backing plate for any oil residue (Figure 1).
3. Did you find any evidence of oil residue?

Inspect and replace the right rear axle shaft if found to be leaking oil after the vehicle has accumulated over 10,000 miles.
