## Technical Service Bulletin

<b>GROUP</b>	<b>NUMBER</b>
<b>CAMPAIGN</b>	<b>23-01-079G</b>
<b>DATE</b>	<b>MODEL(S)</b>
<b>SEPTEMBER 2023</b>	<b>GV70 ELECTRIFIED (JK1A EV)</b>

**SUBJECT:** DOOR TRIM PANEL INSPECTION & REPLACEMENT  
(SERVICE CAMPAIGN T34G)

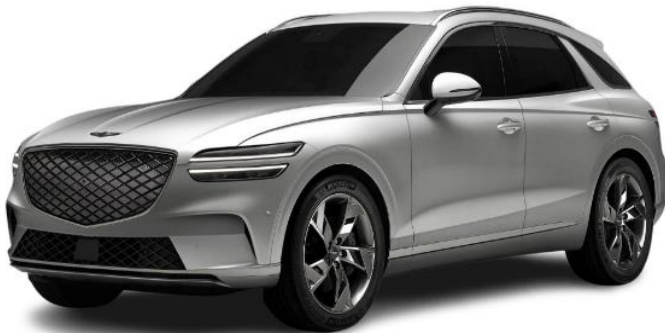
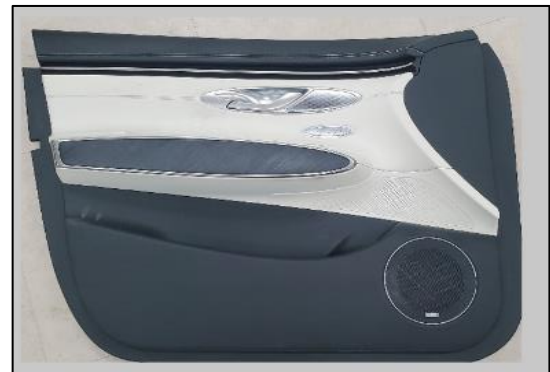
Driver's Side Front Door Trim Panel

**Description:** This TSB provides the procedure to inspect and, if necessary, replace the door trim panel(s) on certain 2023MY GV70 Electrified (JK1A EV) vehicles. The affected door trim panels are produced within specific dates and may exhibit separation of the materials.

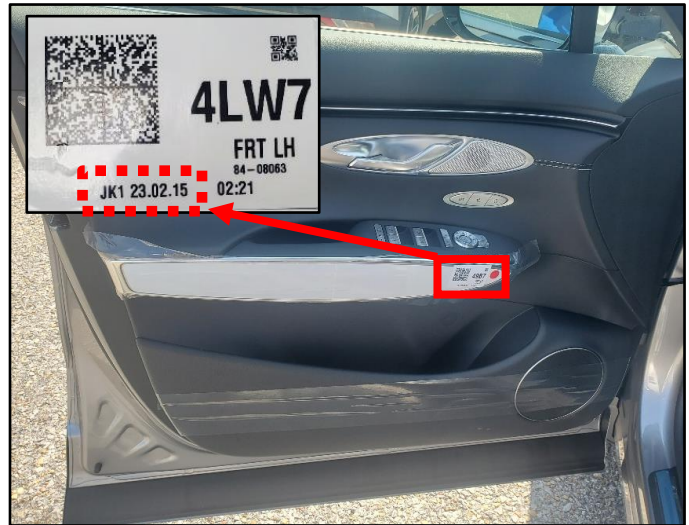
1. If the label is visible on the door trim panel in the area shown:
  - Refer to the date on label.
  - If the date is between 2/1/2023 – 2/24/2023, replace the door trim panel.
  - If the date is outside of that range, do not replace the door trim panel.

Date code format is YY.MM.DD.  
Example: “23.02.15” is February 15, 2023. This door trim panel would be replaced.

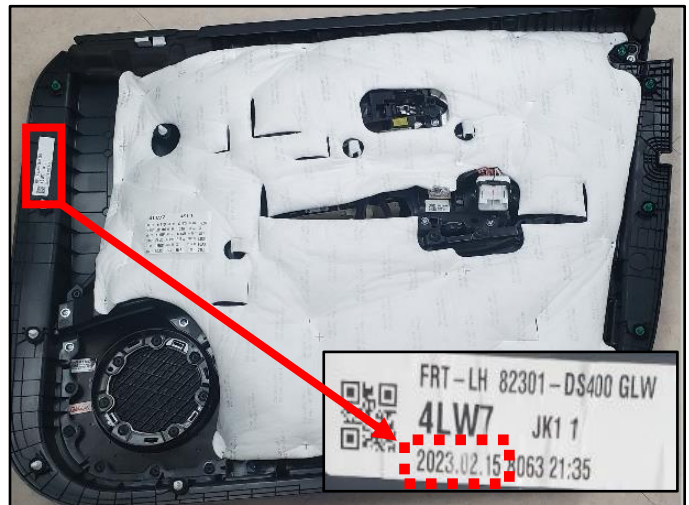
2. If the label is not visible on door trim panel:
  - Remove the door trim panel and locate label on the inside as shown. Refer to Shop Manual:
    - **Body (Interior/Exterior/Electrical) > Front Door > Front Door Trim > Removal and Installation**
    - **Body (Interior/Exterior/Electrical) > Rear Door > Rear Door Trim > Removal and Installation**
  - If the date is between 2/1/2023 – 2/24/2023, replace the door trim panel.
  - If the date is outside of that range, do not replace the door trim panel.

Date code format is YY.MM.DD.  
Example: “23.02.15” is February 15, 2023. This door trim panel would be replaced.

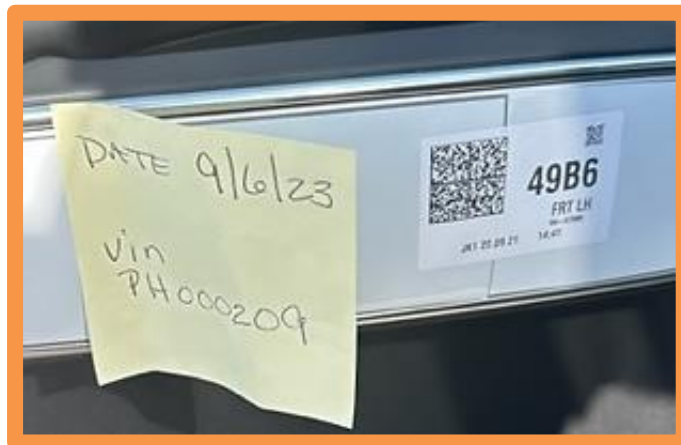
**Example of STUI photo (label visible)**

Using STUI, take a photo of the label clearly showing the date, and a piece of paper with the last 6 digits of the VIN and the date of repair.

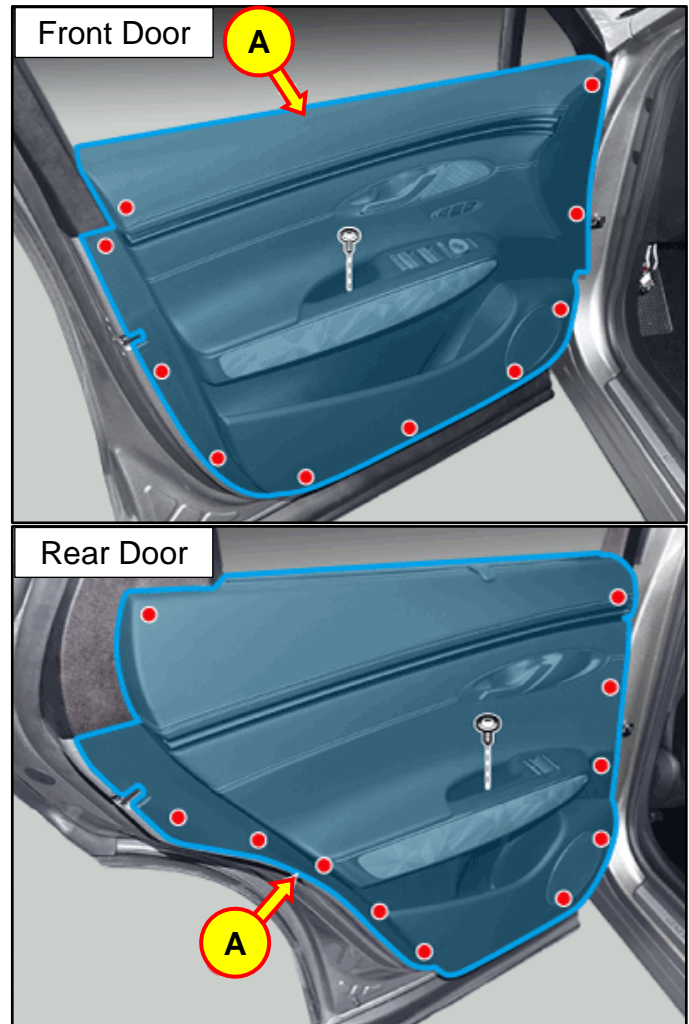
1. Replace the door trim panel (A) if date on label is between 2/1/2023 – 2/24/2023.

Refer to Shop Manual:

- **Body (Interior/Exterior/Electrical) > Front Door > Front Door Trim > Removal and Installation**
- **Body (Interior/Exterior/Electrical) > Rear Door > Rear Door Trim > Removal and Installation**

Be careful not to damage any parts during removal and installation.

Replace any damaged clips as necessary.
