Technical Service Bulletin

GROUP CAMPAIGN	NUMBER 23-01-075H
DATE SEPTEMBER 2023	MODEL(S) IONIQ 5 (NE1)

SUBJECT: ACTIVE AIR FLAP (AAF) ACTUATOR REPLACEMENT
(SERVICE CAMPAIGN TAI)

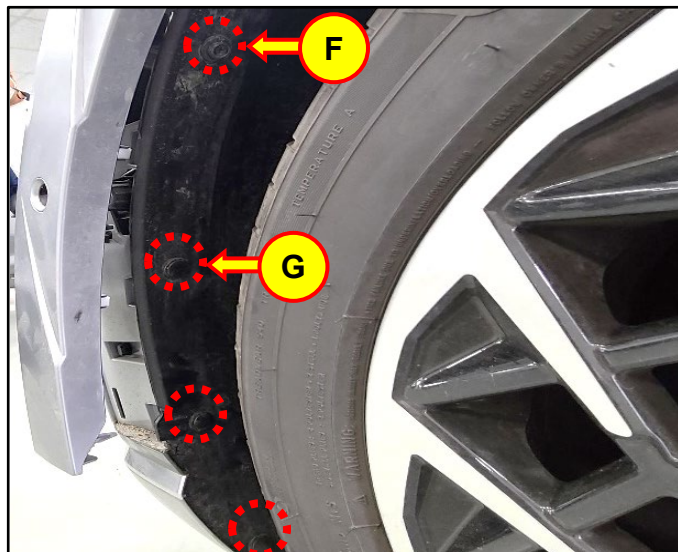
7. Loosen the mounting screws (F) and the clips (G) on the side of the front bumper to separate the side.

Do **NOT** damage the front bumper side hook.

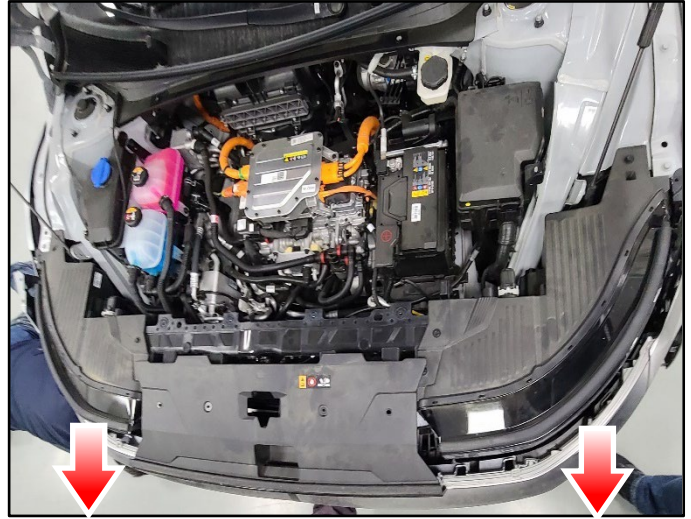
8. Remove the front bumper assembly.

Do **NOT** damage the front bumper covers and panels.

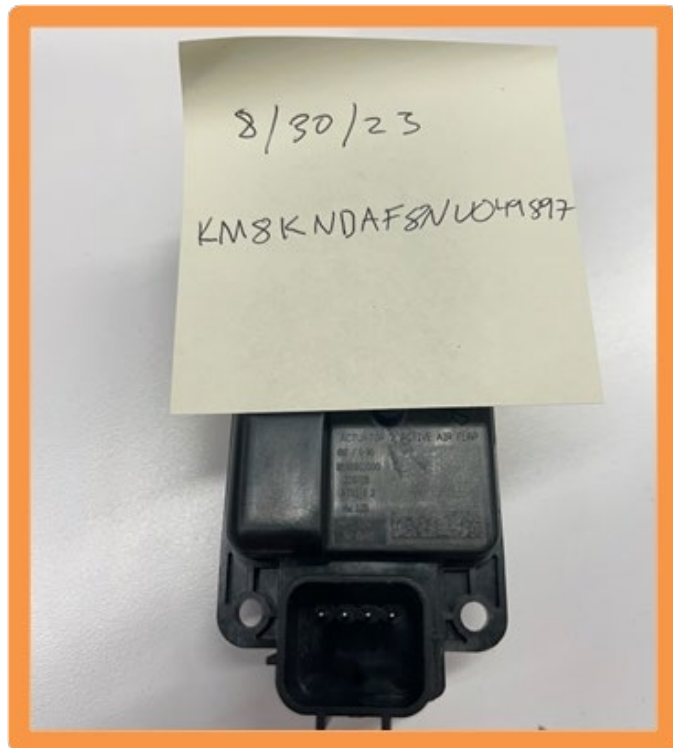
Using STUI, take a photo of the new active air flap actuator that will be installed with the last 6 digits of the VIN and the date of repair on a piece of paper.

Upload the photo to STUI.
