## Credit Procedure

Table 3. Main Harness Rerouting

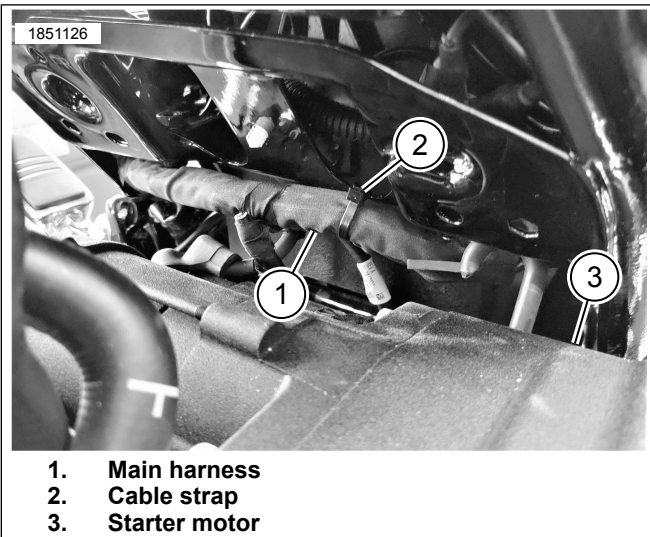
Figure 2. Secure Cable Strap

1. Main harness
2. Cable strap
3. Starter motor
