SERVICE BULLETIN

NUMBER: 12-299-20R
DATE: 09/04/2020
REVISED: **09/28/2023**

SUBJECT: 6/8-way and Driver's Seat Hinge Cover-Design Change

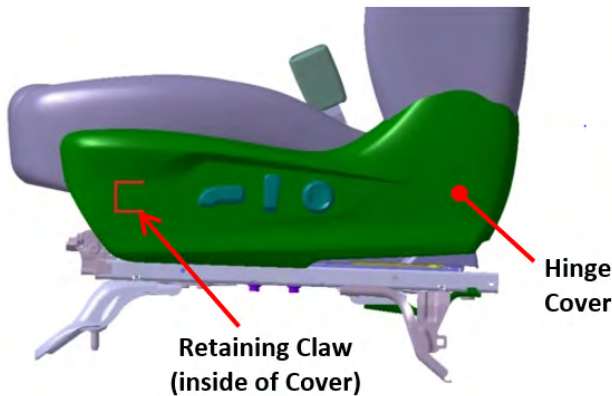
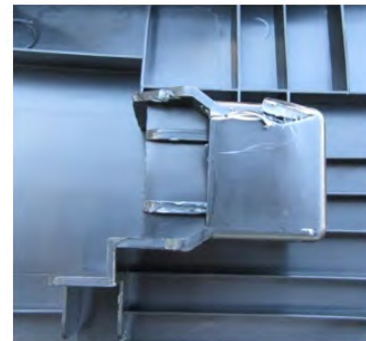
This bulletin announces a design change made to the outer hinge cover on the driver's 10-way adjustable power seats. The change has been made to address several reports about the cover coming loose over time as a result of getting into and out of the driver's seat. The retaining claw portion securing the cover to the seat frame has been changed to improve its strength and durability.

Enlarged View of Damaged Claw

The new Hinge Cover was incorporated into production as listed below:

- Forester: **PH522911**
- Crosstrek: M8251680
- Outback & Legacy: TBD

Description	Part Number	Application
COVER-HINGE FRONT SEAT OUTER LEFT	64115SJ232VH	For 10-way power seat
	64115AN15B	
	64115FL311VH	For 6/8-way power seat
COVER-HINGE FRONT SEAT OUTER RIGHT	64115SJ201VH	For 8-way power seat
	64115AN16B
