**Document ID:** IK2200109

## Title: Bus Seat Back Foam Inspection Guidelines

### Applies To: All Bus Models

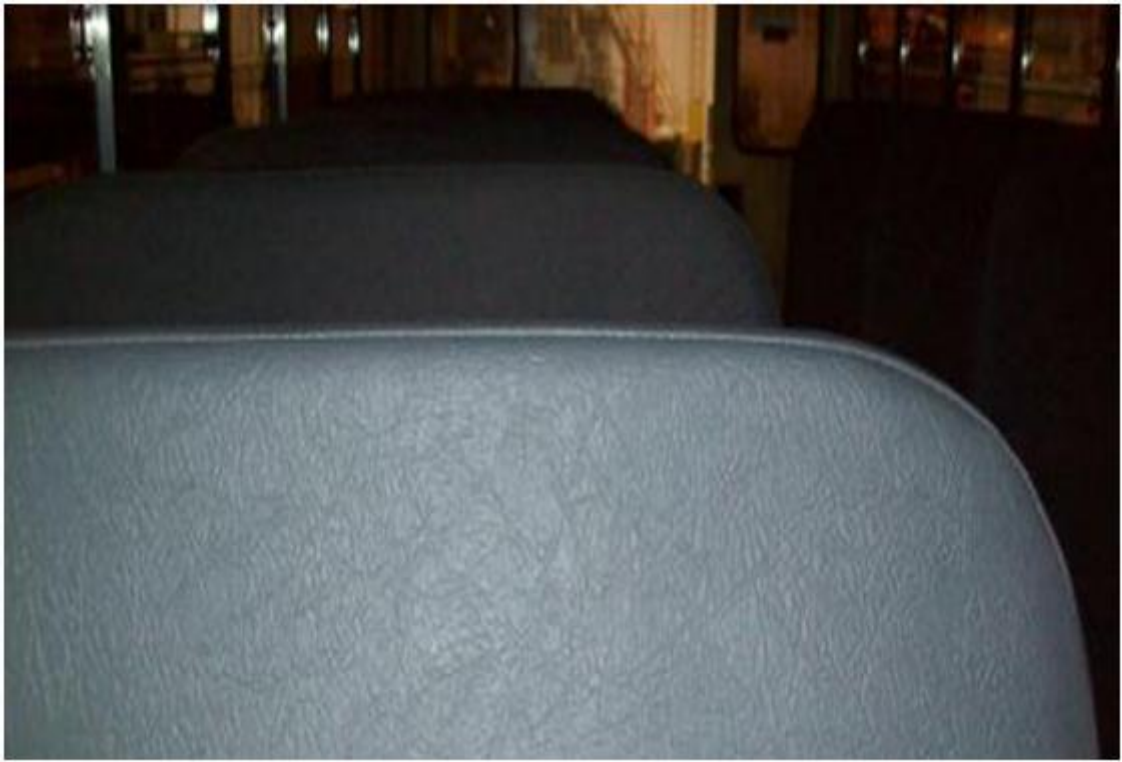
Reasons for removal of the seat back upholstery and foam for further inspection.

- Separation of the seat back foam allowing contact between vinyl and seat frame.
- Separation of glue seams around the radius of the back which can be visually seen.
- Corners of the seats back foam rolled toward the back of the bus.
- Separation of glue seams at the bottom of the backs along the aisles.
