## HEADLAMP WASHER JETS LEAKING

- 20–23MY Defender

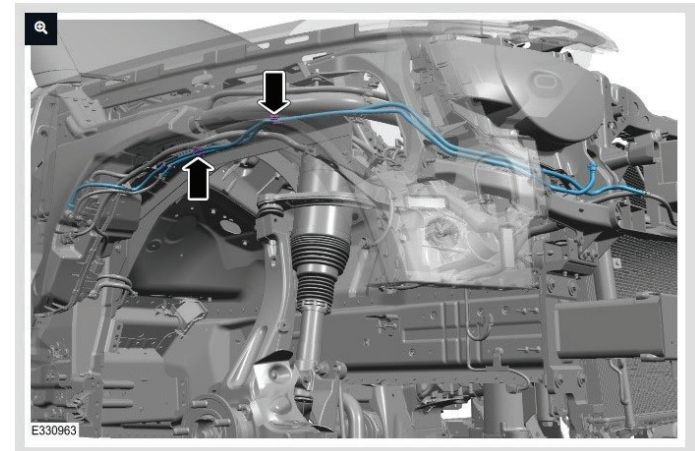
- The headlamp washer jet nozzles are leaking fluid when not operating the washers.

- The check valve in the headlamp washer jet hose assembly may not be sealing properly, allowing washer fluid to siphon out of the wiper jet nozzles.

- **SSM 76076** has been published to address this concern.
- Revised washer one-way check valves are being introduced in production.
- The check valves are only serviced as a headlamp washer hose assembly.
