GROUP	MODEL
ELE	2024MY Telluride (ON) w/Rear HVAC Control
NUMBER	DATE
308	October 2023

TECHNICAL SERVICE BULLETIN

SUBJECT: SERVICE ACTION: REAR HVAC OPERATION INSPECTION AND REPLACEMENT (SA544)

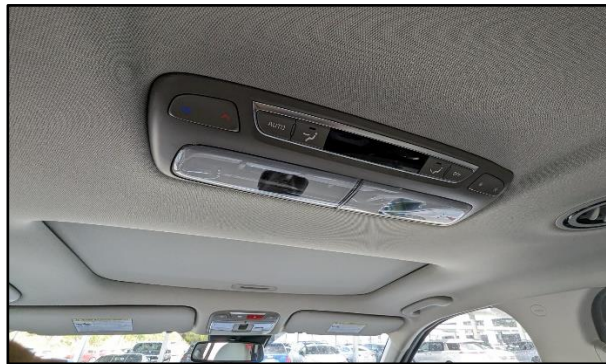
This bulletin provides information to inspect the rear heater control operation on certain 2024MY Telluride (ON) vehicles produced from June 13, 2023 through July 24, 2023, which may exhibit abnormal communication with the AVN head unit, causing the touchscreen controls to be inoperative when attempting to adjust the heating ventilation air conditioning (HVAC) settings. It is possible that during assembly, the affected vehicle may have a rear Heater & A/C Control Unit installed with the incorrect software. Follow the procedure outlined in this publication to confirm the rear heater control operation and if inoperative, replace the rear Heater & A/C Control Unit with a new part. Before conducting the procedure, verify that the vehicle is included in the list of affected VINs.

- Replace the rear heater controller (A) by referring to "Heating, Ventilation, and Air Conditioning → Controller → Heater & A/C Control Unit → Removal and Installation" in the applicable Shop Manual on KGIS.
- Confirm normal operation of the rear heater control selection on the new control unit and via the AVN head unit.

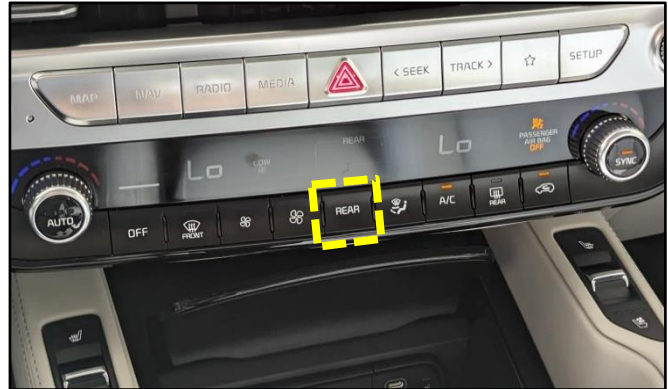
2. Select 'REAR' on the front heater controller (A) to display the rear HVAC controls on the AVN screen.

Note: Ensure you're adjusting the rear HVAC settings on the AVN head unit.

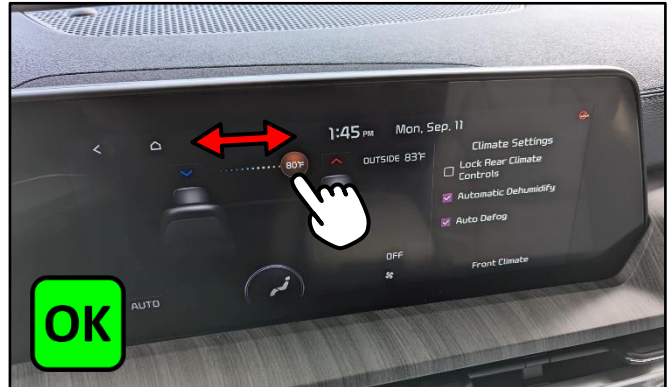
- If the **temperature sets (OK)** to the desired setting and controls operate normally, proceed to step 4.

Temperature set to 80 (Hot) from 'LO' (Cold).

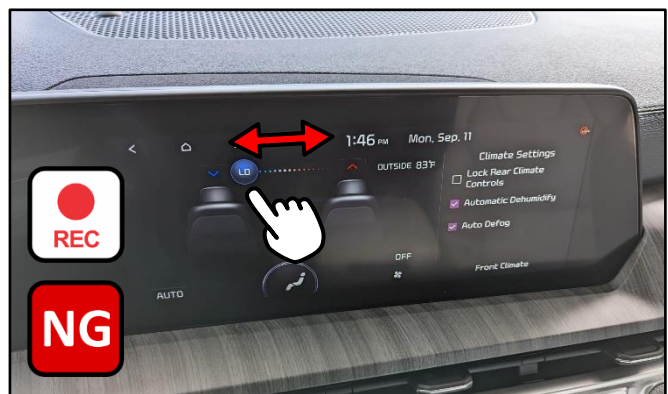
- If the **temperature does not set (NG)**: reverts to the previous temperature setting when finger is removed from the AVN screen, or the control is inoperative, then record a KVID video starting from the VIN label on the door and then showing the NG condition on the AVN screen. Proceed to the 'Replacement Procedure' on page 4.

Temperature set to 'LO' (Cold) but returns to 80 (Hot) When the finger is released from the screen.

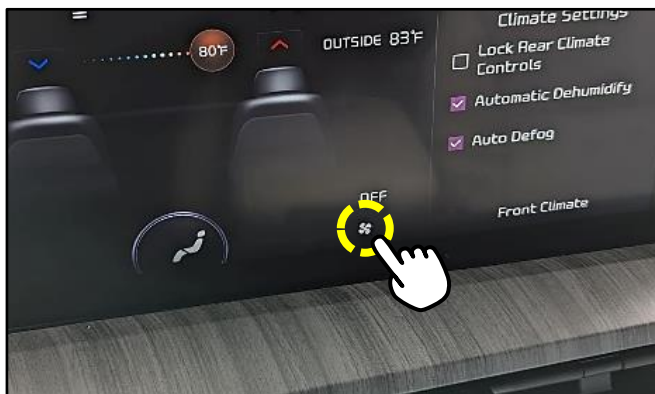
- On the AVN screen, select the 'fan' speed icon to enter the fan blower speed control.

Note: Ensure you're adjusting the rear HVAC settings on the AVN head unit.

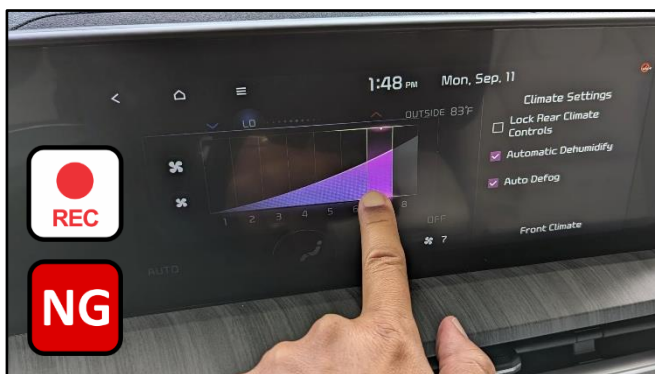
- If the 'fan' blower speed does not set to the desired setting (NG); reverts to the previous fan blower speed setting when finger is removed from the AVN screen, or the control is inoperative, then record a KVID video starting from the VIN label on the door and then showing the NG condition on the AVN screen. Proceed to the 'Replacement Procedure' on page 4.

Fan blower does not set to desired speed/reverts to old setting.
