87 Air conditioning does not cool - P053000, P251500 stored in C5

87 23 55 2068460/5 October 2, 2023. Supersedes Technical Service Bulletin Group 87 number 23-50 dated August 10, 2023 for reasons listed below.

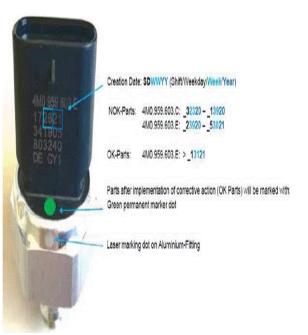
- 2. Inspect the markings on the sensor to determine if the sensor has been previously replaced with an improved sensor produced after Calendar Week 31, 2021. Figure 1 shows the locations of the markings and their interpretation. In this example, while the sensor is an 'E' index sensor, contains a green dot on the connector housing and a laser marking on the aluminum housing the build date of the sensor is *before* Calendar Week 31, 2021, and would require replacement.

Figure 1. Pressure and temperature sensor markings and build date.

The presence of the green dot on the sensor is not the sole, conclusive evidence of the sensor being of the improved type. The green dot was applied in production as an immediate identification of an improved sensor but the green dot was not applied indefinitely. Always check the sensor date as this is the confirmation of the sensor status.

3. A sensor with index 'E', produced after Calendar Week 31, 2021, has a laser marking on the aluminum housing and may or may not contain a green dot on the connector housing is of the improved type and need not be replaced.
