Subject: N232413240 - Service Update  
Air Conditioning Hoses Twisted

Models: 2023 – 2024 Cadillac LYRIQ

# Service Update

## N232413240 Air Conditioning Hoses Twisted

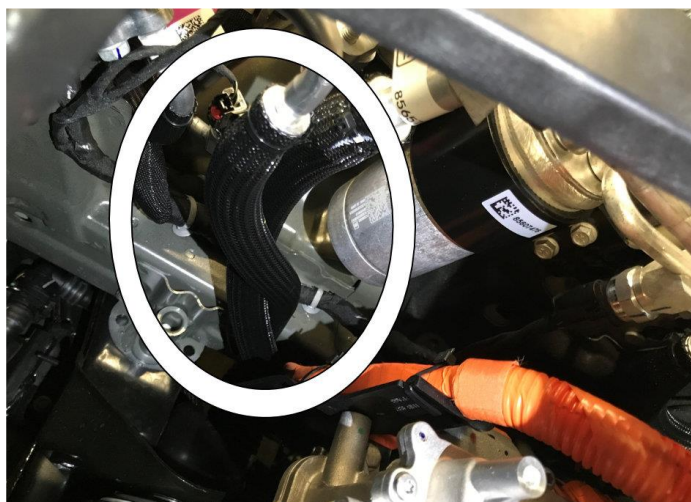
6440329

2. Inspect the Air Conditioning Compressor Hose and Air Conditioning Evaporator Hose for twisting.
  - If the two hoses are twisted around each other, proceed to Step 3.
  - If the two hoses are NOT twisted and run parallel with each other, proceed to Step 16.
3. Recover the Refrigerant. Refer to *Refrigerant Recovery and Recharging* in SI.

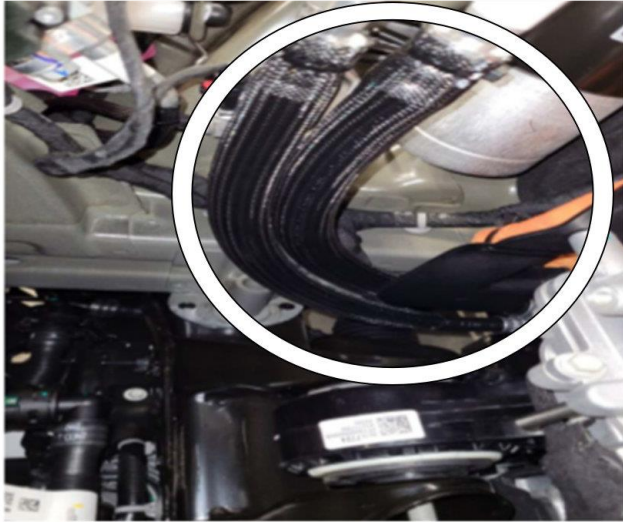
6440887

9. Re-route the Air Conditioning Evaporator Hose from the Air Conditioning Compressor Hose, so that they run parallel to each other.
