Service Bulletin

23-033

2022-23 MDX Popping/Crackling from the Speakers; Display Blank

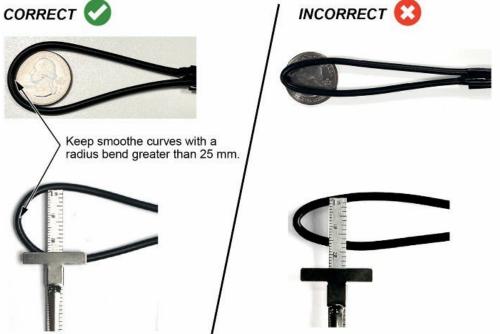
Attach the FAKRA service cables and splice boxes to the appropriate component harness with tape to prevent any rattles.

8. Once the FAKRA splice repair service cables and splice boxes have been attached to the cable connection, tape the splice boxes and FAKRA service cables to the appropriate component harness.

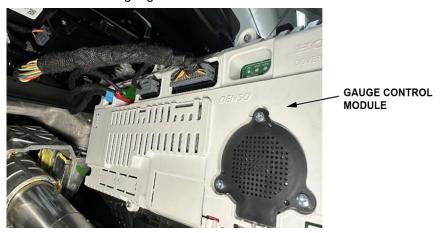
1. Locate and turn the gauge control module to access the rear connectors.

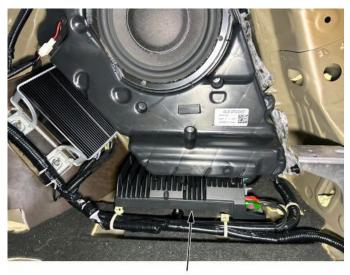
STEREO AMPLIFIER

1. Disconnect the red and green FAKRA connectors at the stereo amplifier.

Disassemble the connectors one at a time to avoid swapping the green and red wires.

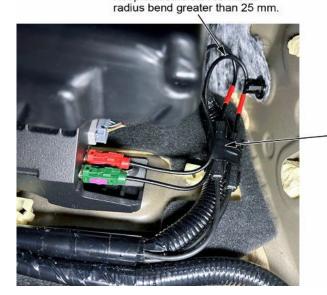
- See the above section FAKRA Connector Housing Disassembly/FAKRA Splice Repair Service Cable Assembly Procedure section for detailed instructions.
- The splice box arrow must always point in the direction of the red flag label or red sleeve on the FAKRA splice repair service cable.
- The splice box is a ONE-TIME use part. Never reuse the splice box after it has been installed.
- If any of the lock tabs break during installation, the splice box halve(s) must be replaced.
- If the splice box is installed incorrectly, the repair will fail; MOST Ring failure conditions will still occur.
- Tape both FAKRA splice repair cables and splice boxes to the stereo amplifier harness.
 Keep smoothe curves with a

Attach the FAKRA service cables and splice boxes to the appropriate component harness with tape to prevent any rattles.
