Service Alert

THIRD ROW SEAT BACK CONCERNS AND/OR ISSUES WHEN LIFTING FROM THE LOWERED POSITION

Service Alert No.: SA-063/23

2024 CX-90

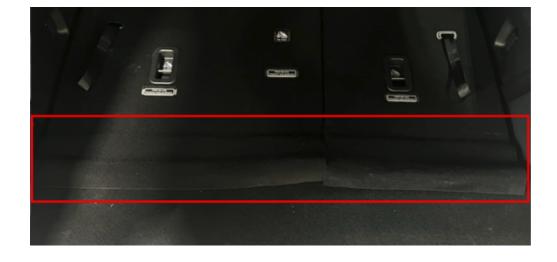
Customers may report issues with third-row seats, loose or damaged trim, not folding down, binding when folding up, and other concerns. The technician may notice the cargo floor is out of place and may attempt to replace parts as defective. This is due to the cargo floor being uneven and/or foreign objects stuck between the third-row seats and cargo floor.
