# Technical product information

| Topic | New Continental GT and GTC - Front Passenger Safety Belt Presenter Does Not Deploy |
| Brand | Bentley |
| Transaction No. | 2058512/8 |

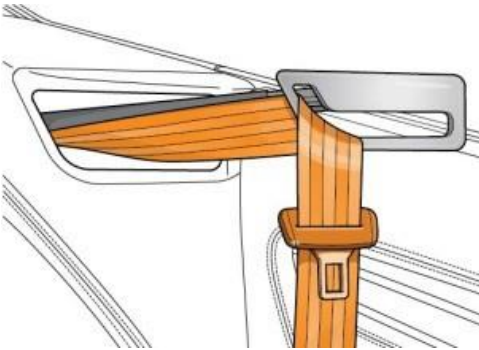
Front Passenger Safety Belt Presenter does not deploy when expected.

Check for Diagnostic Trouble Codes (DTC's) relating to the Front Passenger Safety Belt Presenter, if DTC's are not evident conduct the following process.

**Note: There are various situations in which the Front Driver and Passenger Safety Belt Presenters will deploy. This TPI is specifically designed to only check and prove the functionality of the Front Passenger Safety Belt Presenter. Conduct this specific test process as follows.**

- Ensure the vehicle is unoccupied, Driver and Passenger doors are closed, vehicle unlocked and the ignition switched "off".
- Open Driver's door and sit in Driver's seat.
- Close Driver's door.
- Driver's Safety Belt Presenter will deploy.
- Switch "on" vehicle ignition.
- Have a second person open the Passenger door.
- Have the second person sit in the Passenger seat.
- Close Passenger door.
- Passenger Safety Belt Presenter deploys.
