TECHNICAL SERVICE BULLETIN

Hard Top Roof - Latch Decal Does Not Match After Roof Panel Replacement - Built On Or Before 31-Mar-2022

23-2282

Ford 2021-2022 Bronco	Built on or before 31-Mar-2022
---------------------------------	--------------------------------

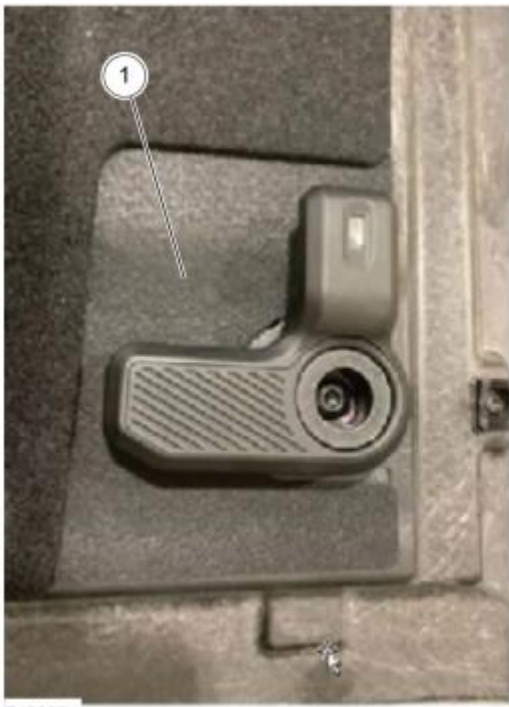
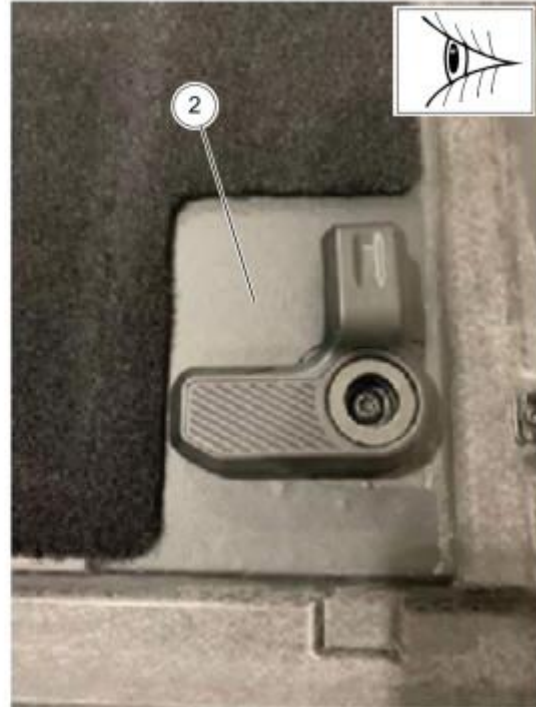
E420574

1. Do the vehicle's new roof panel(s) have latch decals that do not match the original roof panel(s)? Refer to Figure 1 for an image of the new latch decal (Figure 1, Callout 1) and an image of the old latch decal (Figure 1, Callout 2). Refer to Figures 2-3 for latch decal locations.

Figure 1 - View of the new and latch decals on a hard top roof panel

2. Remove the affected roof panels and place them upside down on a flat clean work surface. Refer to the Workshop Manual (WSM), Section 501-18B.
3. Remove the affected hard top flip latches and/or hard top turn handles. Refer to the WSM, Section 501-18B.

4. For vehicles equipped with a headliner, carefully peel back the edges of the headliner(s) located around the decals to gain access to the latch decal(s). If the headliner adhesive separates from the headliner, the headliner must be replaced.

5. Use a plastic scraper and fingers to remove all older style latch decal(s). Make sure the older latch decal(s) are completely removed from the roof panel component(s).

6. Install the new style latch decal(s). The new latch decals are a peel and stick design.
7. When reusing the existing headliner(s), use gloves and a sponge to apply 3M™ 4298UV Adhesion Promoter on the areas where the headliner will reattach to the bare roof and/or latch decal(s). Make sure to not extend the adhesion promoter outside of the contact area on the latch decal(s).

8. Use firm pressure to secure the headliner back into place on top of the latch decals.
9. Reinstall the affected hard top flip latches and/or hard top turn handles. Refer to the WSM, Section 501-18B.

10. Reinstall the affected roof panels back onto the vehicle. Refer to the WSM, Section 501-18B.

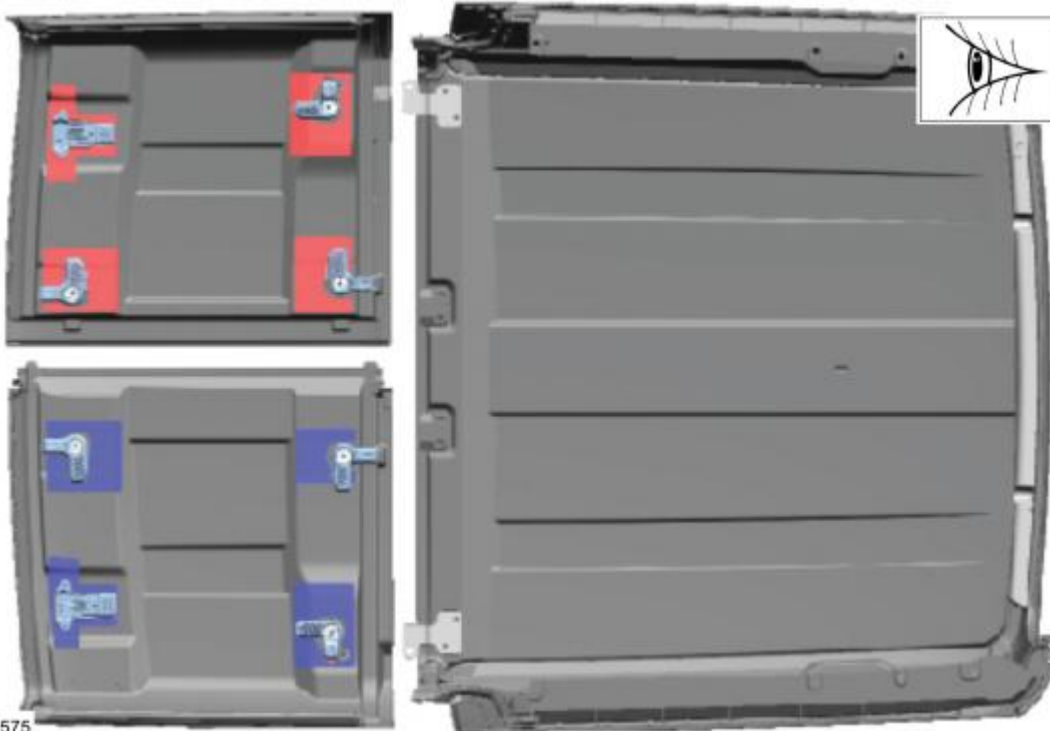
E420575

Figure 2 - View of the latch decal locations on the Bronco 3-door hard top roof

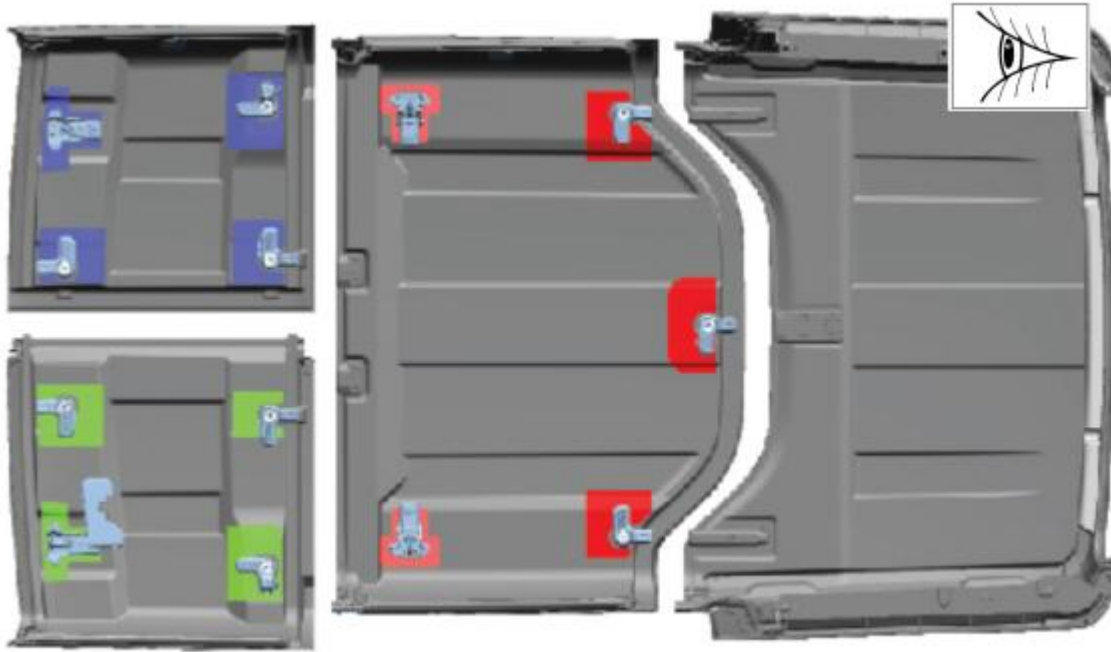
E420576

Figure 3 - View of the latch decal locations on the Bronco 5-door hard top roof
