October 2023  
SF674A-C

## Subject: Front Wall Huck Bolt Fasteners

**Models Affected:** Specific model year 2023 Freightliner eCascadia vehicles; and Western Star 47X, 48X, and 49X series vehicles including right-hand drive models, manufactured February 4, 2022, through February 2, 2023.

## Installation of the Toe Kick Fastener on the Front Wall, Floor Panel, and Toe Kick Area

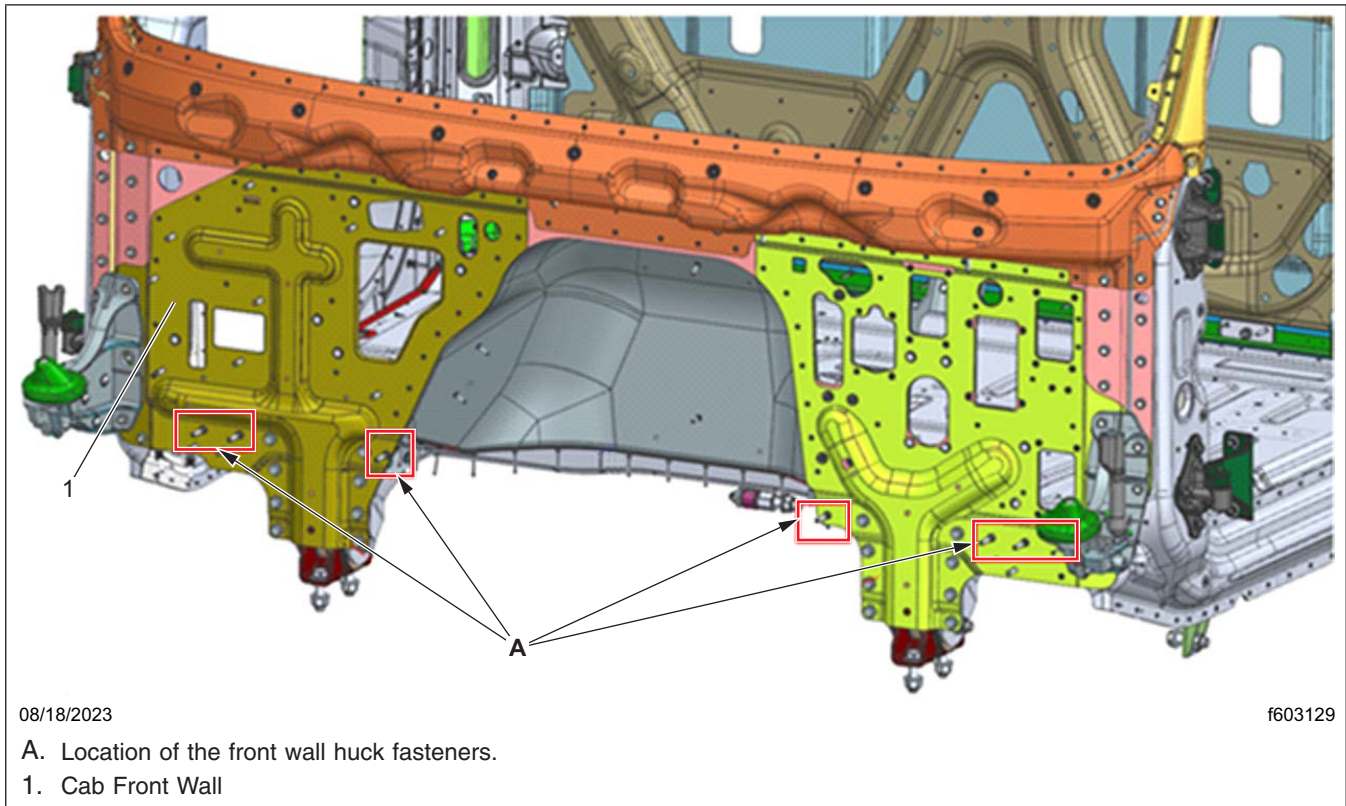
**Fig. 1, Location of the Front Wall Huck Fasteners**

4. Inspect whether the fasteners are already installed in the front wall or floor toe kick area, as shown in [Fig. 1](#).

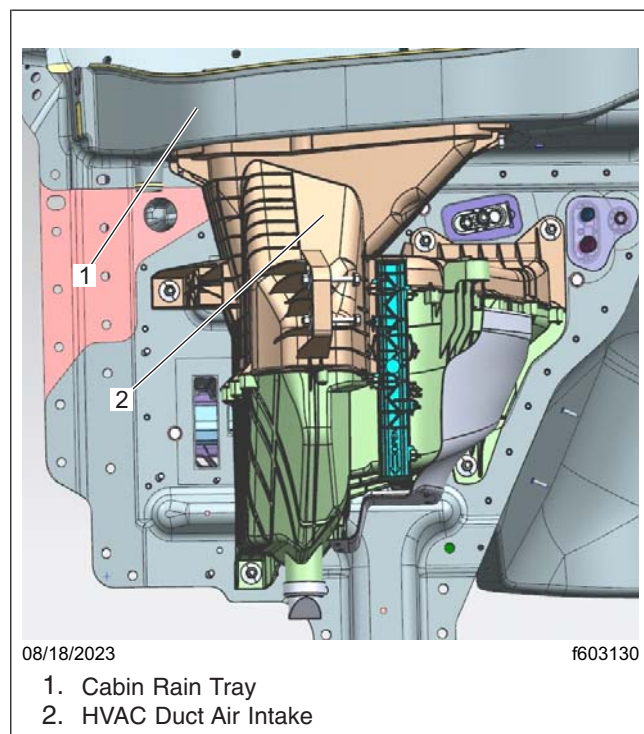
**Fig. 2, Location of the Cabin Rain Tray and HVAC Duct Air Intake**

5. Remove the heating, ventilating, and air conditioning (HVAC) duct air intake to access the fastener location, which is behind the duct. See [Fig. 2](#) and [Fig. 3](#). Location of air intake and the huck fastener are shown in [Fig. 4](#) and [Fig. 5](#).

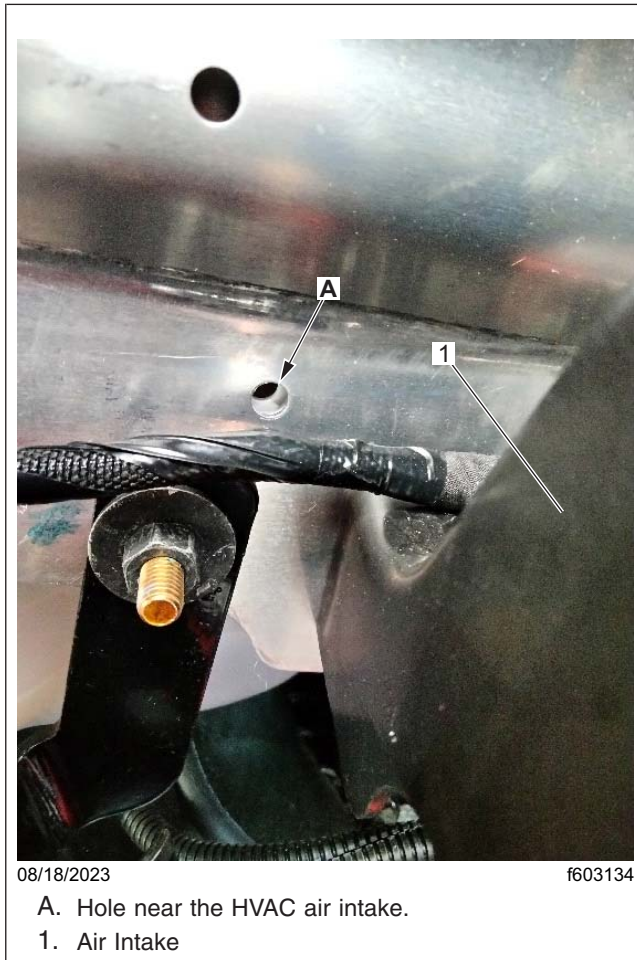
**Fig. 6, Misaligned Hole Located near the Air Intake**

6. If the three-layer (front wall, floor panel and toe kick) panels do not align, or the front wall adhesive has covered the holes, use a 1/4-inch (6.5 mm) drill bit to drill out the holes for the missing fasteners.
- While drilling in the location near the washer bottle, be careful to not drill through the bottle.
  - **Figure 6** shows the location near the HVAC duct, and **Fig. 7** shows the location behind the HVAC duct air intake.

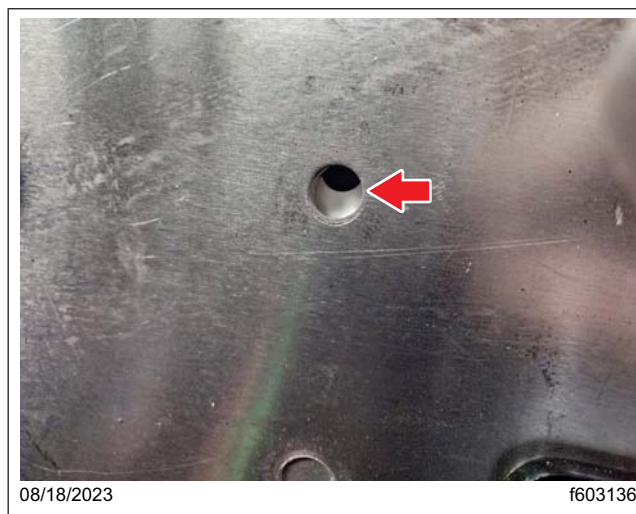
**Fig. 8, Misaligned Panel that needs to be Drilled**

- **Figure 8** shows the misaligned panel that needs to be drilled out.

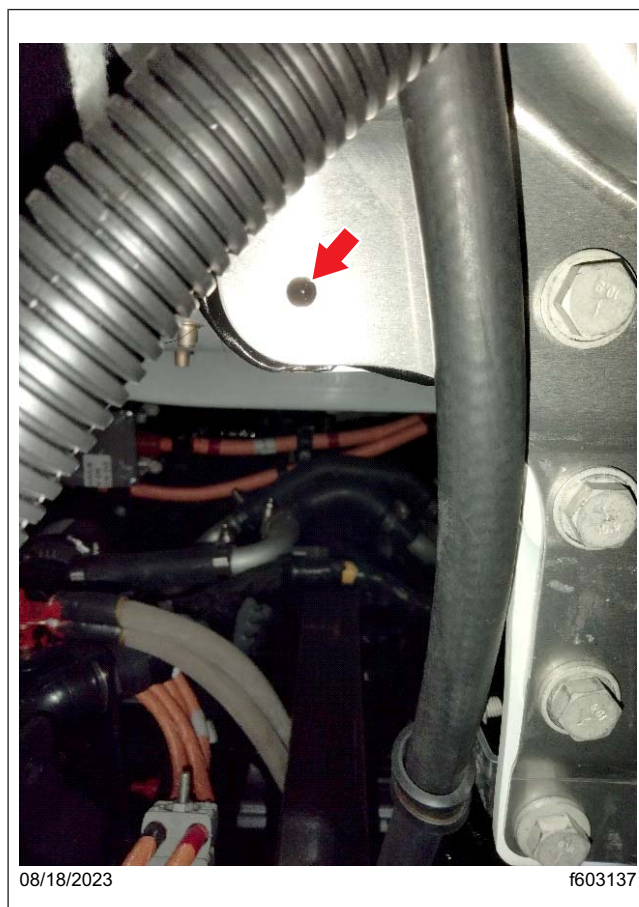
**Fig. 9, Hole Covered with Bonding Glue**

- Drill the front wall holes in all seven locations.
- The bonding glue may be filling the holes, and the floor panel and toe kick edge holes may not align with the front wall holes. See **Fig. 9** and **Fig. 10**.

- Drill out each hole as required and debur the drilled holes.
7. Install the fasteners and tighten 98 lbf-in (1107 N-cm).
  8. Install the HVAC duct air intake.
  9. On the steering-shaft side of the vehicle, repeat steps 5 and 6 to drill the remaining holes and to install the fasteners.
  10. Remove the zip ties, if necessary, to allow movement of the air bundle or the harness. This allows access to the holes for installing the fasteners. See [Fig. 11](#).
  11. To access the holes located near the harness, remove the bulkhead connection harness, if necessary. See [Fig. 12](#).

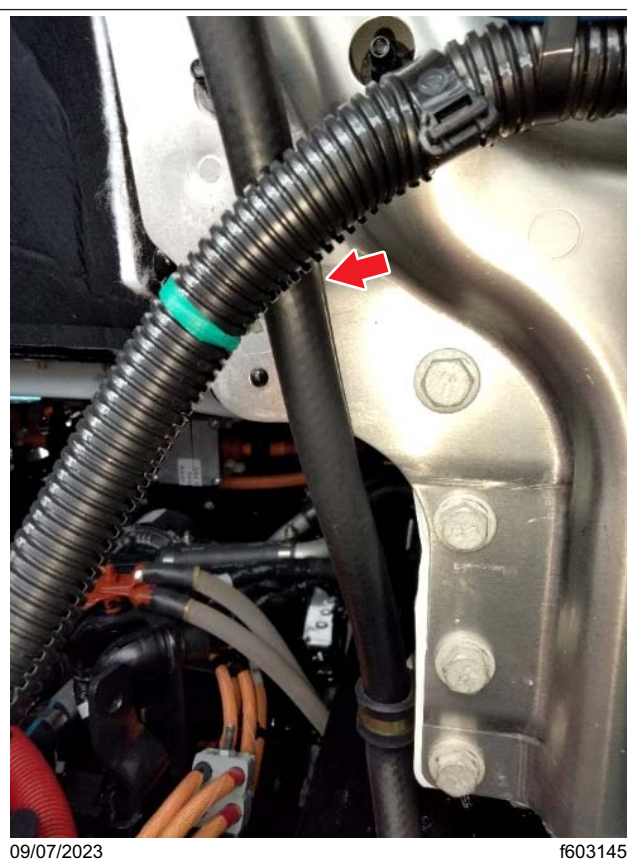
**Fig. 12, HVAC Drain Hose**

HVAC drain hose moved over to reveal the hole that is covered with bonding glue.

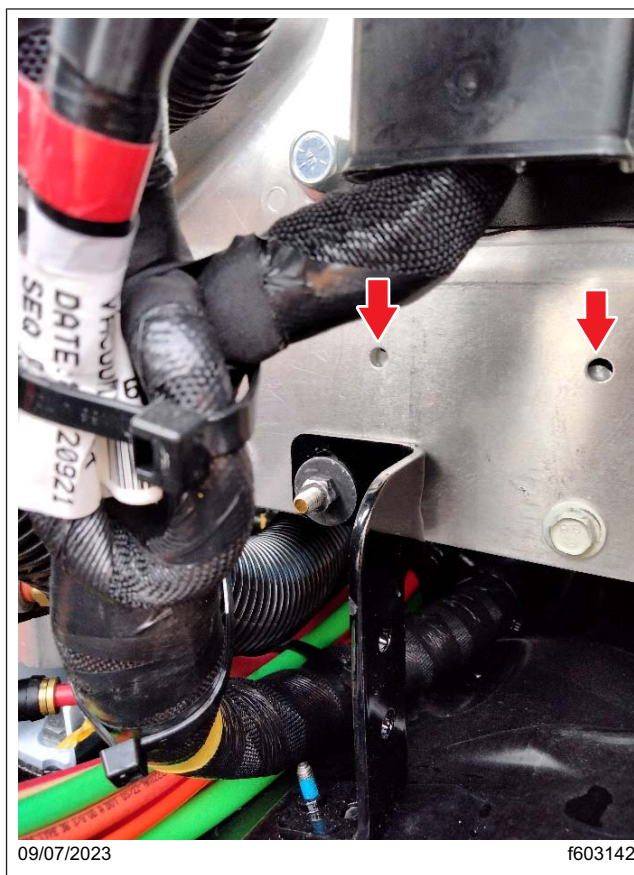
**Fig. 13, Holes Located Behind the Harness**

12. If removed, install the bulkhead connection harness. See [Fig. 13](#).

13. If removed, use zip ties to secure the harness, similar to the factory routing and clipping.
14. Clean a spot on the base label (Form WAR259), and attach a campaign completion sticker for SF674 (Form WAR261), indicating this work has been completed.
