Countries: CANADA, UNITED STATES Document ID: IK0800660  
Availability: Revision: 0  
Major System: ELECTRICAL SYSTEM Created: 8/21/2023  
Current Language: English Last Modified: 10/3/2023  
Other Languages: NONE Author: Anthony Tondola  
Viewed: 30

Title: RH Chassis Harness Rubbing Inner Fender

Applies To: RH built prior to 07/03/2023

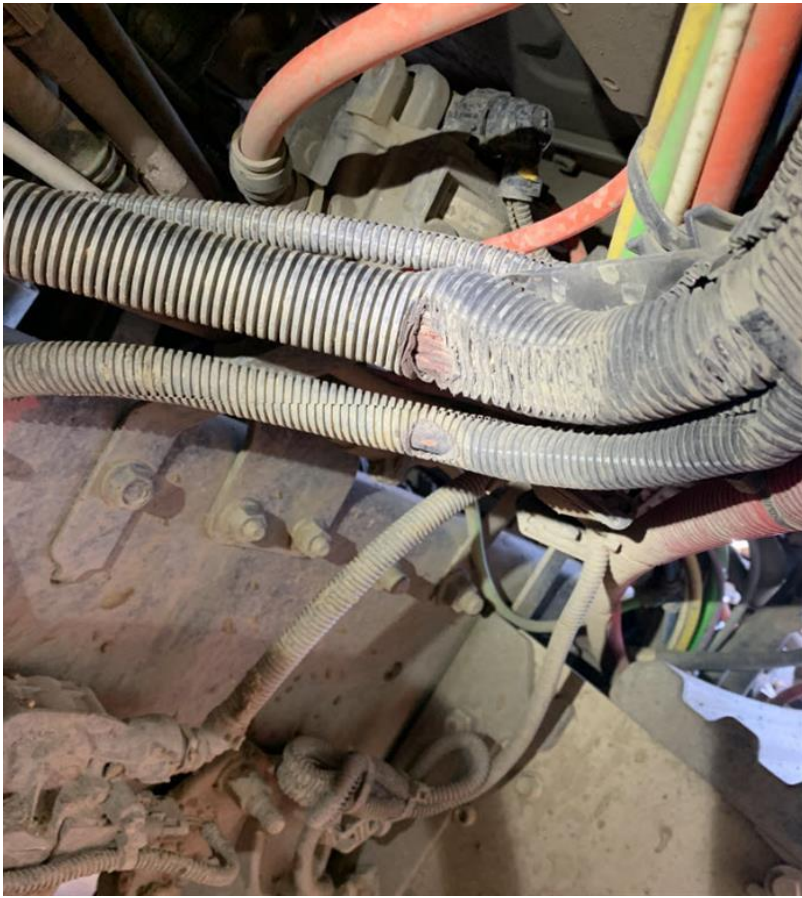
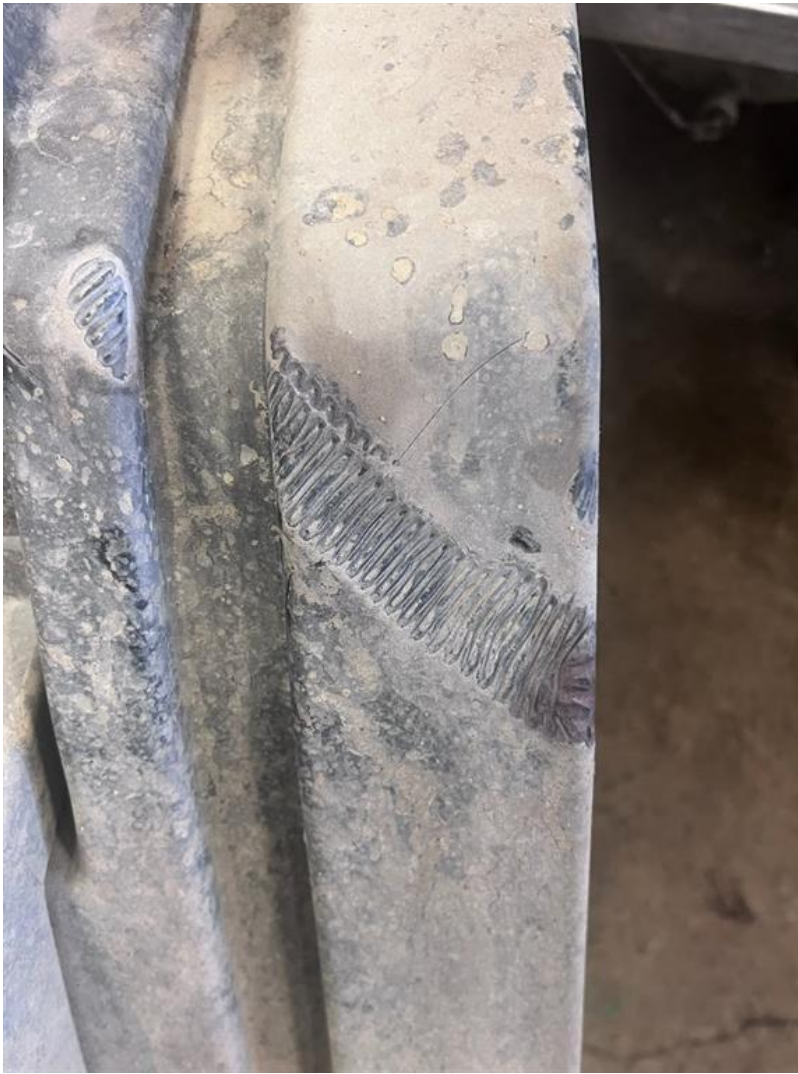
This document will guide the user through changing the routing of the chassis harness that passes behind the left inner fender. In some cases, the wiring harness in this area can be damaged by rubbing the inner fender. The purpose of the following procedure is to reduce the possibility of the harness contacting the left Inner fender.

1. Remove the left inner fender (Refer to the appropriate service manual for removal instructions)
2. Inspect for signs of harness damage

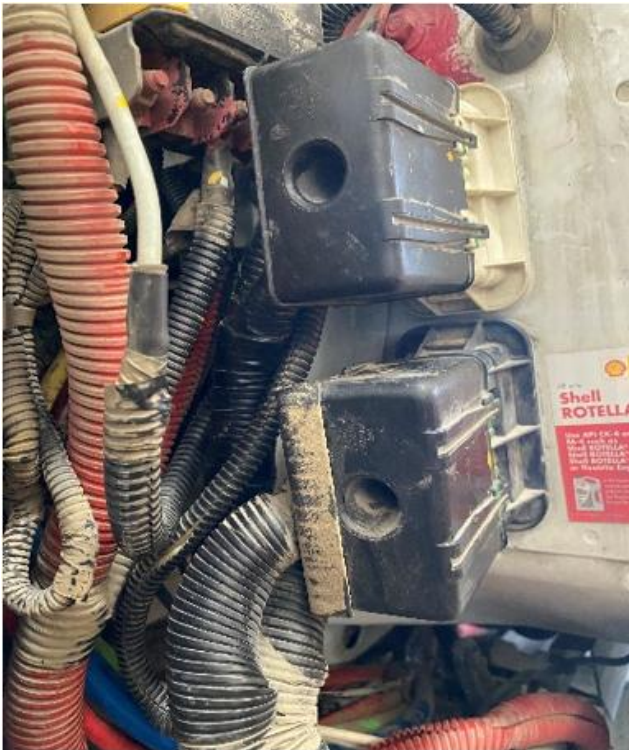
1. Bring the vehicle into the shop and park on a flat surface
2. Shift the transmission into park or neutral, set the parking brake, and install wheel chocks
3. Remove the left front inner fender wheel well and set it aside.
4. Remove both passthrough connectors at the cowl.
5. It may be necessary to remove the ground wire
  - Follow iKNOW article - [IK0800582 - Red Gel Coat Removal from Start Studs and Electrical Connections](#)

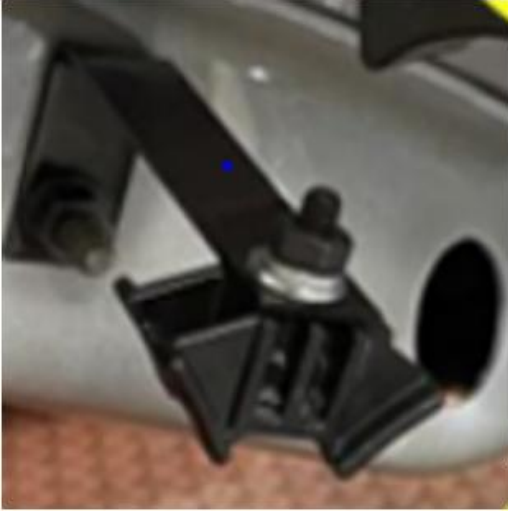
9. Install saddle clamp 2041341C1 to extension 364084C1 using washer, 25705R1 and nut 25519R1.

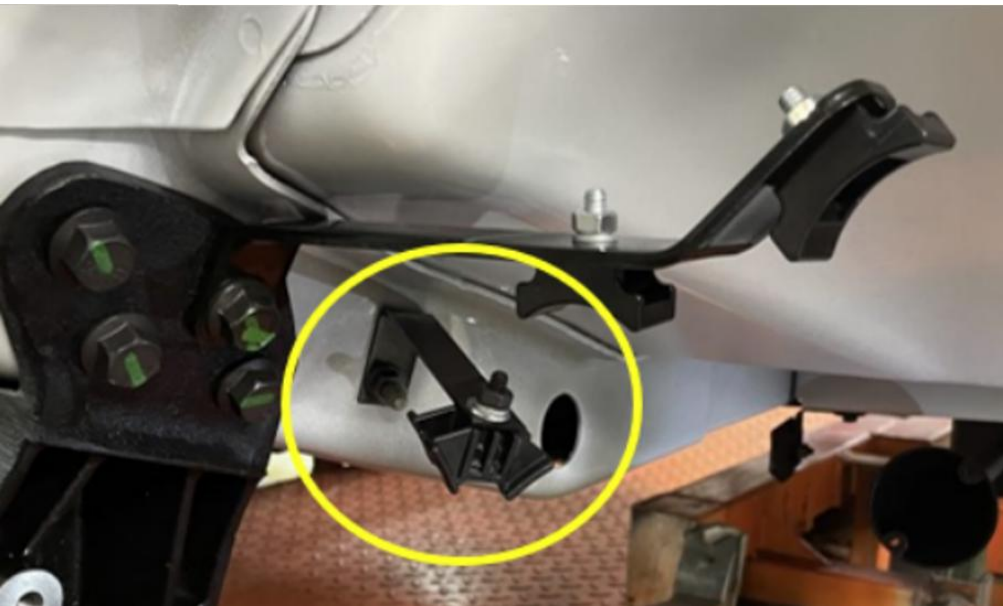
10. Mount extension, 364084C1 to stud behind the front cab mount using nut 25519R1 and washer 25707R1

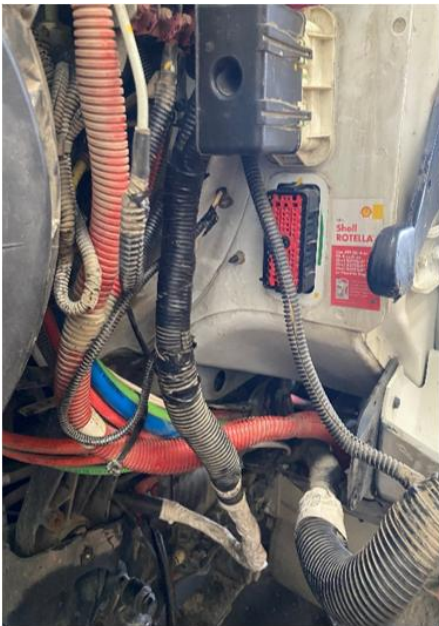
Original layout

11. Reroute the electrical harness to the right side of the airlines.

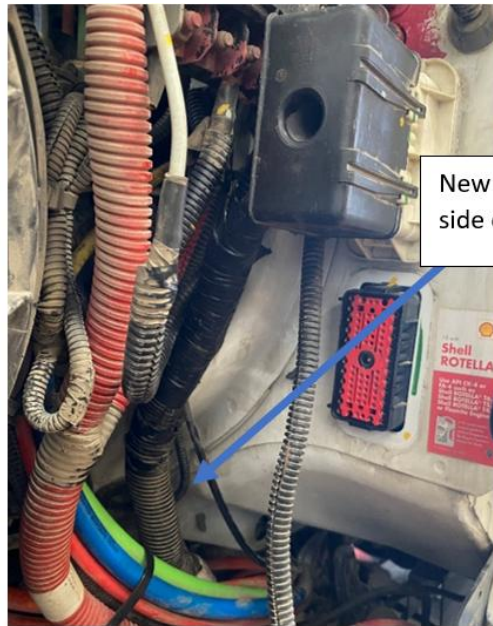
New routing on right side of airlines

New layout
