INSTRUCTION TO SERVICE

ITS: 60825		09/29/2023
SECTION:	420 – Exterior Applied Parts	
WRITTEN BY:	Jeff Kosheluk	
SUBJECT:	Install spring on latch on condenser door	
ISSUE:	Spring missing on door latch	
SUMMARY:	Install spring on latch on condenser door.

ITS60825

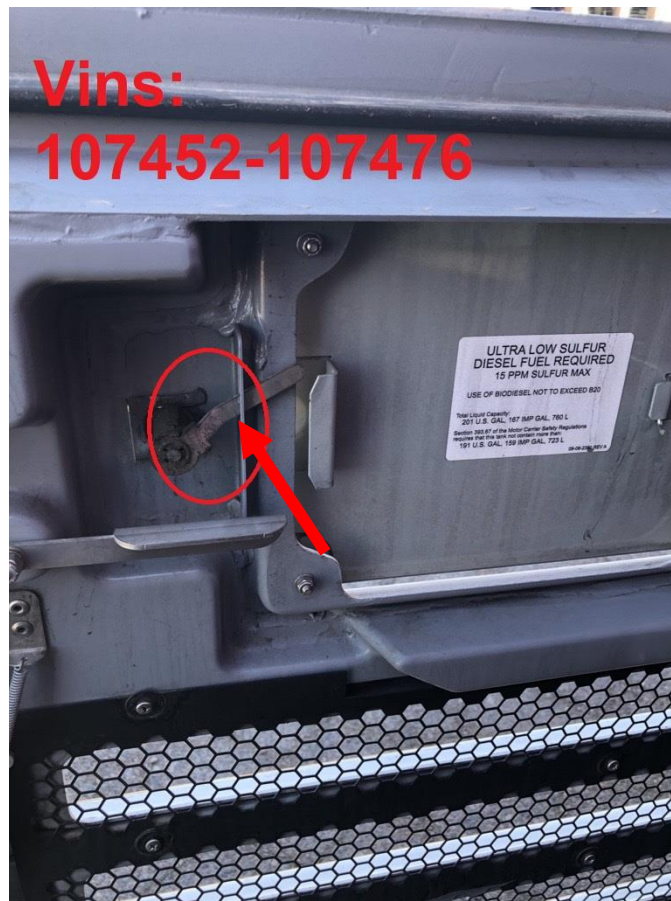
4. Open the access door to gain access to the latch. See Figure 2.

Figure 2: Missing spring on latch.

5. Install spring (PN: 03-29-1173) on latch as shown. Refer to Figure 3

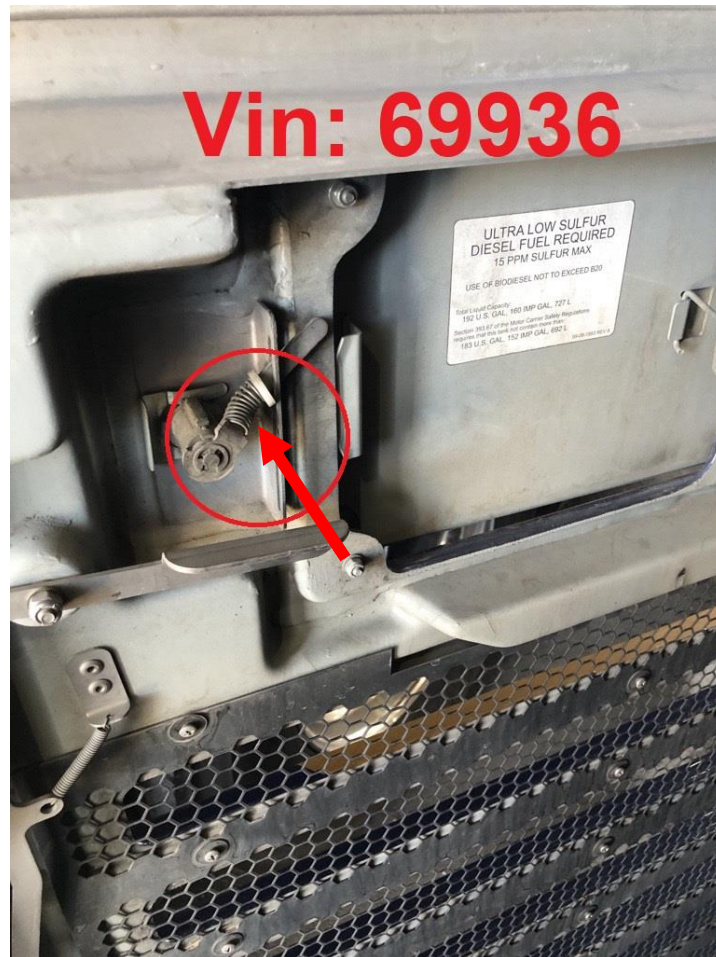
Figure 3: Spring on latch as shown.
