Service Bulletin

Bulletin No.: 23-NA-179

Subject: Loose B-Pillar Applique

Brand:	Model:	Model Year:		Build Date:		Engine:	Transmission:
		from	to	from	to		
Buick	Envista	2024	2024	SOP	September 27, 2023	—	—

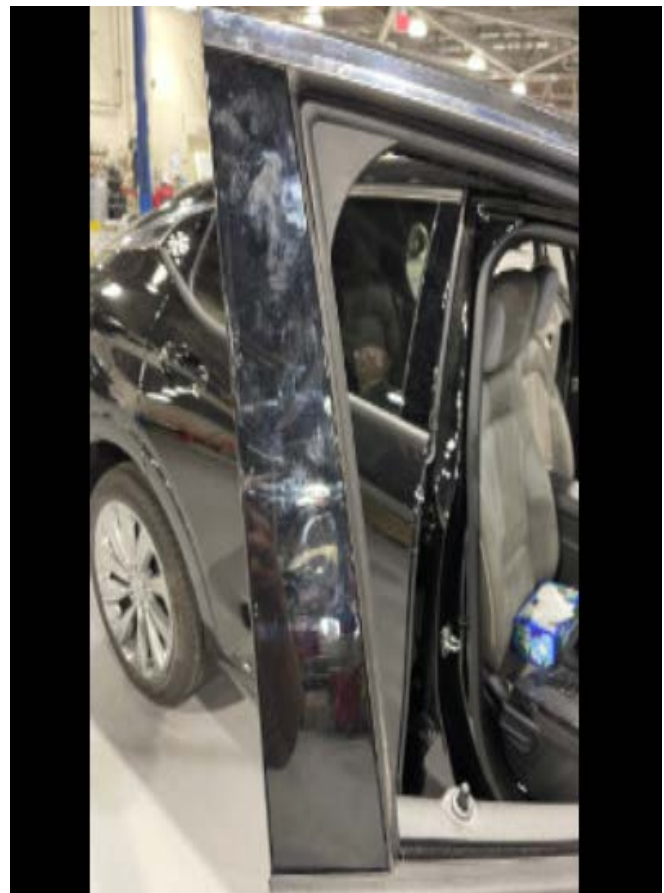
6450837

1. Lower the front side door window to the full down position.

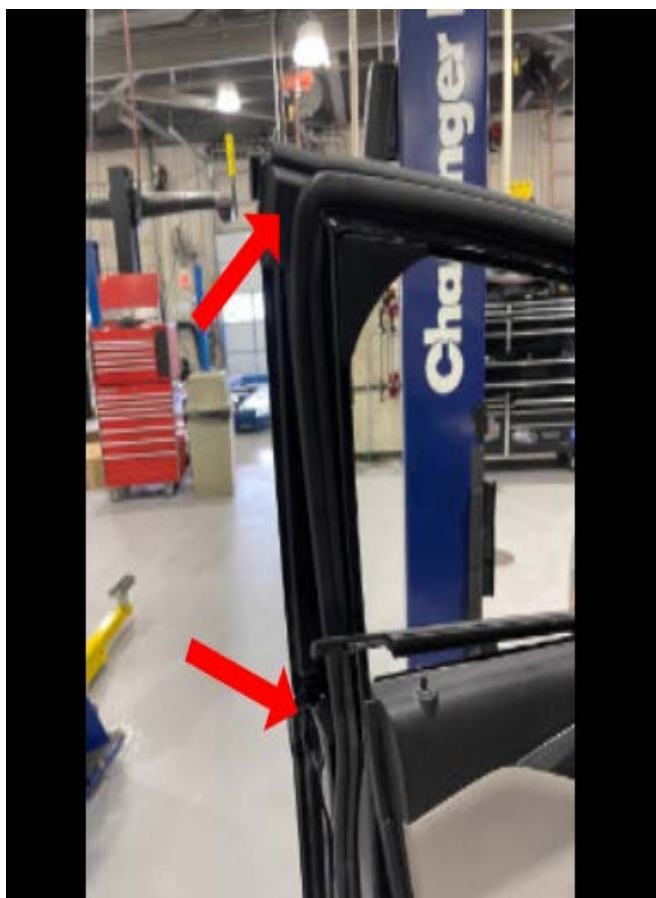
6450839

2. Partially remove the weatherstrip at the upper and lower applique bolts and retainers.
3. Remove both the upper and lower applique bolts.

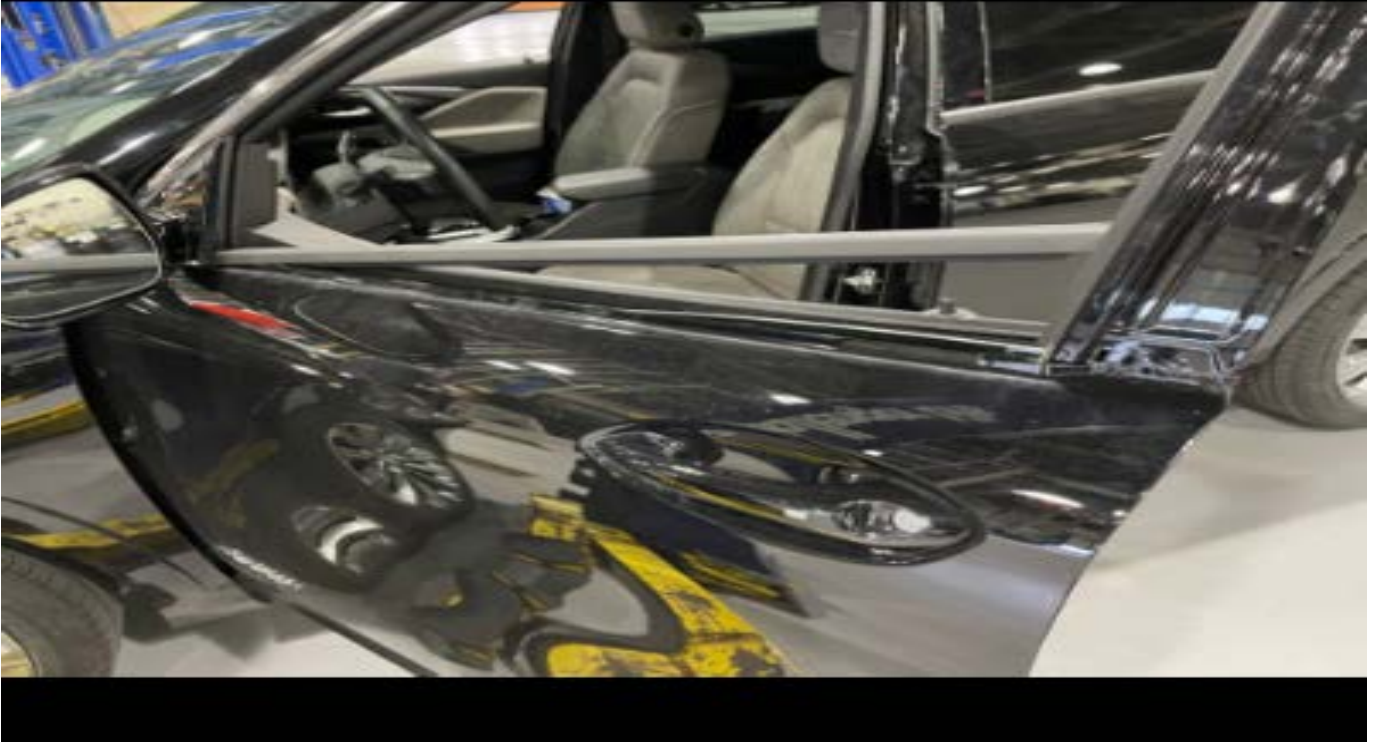
6450840

4. Lift up the end of the window belt reveal molding closest to the rear applique.

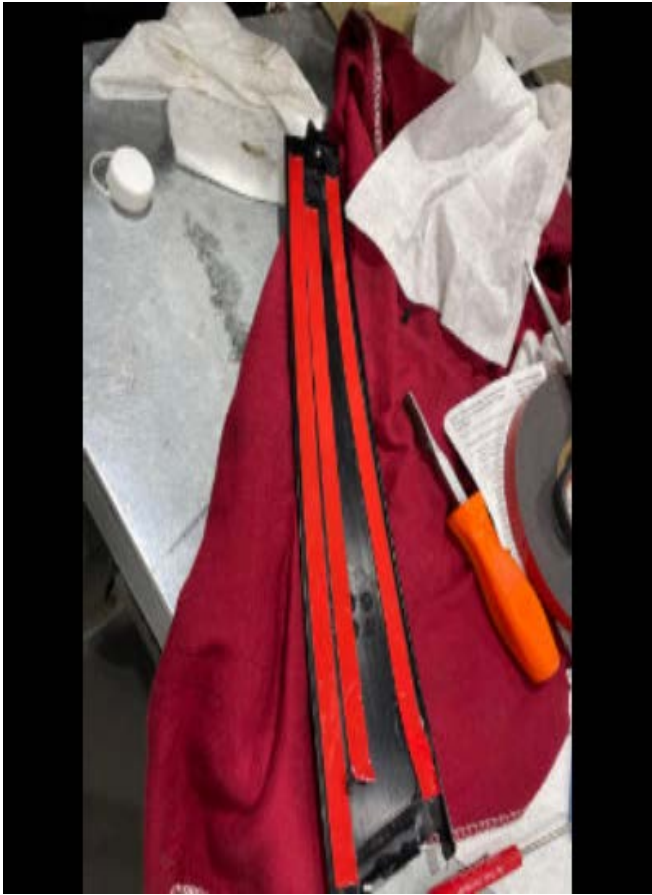
6450848

7. Apply three double-sided adhesive tape along the length of the applique leaving one side of the tape covered.

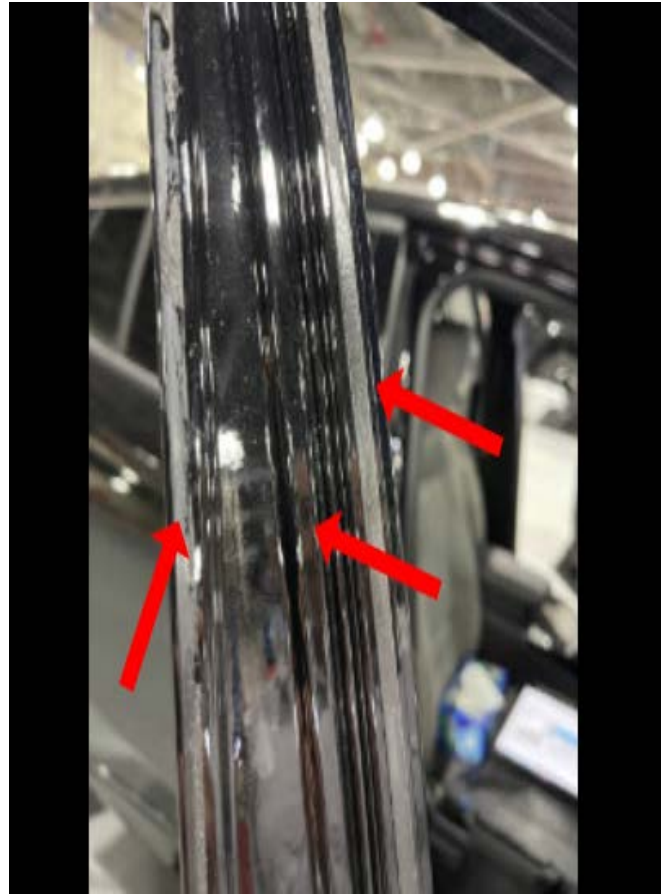
6450842

Note: There is a lifted ridge on the frame of the door. Use that as the middle line of tape.

- Heating: Preheating the product helps secure adhesion at 15°C (59°F) or lower.
- Pressurizing by hand along the adhesive tape line so that the area of use of the tape is 90% or more in contact with the vehicle surface (at least 60N).

8. Position the rear applique panel properly on the door frame, remove the tape cover and secure the applique panel on the door frame.

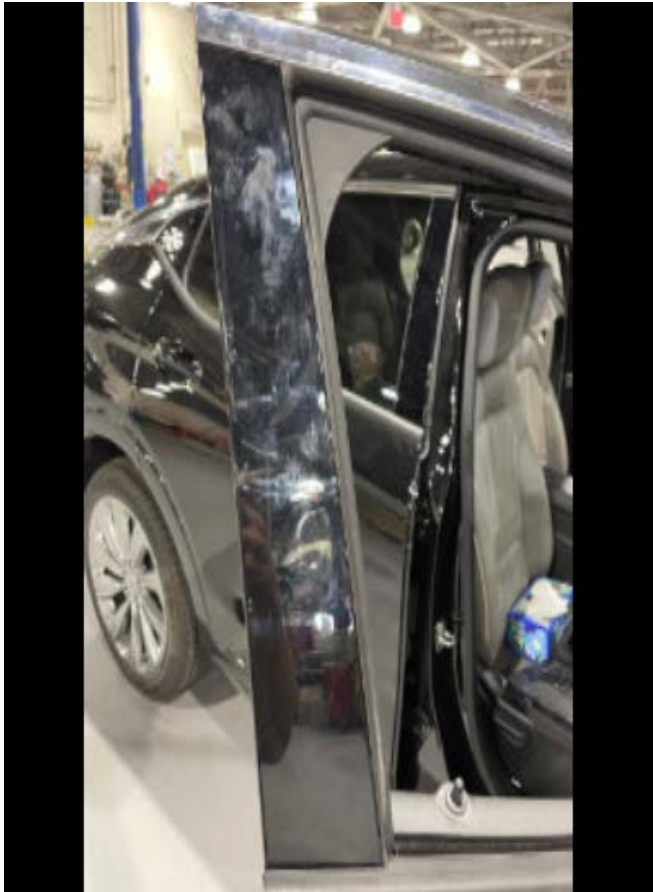
6450837

9. Reattach the upper and lower applique bolts, re-secure window belt reveal molding, then the window weatherstrip.
