Technical product information

Topic	V8 Kovomo - Bentayga - Water pump drive gear cover (Deletion)
Market area	Australia E04 Bentley rest Asia and Australia (6E04),China 723 Volkswagen (Anhui) Automotive CO (6723),China 796 VW Import Comp. Ltd (Vico), Beijing (6796),Germany E02 Bentley rest Europe (6E02),Japan E03 Bentley Japan (6E03),Korea, (South) E08 Bentley South Korea (6E08),United Arab Emirates E06 Bentley Middle East and Africa (6E06),United Kingdom E01 Bentley UK (6E01),United States E05 Bentley USA and rest America (6E05)
Brand	Bentley
Transaction No.	2065918/3
Level	EH
Status	Released for publishing
Release date	28-Sep-2023

V8 Kovomo engine

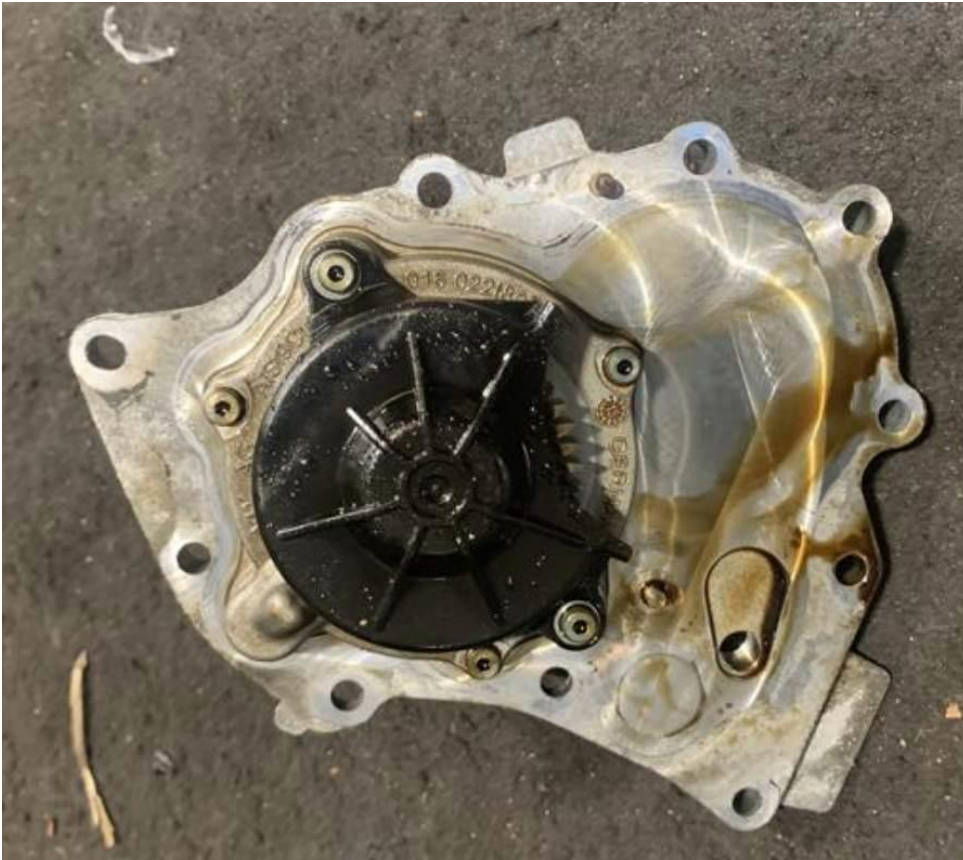
Figure 1

The original water pump has a cover fitted directly over the top of the water pump drive gear (Figure 1)

The cover is no longer fitted on replacement water pumps, the cover is not required and **MUST** not be transferred to the new water pump

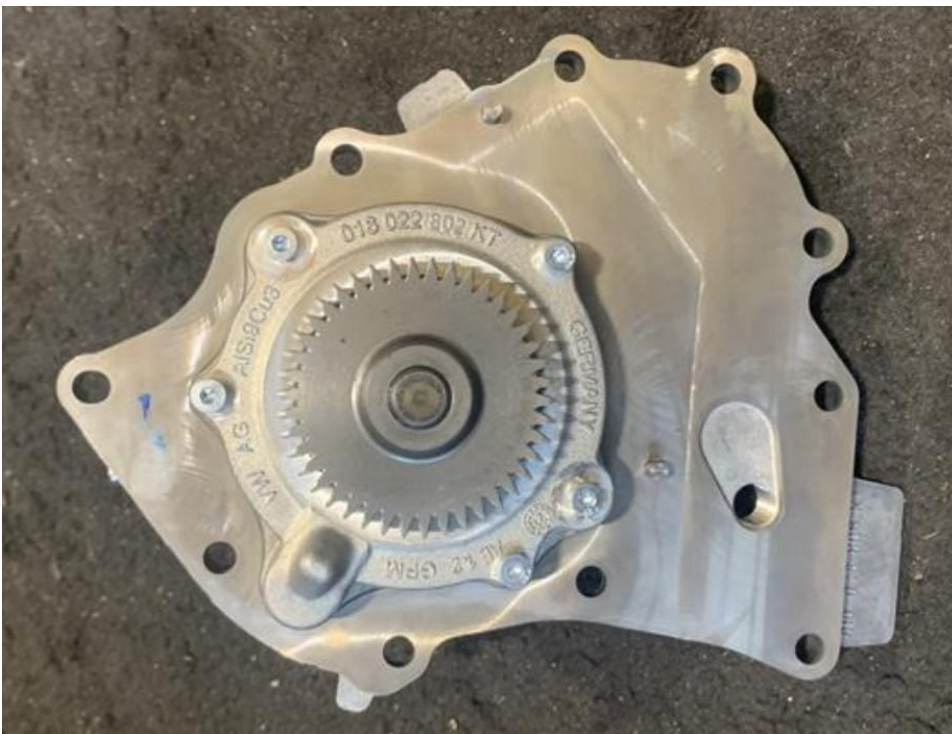
However the replacement water pump does not have a cover fitted (Figure 2)

The operative should fit the new water pump without the cover as shown in Figure 2
