**Surround Camera Intermittent Operation**

**Vehicles Affected**

Models	Model Year	Model Type	VIN Range	Vehicle-Specific Equipment
Cayenne	As of 2019 up to 2023	9YA, 9YB	N/A	KA6

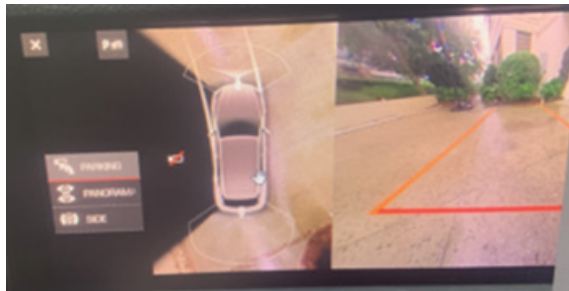
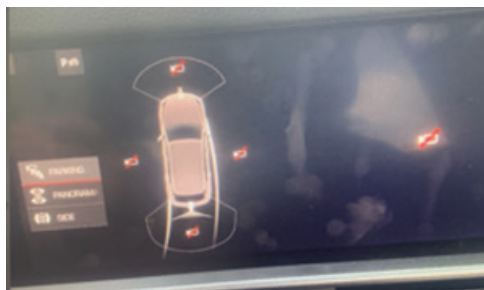
Customer complains of intermittent operation for one or multiple surround view cameras while appearing blank with a crossed-out camera icon for each failed camera.

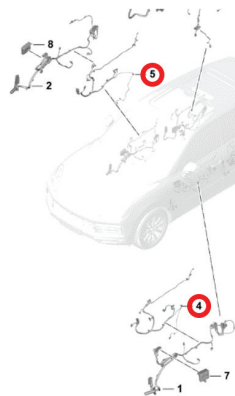
Figure 2 -  
Door harnesses

- c. Both front door harnesses (**Figure 2 - #4 & #5**)
  - d. Both side-view mirror harnesses (**Figure 3 - #10**)
  - e. zFAS control unit
4. Verify operation of the surround view system after the repair has been completed.
