# TECHNICAL SERVICE BULLETIN

Classification: BT23-017	Reference: ITB23-025	Date: October 9, 2023
-----------------------------	-------------------------	--------------------------

## GURGLING NOISE FROM MOONROOF AFTER IT RAINS

**APPLIED VEHICLES:** 2022-2023 QX60 (L51)  
**APPLIED DATES:** Built on or before August 11, 2023

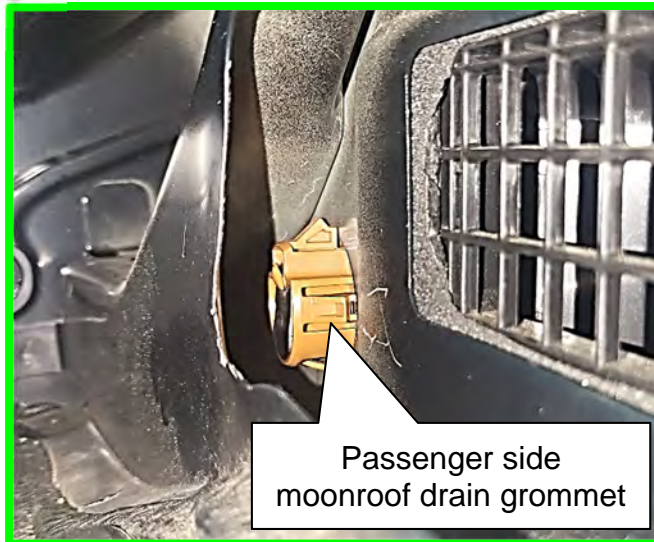
4. Locate the front passenger side moonroof drain grommet under the Cowl Top Cover.

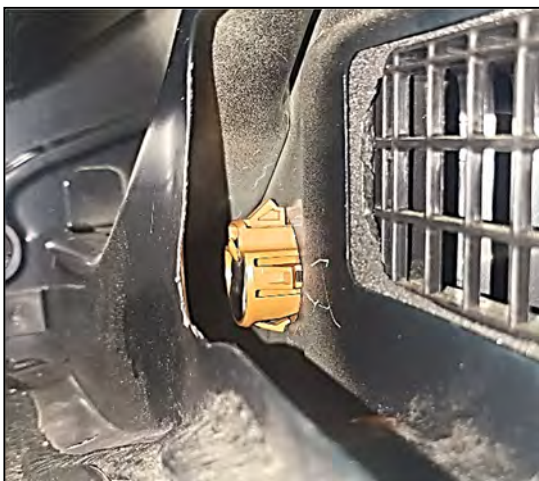
5. Release the four (4) locking tabs and push inward to remove the moonroof drain grommet from the inside.

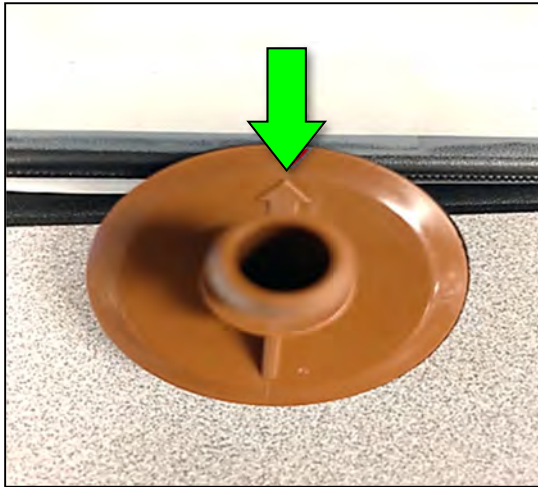
6. Install the new moonroof drain grommet from **PARTS INFORMATION** with the arrow pointing toward the dimple in the bulkhead, and then reinstall the moonroof drain tube.
