TECHNICAL SERVICE BULLETIN

Classification: BT23-018	Reference: NTB23-072	Date: October 9, 2023
-----------------------------	-------------------------	--------------------------

GURGLING NOISE FROM MOONROOF AFTER IT RAINS

APPLIED VEHICLES: 2021-2023 Rogue (T33)
APPLIED DATES: VINs beginning with 5N1: Built on or before August 16, 2023
VINs beginning with JN8: Built on or before September 05, 2023

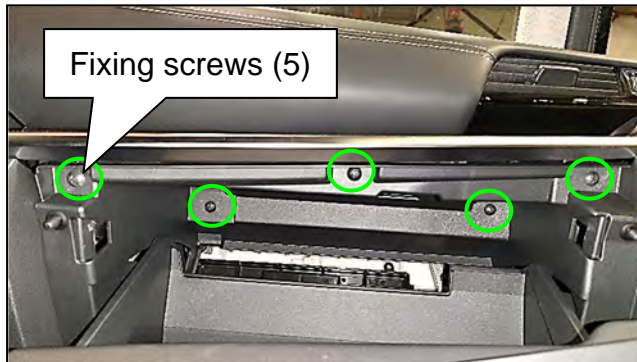
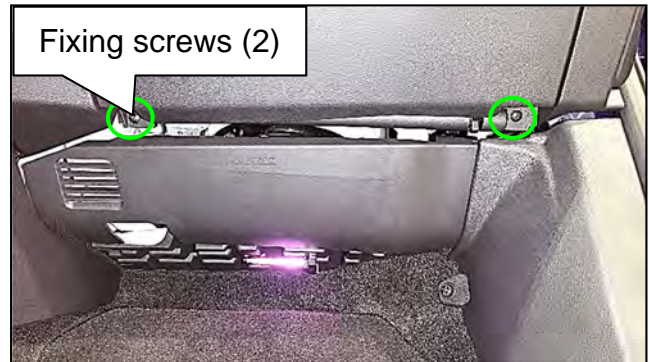
1. Remove the Front Wiper Drive Assembly (Front Wiper Motor).
 - Refer to the ESM: **DRIVER CONTROLS > WIPER & WASHER > REMOVAL AND INSTALLATION > FRONT WIPER > WIPER DRIVE ASSEMBLY > Removal and Installation**
2. Remove the Glove Box Assembly.
 - a. Remove the seven (7) Glove Box Assembly fixing screws.

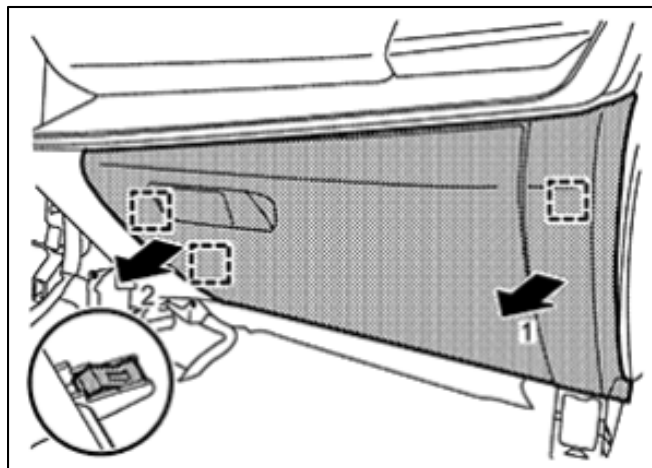
Figure 3

- b. Disengage the three (3) fixing metal clips according to numerical order 1→2 indicated by the arrows shown in Figure 3, and then remove the Glove Box Assembly.

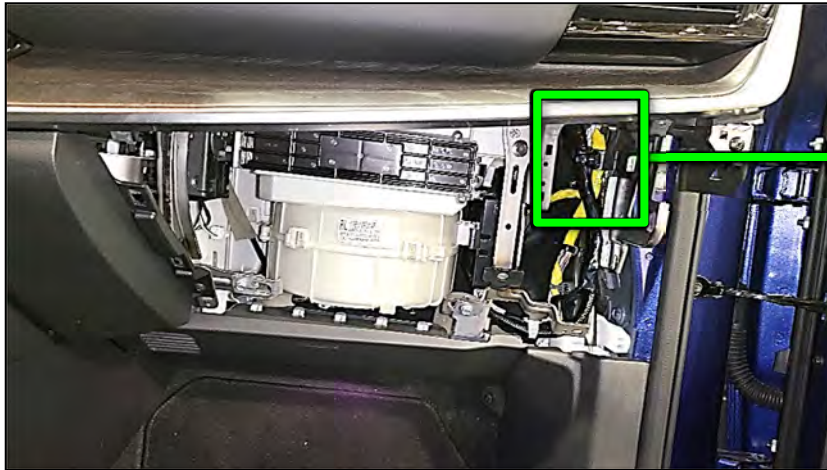
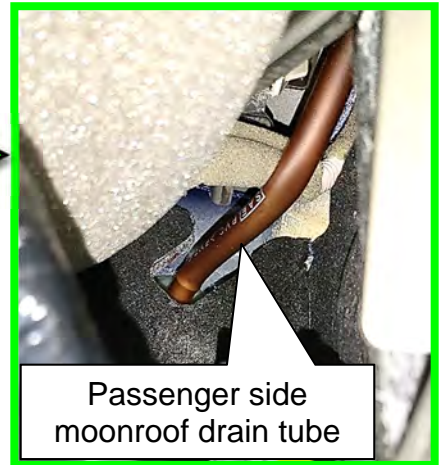
3. Locate the front passenger side moonroof drain tube, and disconnect the drain tube from the moonroof drain grommet.

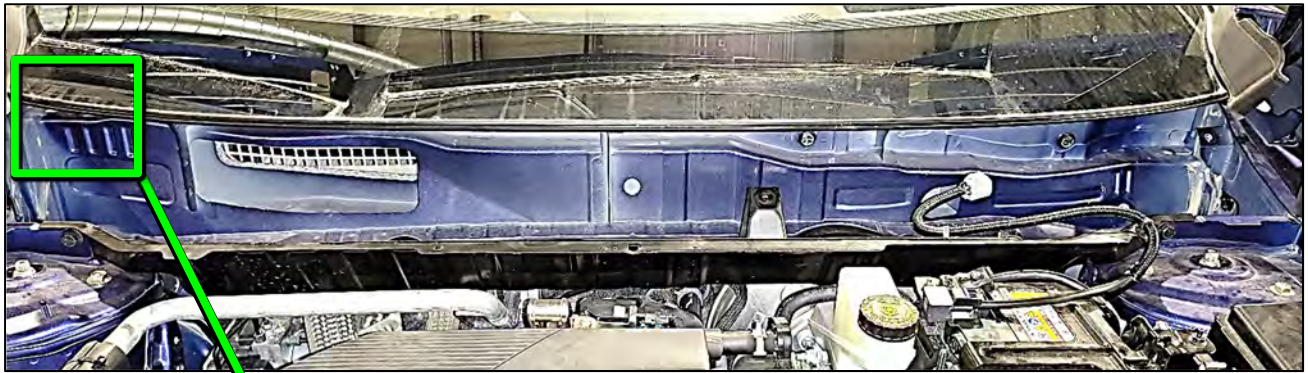
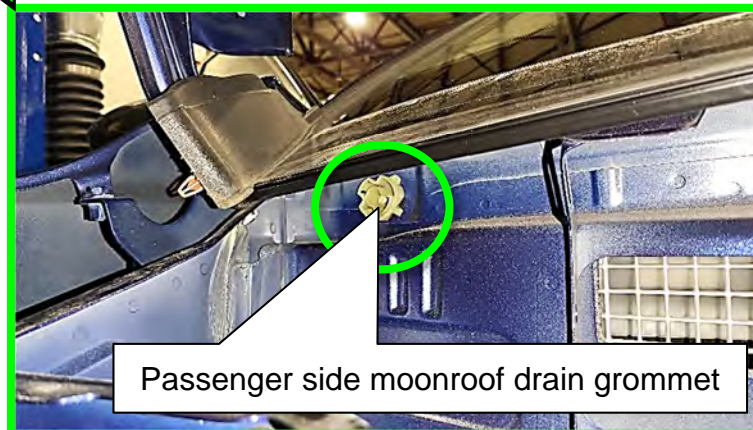
4. Locate the front passenger side moonroof drain grommet under the Cowl Top Cover.

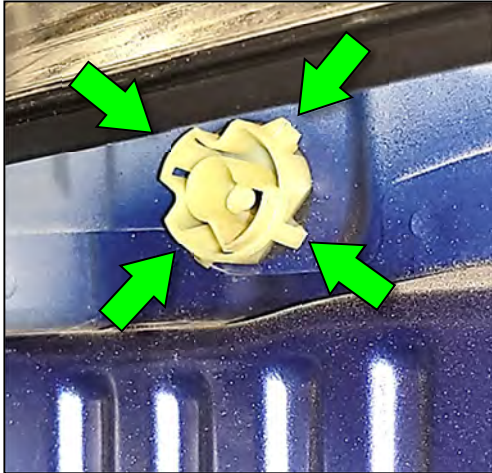
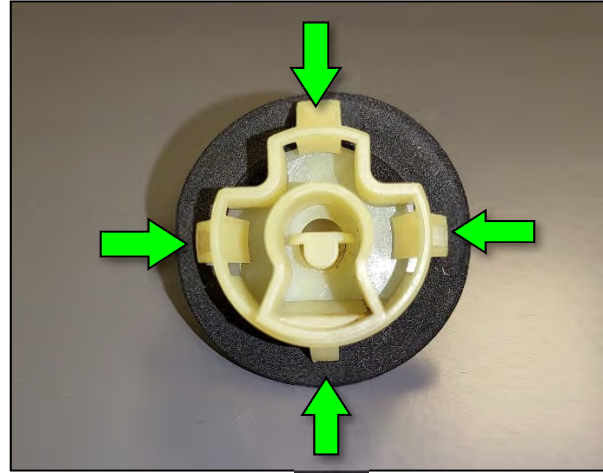
5. Release the four (4) locking tabs and push inward to remove the moonroof drain grommet from the inside.

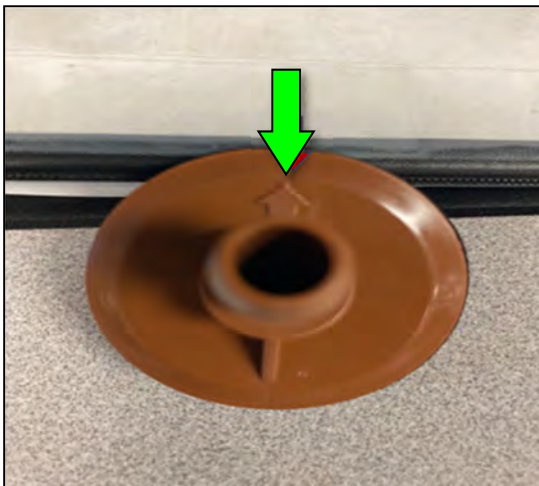
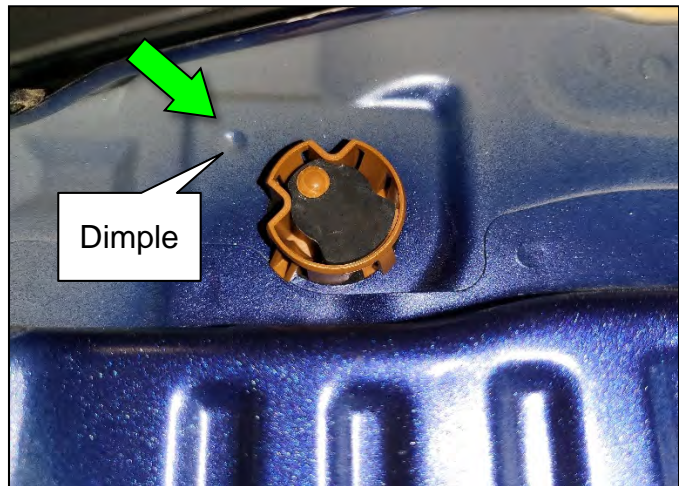
6. Install the new moonroof drain grommet from **PARTS INFORMATION** with the arrow pointing toward the dimple in the bulkhead, and then reinstall the moonroof drain tube.

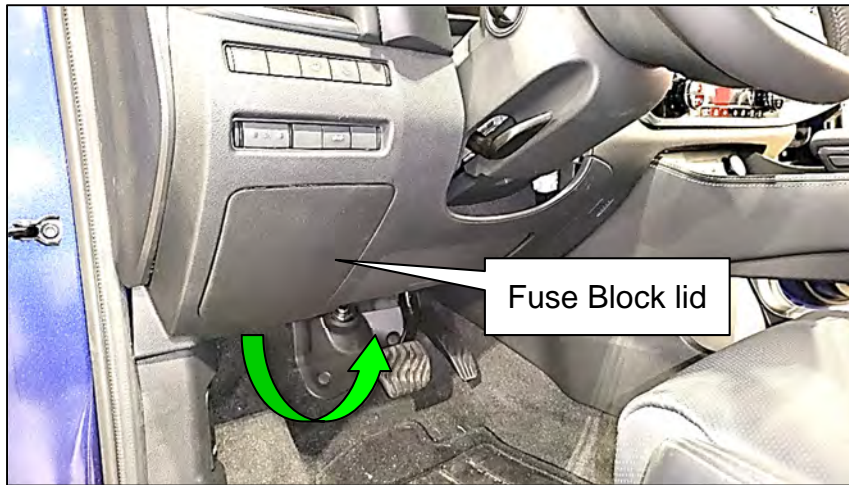
Figure 12

8. Remove the Fuse Block lid.

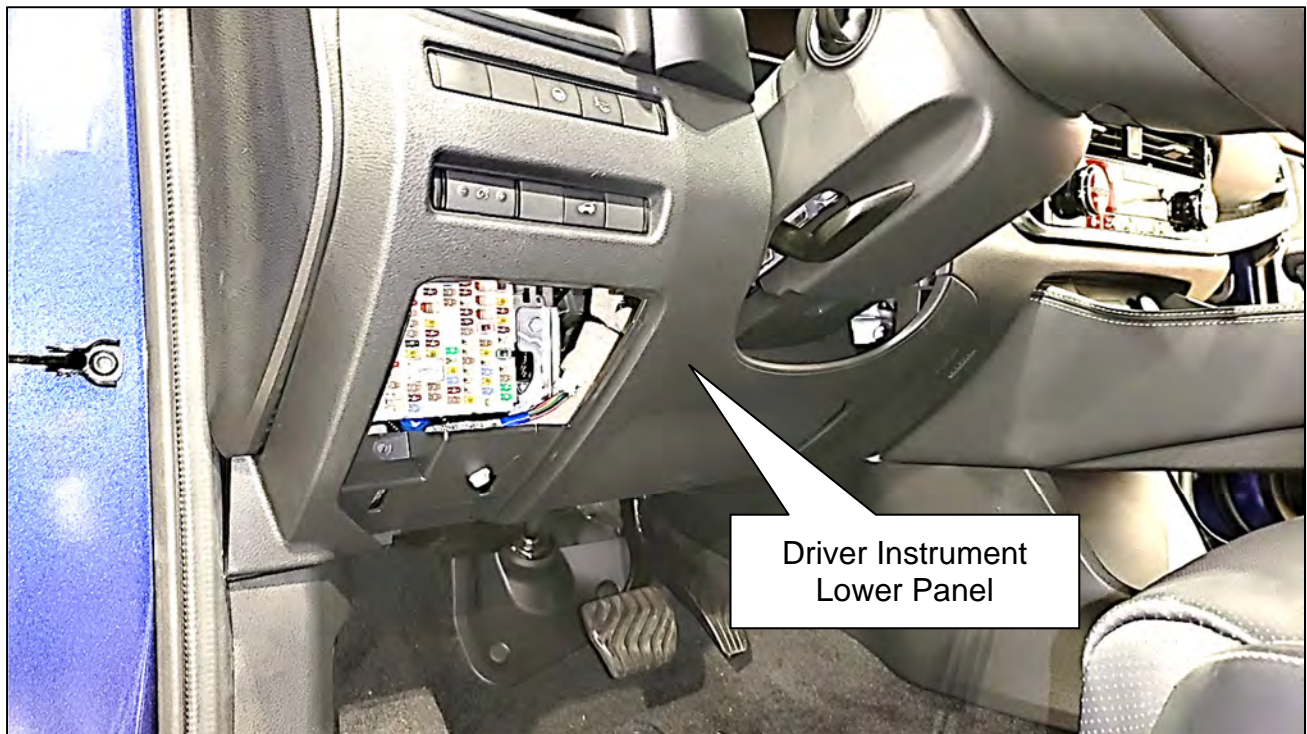
Figure 13

9. Remove the Driver Instrument Lower Panel.

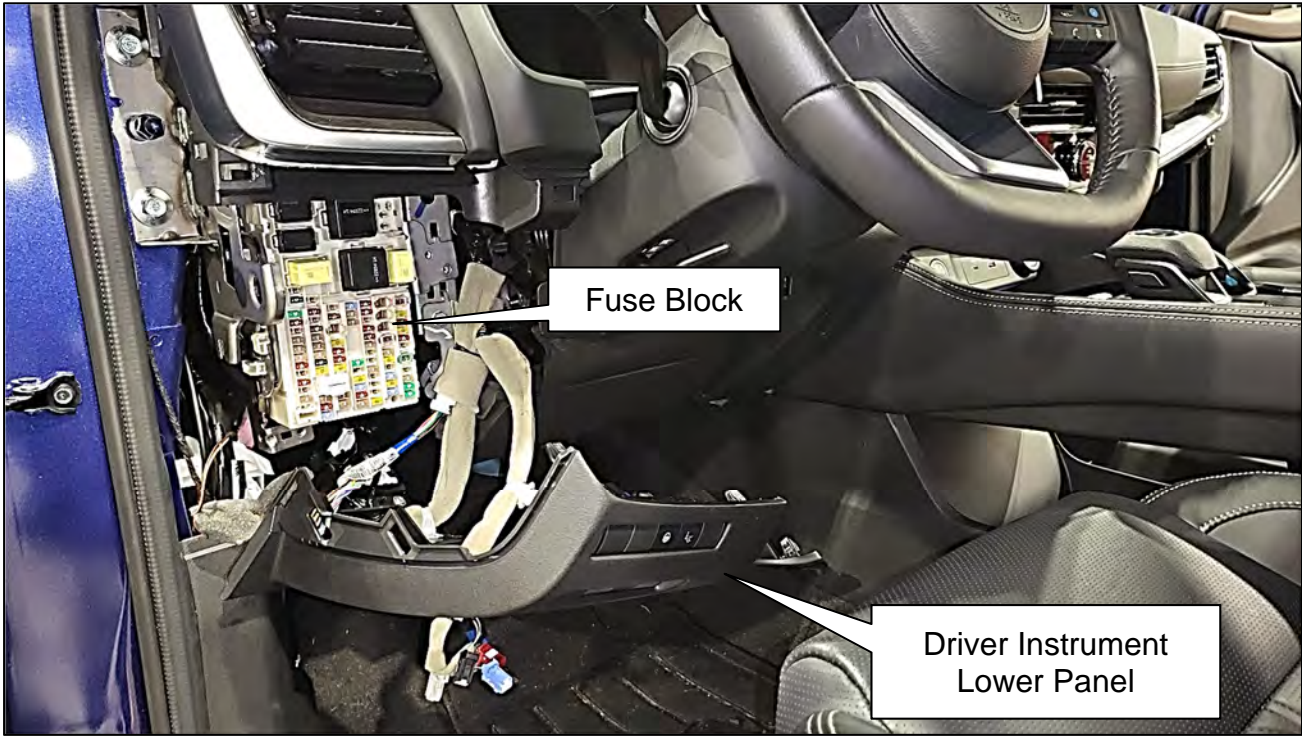
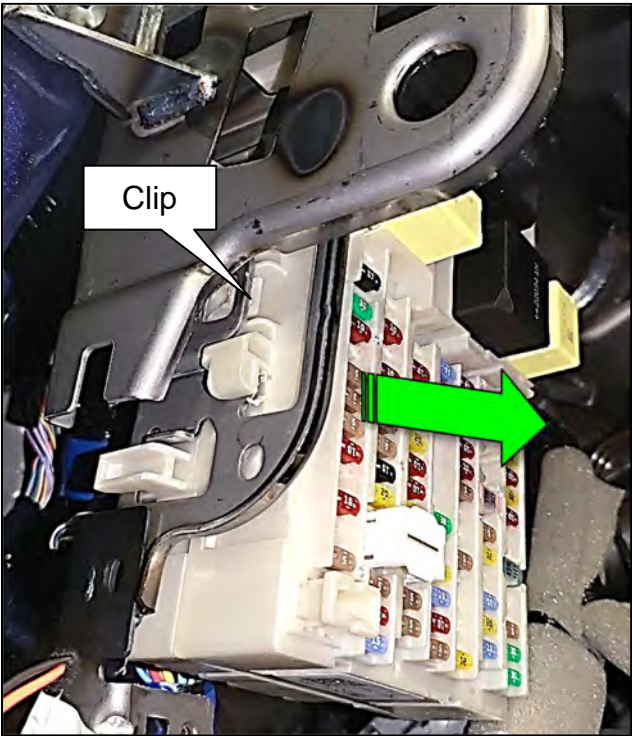
10. Remove the Fuse Block by depressing the clip on the driver (LH) side of the Fuse Block and pulling outward (Figure 15).

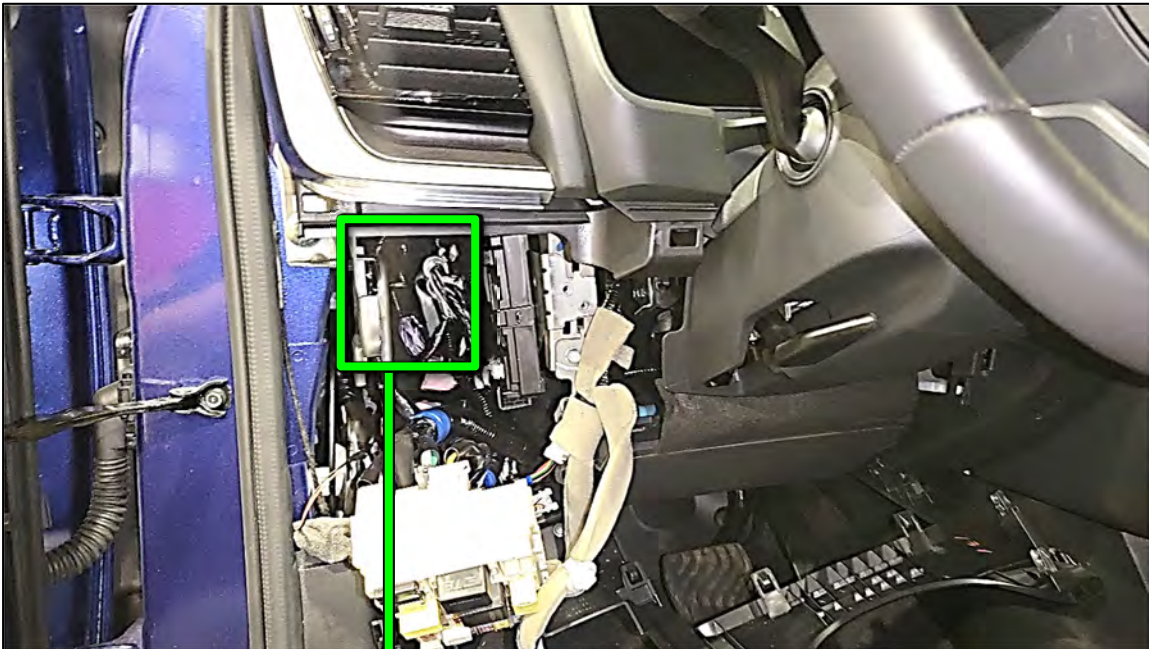
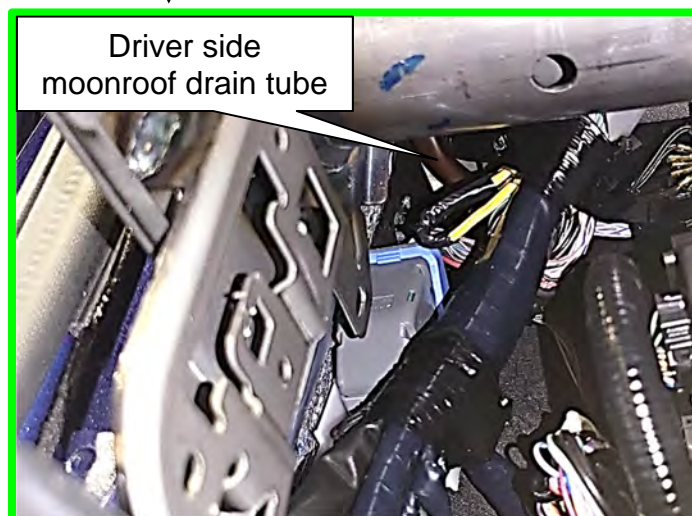
12. Locate the front driver side moonroof drain tube, and disconnect the drain tube from the moonroof drain grommet.

IMPORTANT: The front driver side moonroof drain tube may be visually obstructed. You may have to feel for the moonroof drain tube located under the driver side dash speaker behind bulk head insulation.

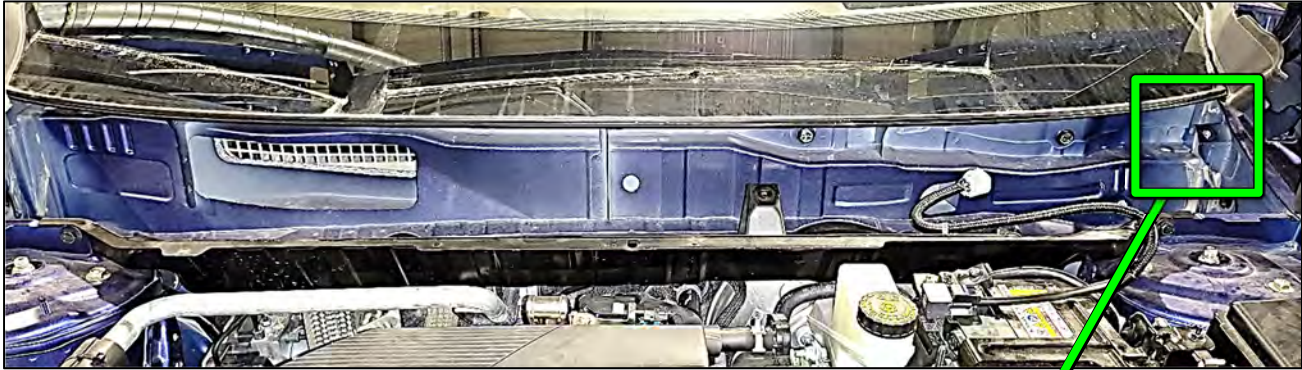
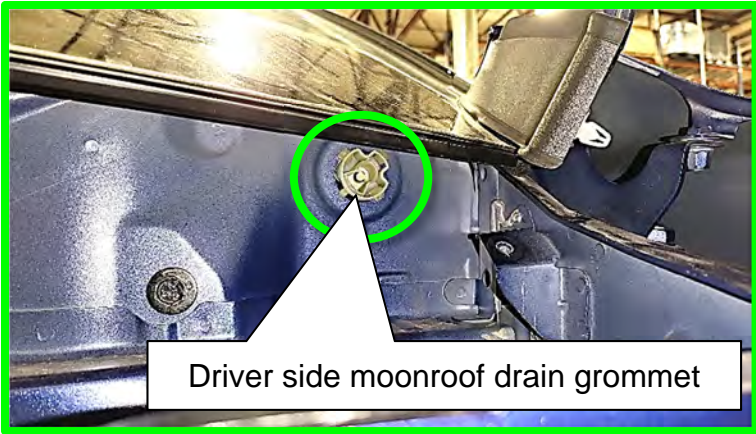
13. Locate the front driver side moonroof drain grommet under the Cowl Top Cover.

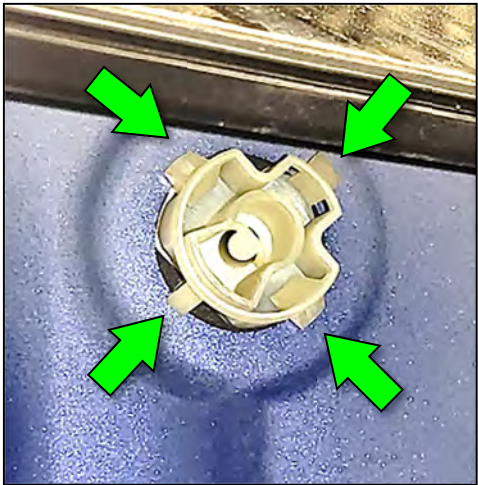
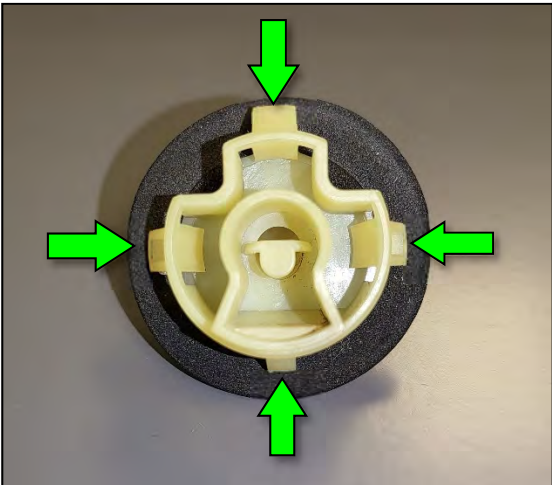
14. Release the four (4) locking tabs and push inward to remove the moonroof drain grommet from the inside.

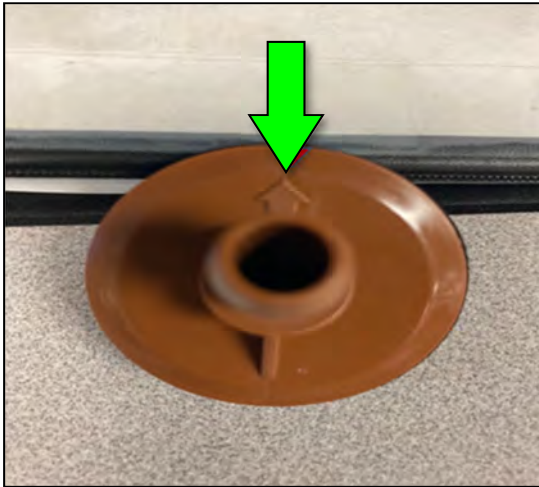
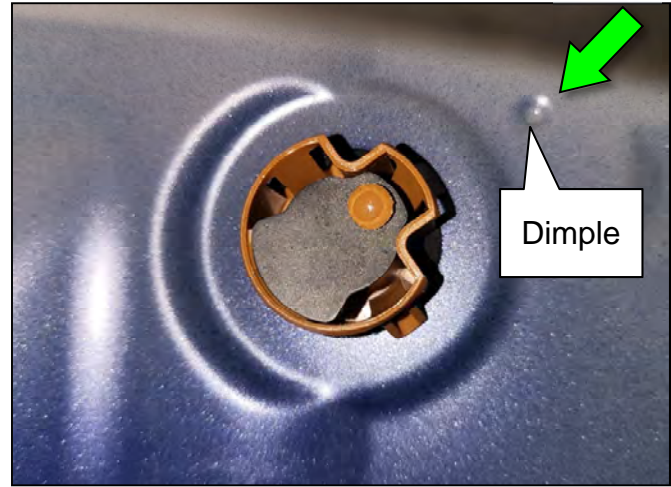
15. Install the new moonroof drain grommet from **PARTS INFORMATION** with the arrow pointing toward the dimple in the bulkhead, and then reinstall the moonroof drain tube.
