TECHNICAL SERVICE BULLETIN

Classification: BT23-016	Reference: NTB23-073	Date: October 9, 2023
-----------------------------	-------------------------	--------------------------

GURGLING NOISE FROM MOONROOF AFTER IT RAINS

APPLIED VEHICLES: 2022-2023 Pathfinder (R53)
APPLIED DATES: Built on or before August 11, 2023

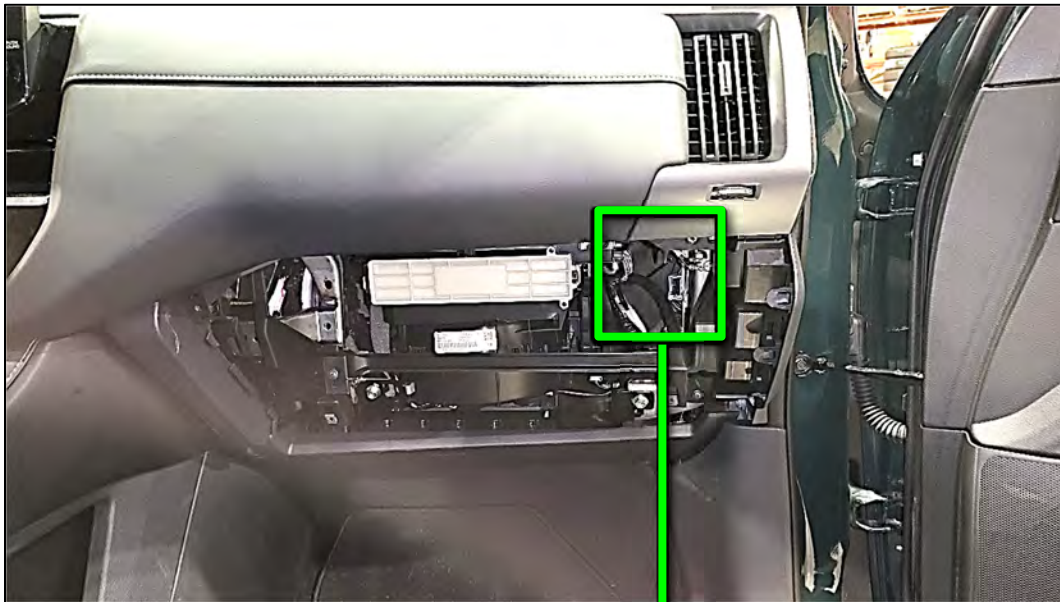
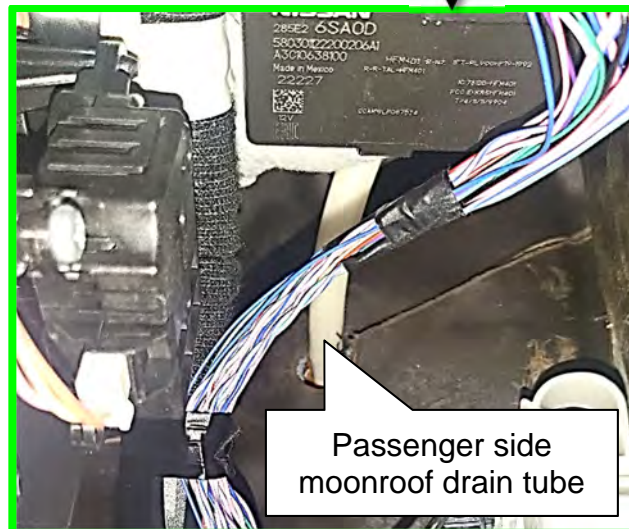
Figure 1

1. Remove the Cowl Top Cover.
 - Refer to the **ESM: BODY EXTERIOR, DOORS, ROOF & VEHICLE SECURITY > EXTERIOR > REMOVAL AND INSTALLATION > COWL TOP > Removal and Installation > REMOVAL**
2. Remove the Glove Box Assembly.
 - Refer to the **ESM: BODY INTERIOR > INSTRUMENT PANEL > REMOVAL AND INSTALLATION > GLOVE BOX ASSEMBLY > Removal and Installation > REMOVAL**
3. Locate the front passenger side moonroof drain tube, and disconnect the drain tube from the moonroof drain grommet.

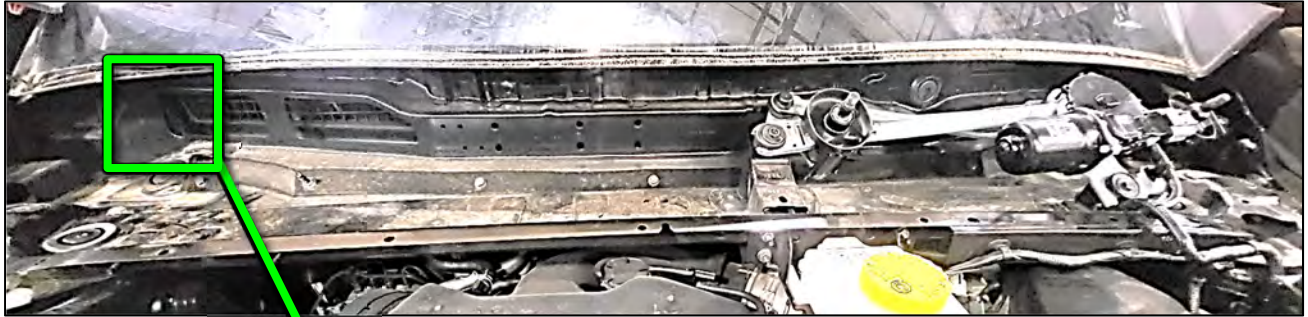
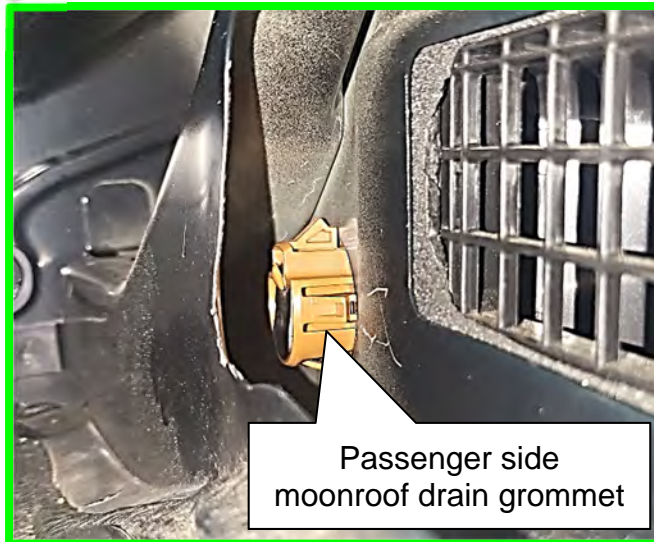
Figure 3

4. Locate the front passenger side moonroof drain grommet under the Cowl Top Cover.

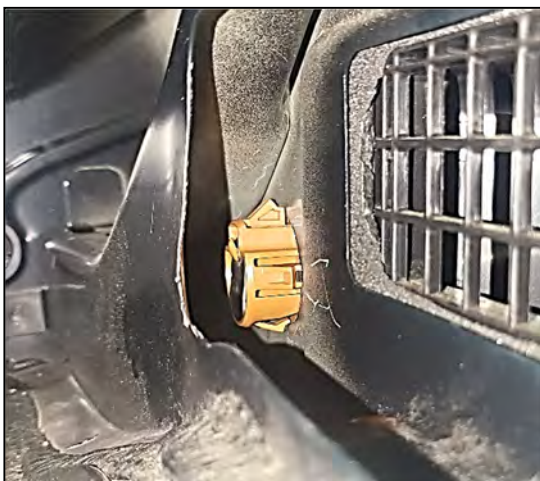
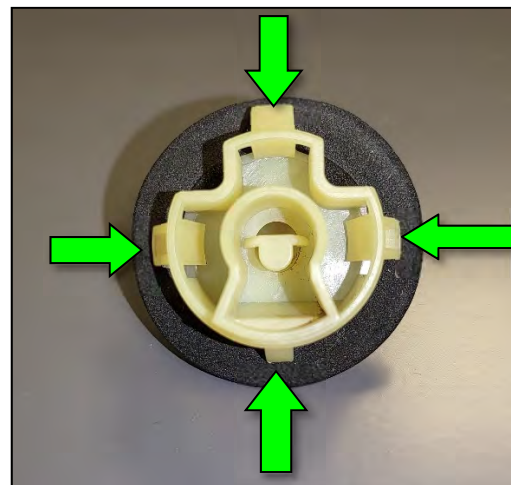
Figure 5

5. Release the four (4) locking tabs and push inward to remove the moonroof drain grommet from the inside.

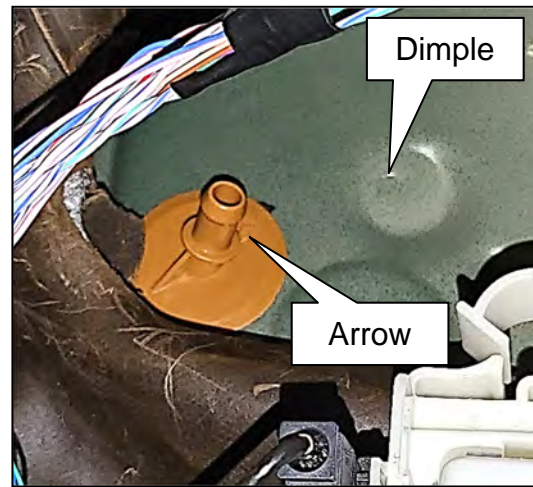
Figure 7

6. Install the new moonroof drain grommet from **PARTS INFORMATION** with the arrow pointing toward the dimple in the bulkhead, and then reinstall the moonroof drain tube.

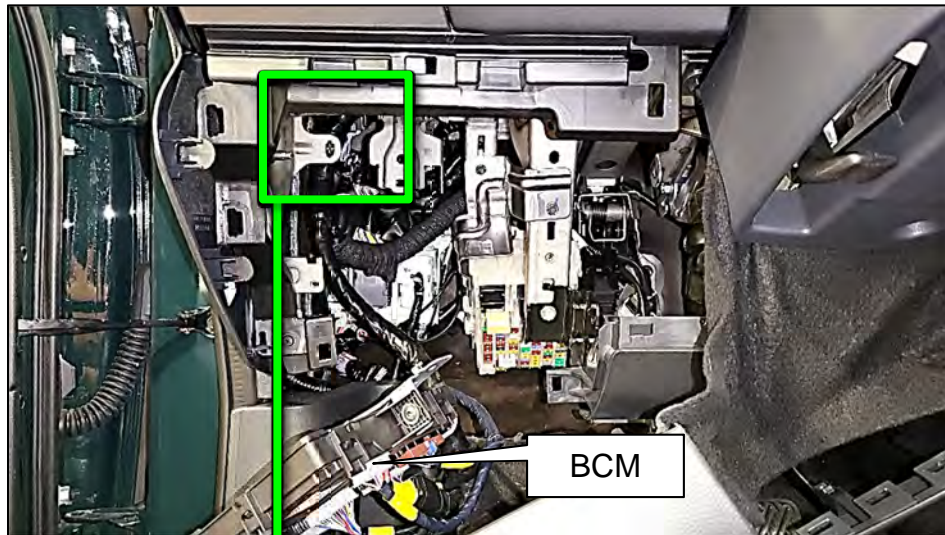
Figure 9

IMPORTANT: Do not unplug the BCM. Only unbolt the BCM from the dash frame so it can be moved out of the way, as shown in Figure 9.

9. Locate the front driver side moonroof drain tube, and disconnect the drain tube from the moonroof drain grommet.

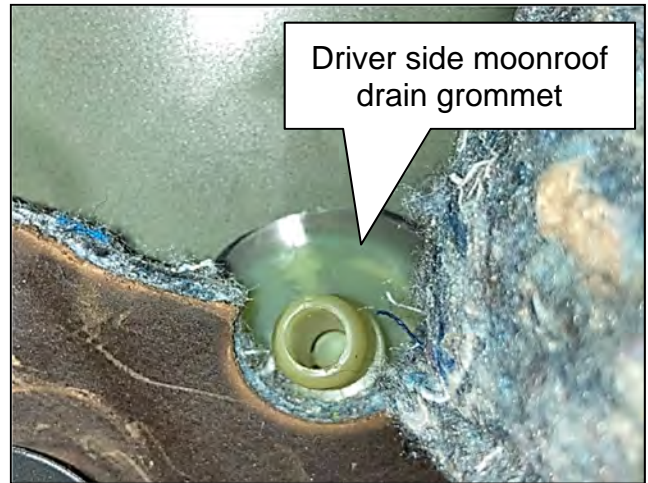
Figure 11

10. Locate and remove the front driver side moonroof drain grommet, behind the bulk head insulation, by inserting a pry stick behind the moonroof drain grommet and prying downward.

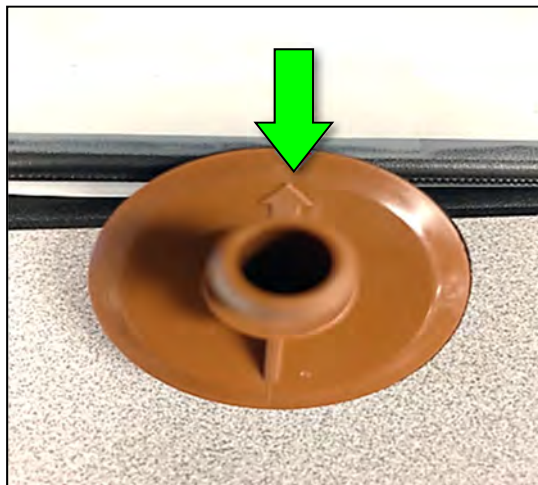
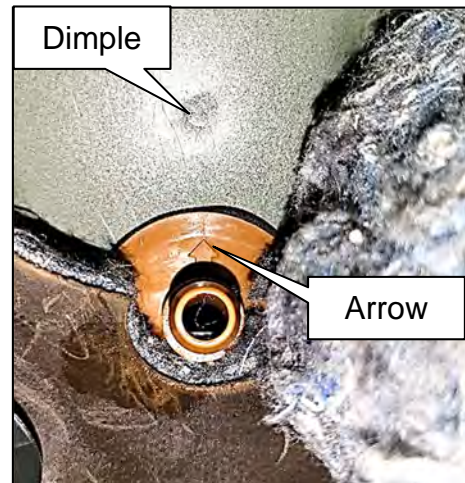
Figure 12

11. Install the new moonroof drain grommet from **PARTS INFORMATION** with the arrow pointing toward the dimple in the bulkhead, and then reinstall the moonroof drain tube.
