GLOBAL SAFETY FIELD INVESTIGATIONS
DCS6716
URGENT - DISTRIBUTE IMMEDIATELY

Subject: N222383860 - Service Update
Incorrect Material on 18 Inch Wheel Rivet

Models: 2022 – 2023 GMC HUMMER EV

N222383860 Incorrect Material on 18 Inch Wheel Rivets

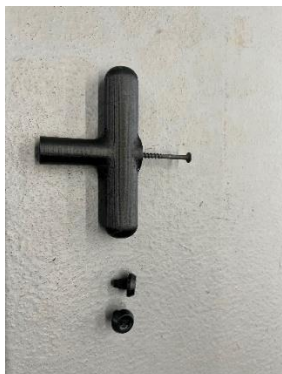
6443192

Note: A rubber mallet or equivalent is required for this procedure to seat the wheel rivets.

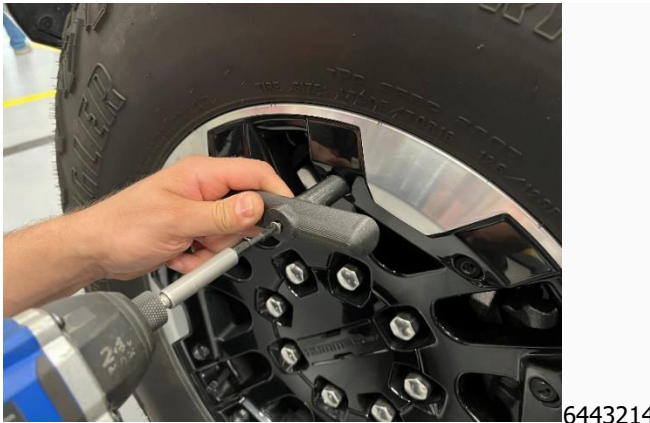
6443214

1. Using the special tool, center the tool over the rivet and slowly screw into the rivet.

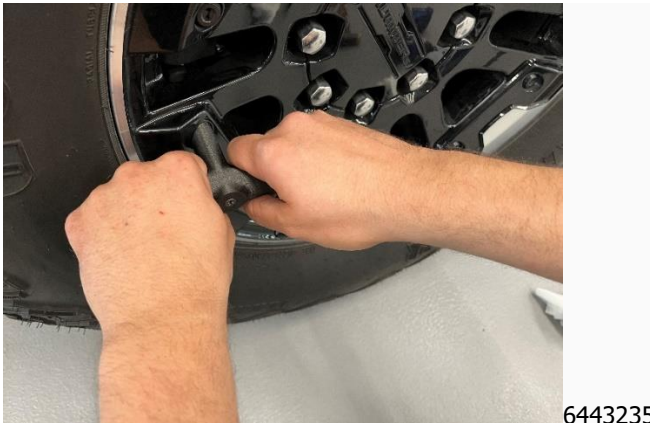
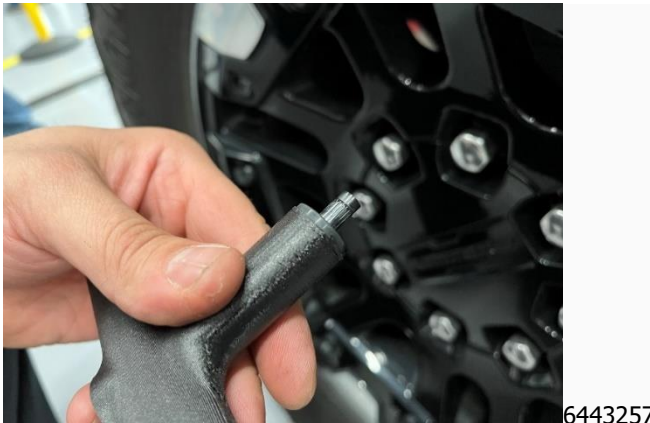
2. Using both hands, pull the rivet straight out of the wheel.
3. Continue this process for the remaining wheels and rivets.
4. Clean the wheel where the rivets were removed.

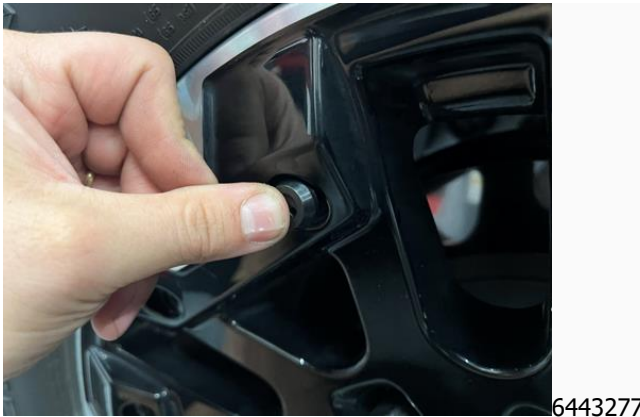
6443277

5. Manually insert the rivet into the wheel.

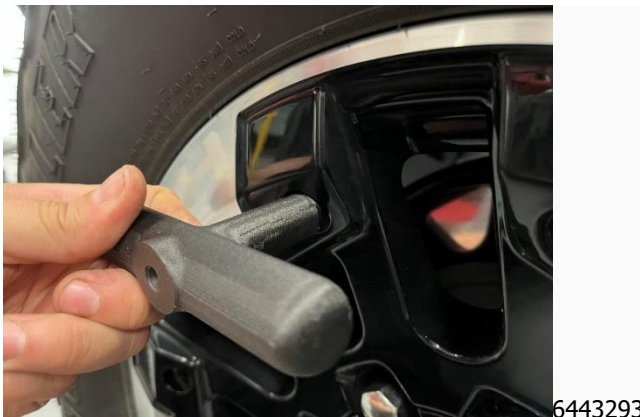
6443293

6. Center the tool over the rivet, while using a rubber mallet, strike the tool to seat the rivet into the wheel.
7. Continue this process for the remaining wheels and rivets.
