Do Not Over-Torque the Rear Differential Drain Plugs When Servicing

AFFECTED VEHICLES

Year	Model	Trim Level
2018–24	CR-V	AWD
2018–24	HR-V	AWD

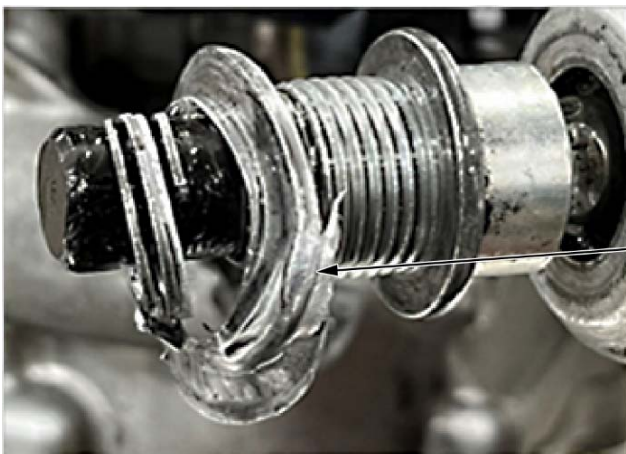
Honda has analyzed returned rear differential assemblies, and many of the rear differential drain plug threads were over-torqued and stripped during normal maintenance servicing, creating a fluid leak that allows the fluid level to get low enough to cause the rear differential to fail.

A 3/8-inch drive electric impact driver has a range of 203 to 338 N·m (150 to 250 lb-ft) of torque, which far exceeds the drain plug specification. The AWD rear differential drain plug threads will fail between 108 N·m (80 lb-ft) to 164 N·m (121 lb-ft) of torque.

STRIPPED THREADS CAUSED BY EXCESSIVE TORQUE.

This seems like common sense, but **NEVER use an impact tool on the differential drain plug**. Final torque will be achieved using a torque wrench. Always verify the fastener torque specification in the service manual prior to starting each job.

The AWD rear differential drain plug specified torque is **47 N·m (35 lb-ft)**.
