SIB 31 01 23
SERVICE SOLUTION: Apparent Leak Front Fork Cap

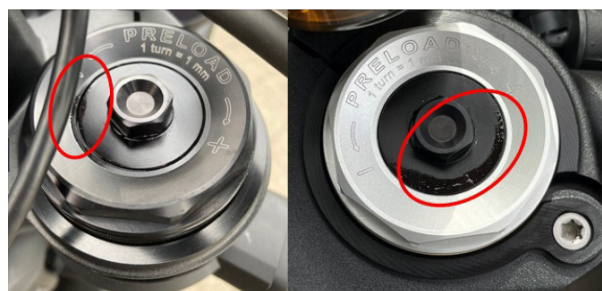
On the above listed vehicles, lubricant residue can be found on the fork cap on the right side telescoping fork. Vehicles with caps 31 42 1 754 557 and 31 42 1 757 701 can show this residue.

These are not leaks at the cap, but assembly grease residue.

Forks with this apparent leak have been received and leak testing was performed. **NO** leaks could be detected.

In the event of an apparent leak complaint, clean the cap area with a suitable cleaning solution.
