| <b>Tesla, Inc.</b><br>Service Bulletin | | <b><i>Inspect Radiator Outlet Hose</i></b> | |
| <b>SB-23-18-006</b><br>October 10, 2023 | | | |

On some Semi, the radiator outlet hose may rub against the cooling fan module (CFM), which may damage the hose.

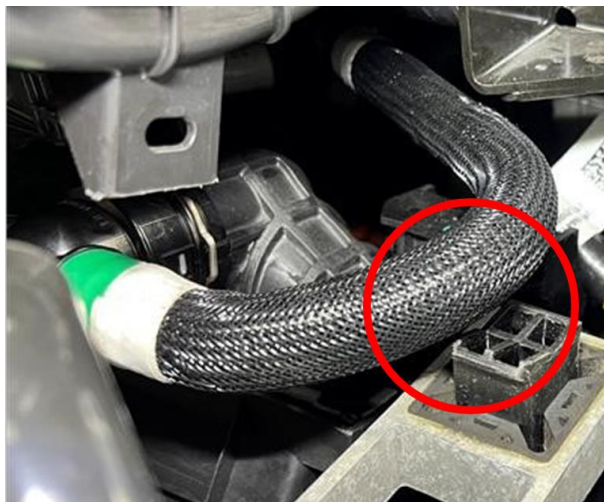
Figure 1

1. Chock the LH front wheel.
2. Open the hood.
3. Inspect the LH end of the radiator outlet hose where it passes over the LH CFM bracket (Figure 1). Look carefully for signs of damage, especially if the hose contacts the LH CFM bracket (Figure 2). Possible damage includes chafing (Figure 3) or coolant leakage (Figure 4):

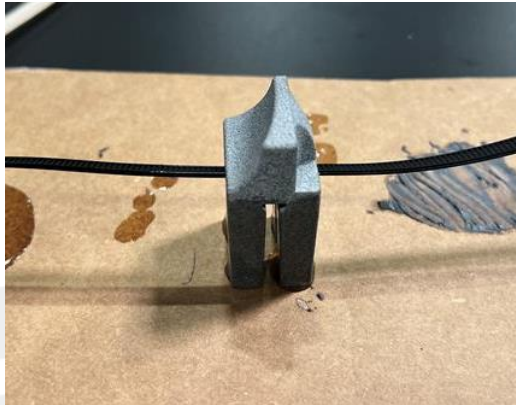
**Figure 5 – Run the cable tie perpendicular to the concave feature at the top of the bracket**

4. Slide the cable tie through the upper recess in the coolant hose bracket, as shown in Figure 5.

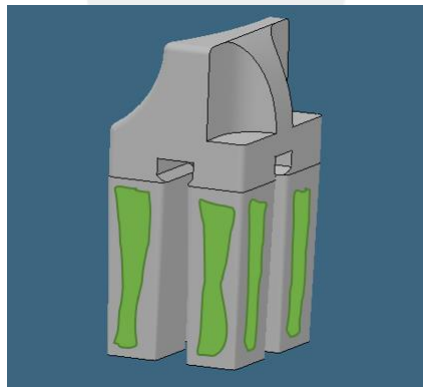
**Figure 6 – Also apply adhesive to the 2 other sides (not shown in this image)**

6. Apply the adhesive to all outer side surfaces of the bracket legs (Figure 6).

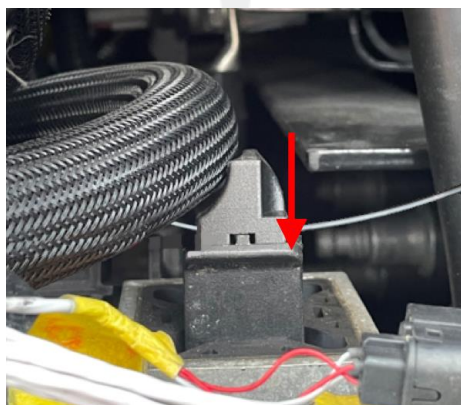
**Figure 7**  
**TESLA**

7. Position the coolant hose bracket in the LH CFM bracket, making sure the concave feature at the top of the coolant hose bracket supports the radiator outlet hose (Figure 7).

**NOTE:** Push the bracket all the way down, until it goes no further, and then wipe off any excess adhesive.

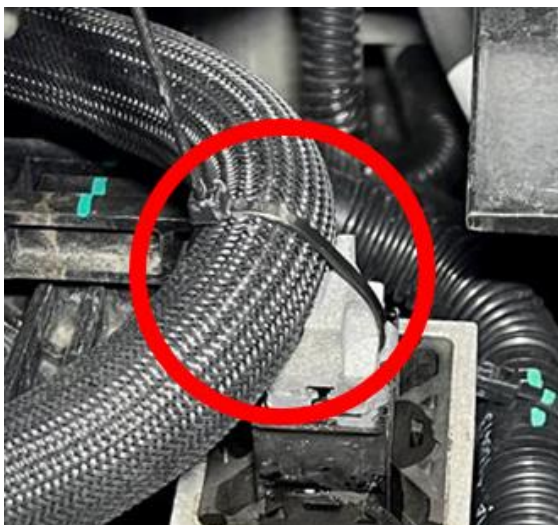
**Figure 8**

8. Allow the adhesive to set for 5 minutes.
9. Fasten the cable tie around the radiator outlet hose (Figure 8), and then cut off the excess cable tie (Figure 9).

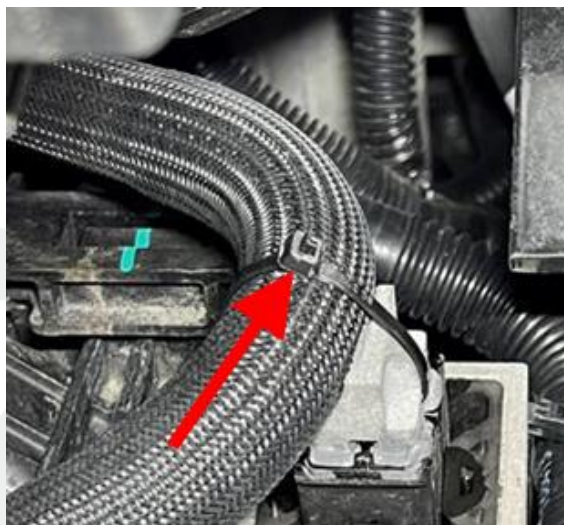
**Figure 9**

**NOTE:** Make sure the cable tie locking head is facing away from the coolant hose (Figure 9).

**NOTE:** Align the cable tie so that when the cable tie is fastened in a later step, the locking head is facing up and away from the coolant hose bracket (Figure 9)
