Technical Service Bulletin

GROUP	NUMBER
DRIVESHAFT AND AXLE	23-DS-002G
DATE	MODEL(S)
NOVEMBER 2023	GV70 (JK1) G90 (RS4)

SUBJECT: TRANSFER CASE ACTUATOR DIAGNOSIS AND REPLACEMENT

This TSB supersedes 23-DS-001G-1 to add the G90 (RS4), expand the applicable vehicles production dates, and include updated actuator dates.

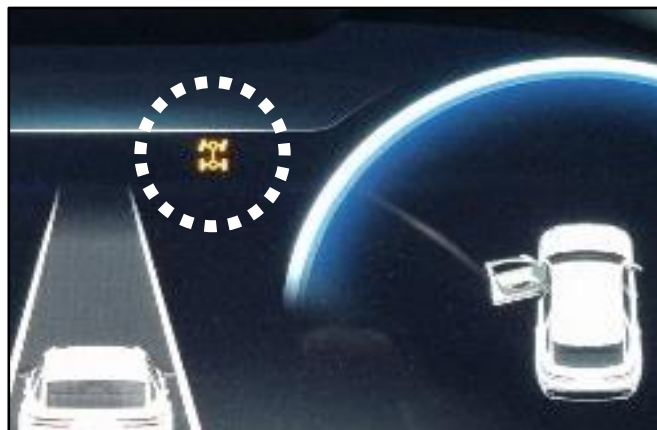
1. Confirm transfer case warning lamp is displayed in the cluster.

If any of the following DTCs are present, P196000, P195800, or P195513, continue with transfer case actuator replacement.

If other DTCs are present, follow the shop manual for repairs.

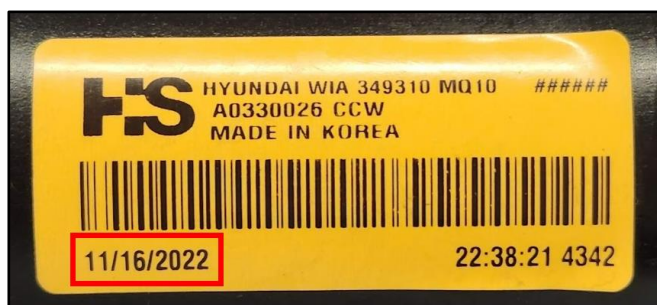
- Confirm date on the new actuator label is 06/05/2023 or after.
