REFERENCE:	Nova Bus Manuals
SECTION:	16: Electrical system
RS N°:	MQR 7621-2730
EFFECTIVE IN PROD.:	NA

SUBJECT:	Harness routing
JUSTIFICATION:	The WHA11 harness has a potential chafing issue.

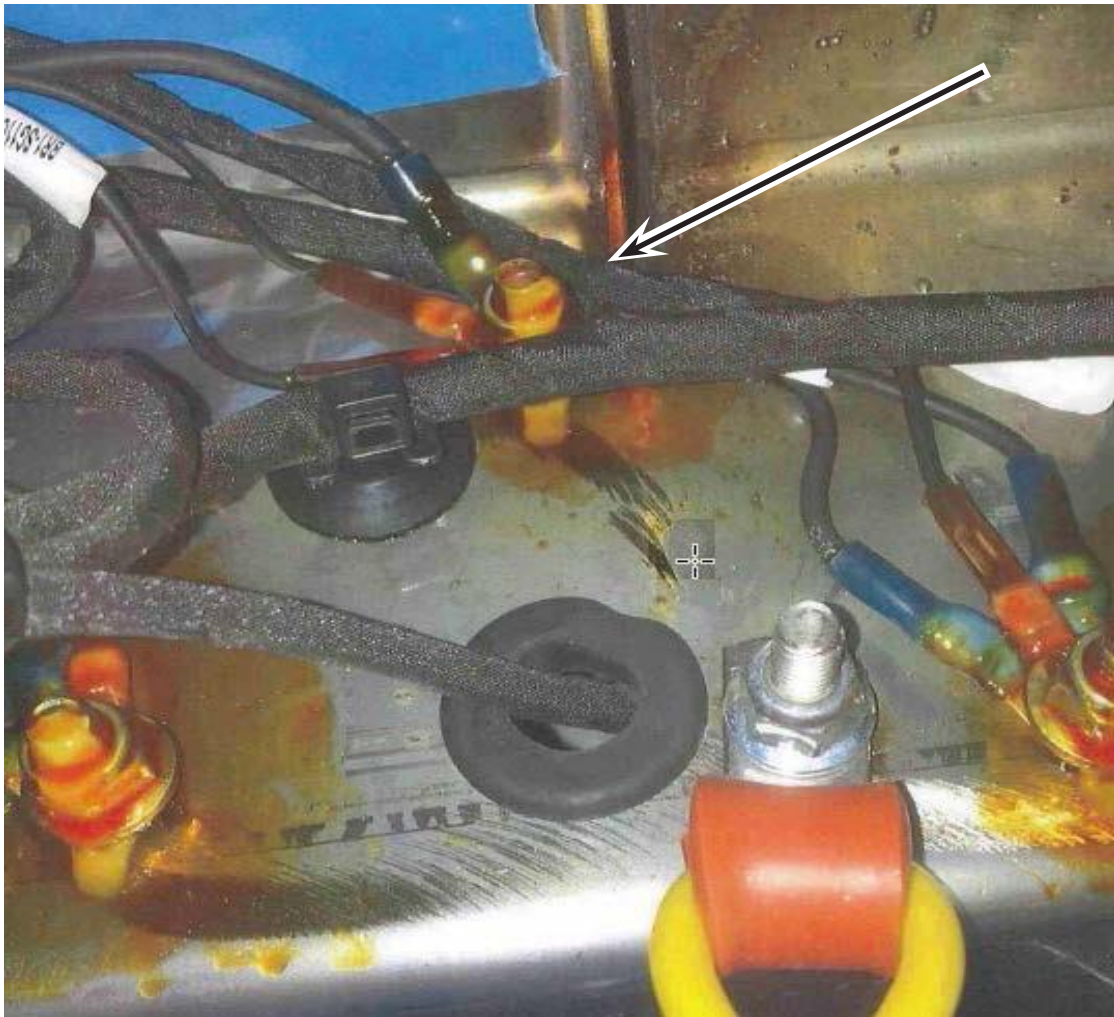
Figure 1 - Look for a Potential Chafing Issue

- 1.1. Park the vehicle on an even surface with the transmission on neutral.
- 1.2. Apply the parking brake and set the master control switch to the **stop** position.
- 1.3. Set the battery disconnect switch in the battery compartment to the **off** position.
- 1.4. Remove the BR1 panel, which is the panel above the first window, curb side.
- 1.5. Look for the potential chafing issue with the harness WHA11 on the omega #2. See the figure below as a reference.

- 1.6. Secure with a cable tie both branches of the harness to the exiting mount to avoid possible chafing on the edges. See the figure below.
