SIB 52 23 19

SEATS IN THE G05, G06, G07

2023-11-22

With the launch of the G05 (X5) Sports Activity Vehicle in August 2018, a new style of networked seats was introduced that have new operating parameters. This service information bulletin details the operation of the new style seats.

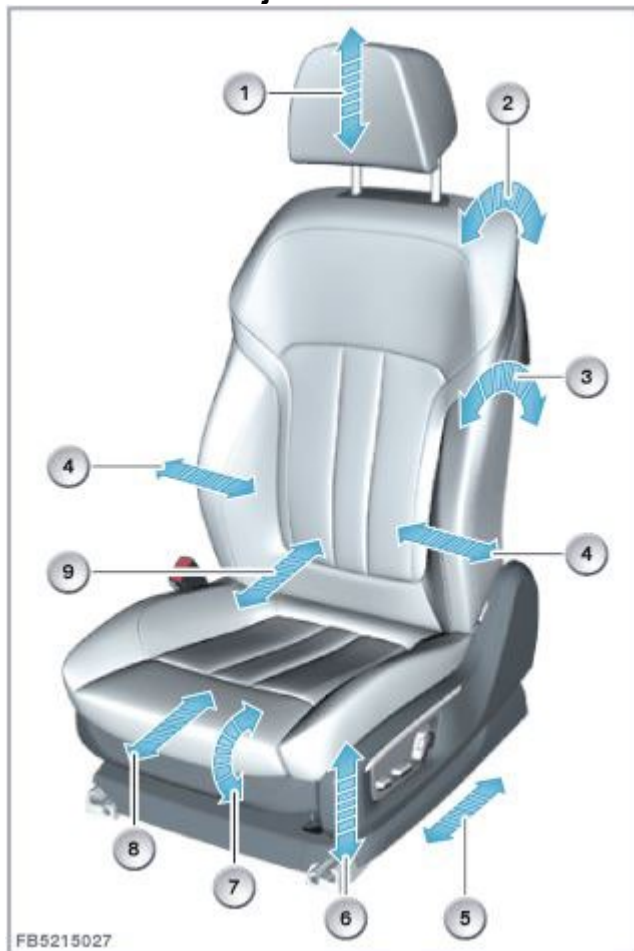
#### Possible Adjustments of the Seat

Index	Explanation	Index	Explanation
1	Headrest restraint height adjustment	2	Backrest upper section adjustment
3	Backrest angle adjustment*	4	Backrest width adjustment
5	Forward/back seat adjustment*	6	Seat height adjustment*
7	Seat angle adjustment	8	Seat depth adjustment
9	Lumbar-support adjustment

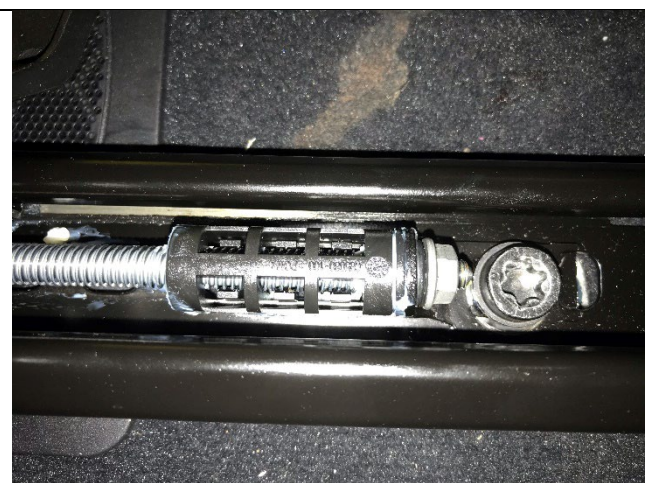
The seat rails are equipped with a **mechanical end stop**.

- When replacing a seat rail, this end stop must be transferred to the new rail.
- Failure to install these end stops will prevent the seat from initializing.
- End stop part number 52 10 7 469 879

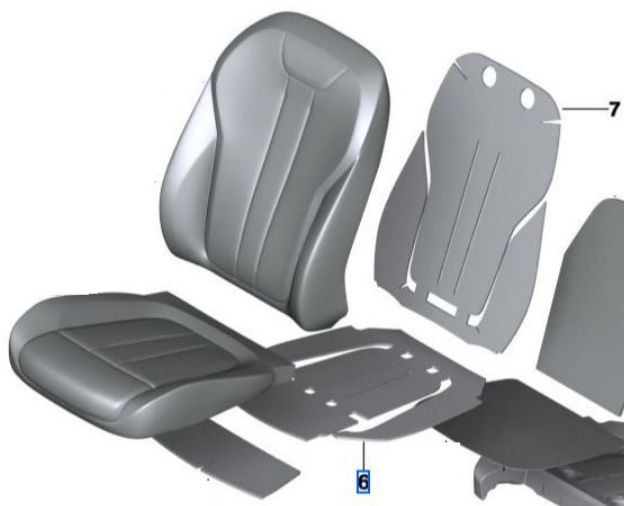
## Seat Heater Mats

The seat heater mat is controlled by the seat module.

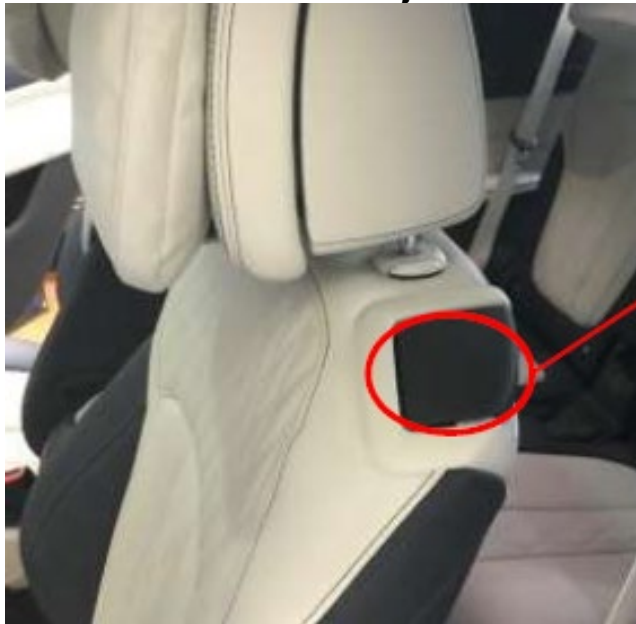
#### 2<sup>nd</sup> Row Lift / Tilt adjustment

This lever moves the seat forward and lifts/tilts to allow easy access to the 3<sup>rd</sup> row seats.

- If you hold it up, then let it go, it will return to its original position
- Or, you can pull back on the entire seat manually until you hear the seat click and it will finish returning to its original position
- **Captains Seat** will move forward but **doesn't fold flat**

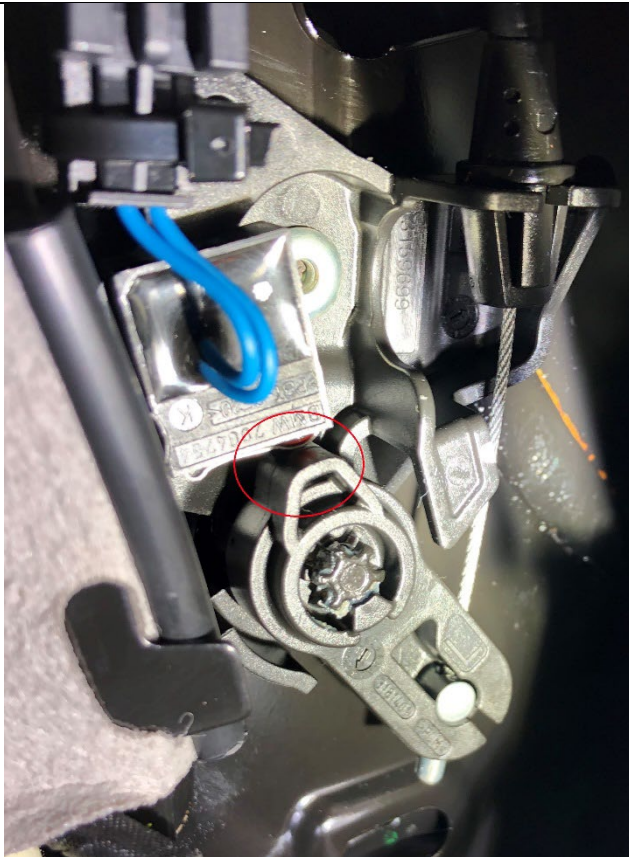
**2<sup>nd</sup> Row Lift - Tilt adjustment cam**

When the lever controlling the Bowden cable for the tilt adjustment is applied, the microswitch is no longer actuated by the cam.

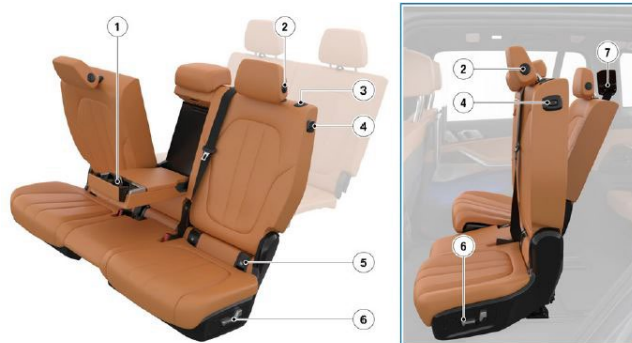
### Seat overview

1. Cupholder
2. Release for head restraint tilt
3. Release for electrically folding the backrest
4. Button for electric easy entry function
5. ISOFIX mount
6. Button for electric seat adjustment
7. Safety belt height adjustment

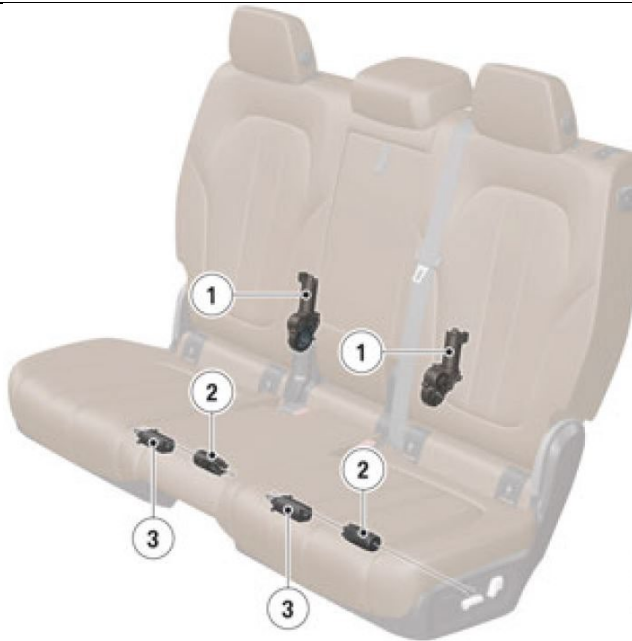
## Electric motor locations

1. Electric Motors for adjusting, folding down and raising up the backrest

2. Electric Motors for Forward / Back Adjustment
3. Electric Motors for Comfort Entry

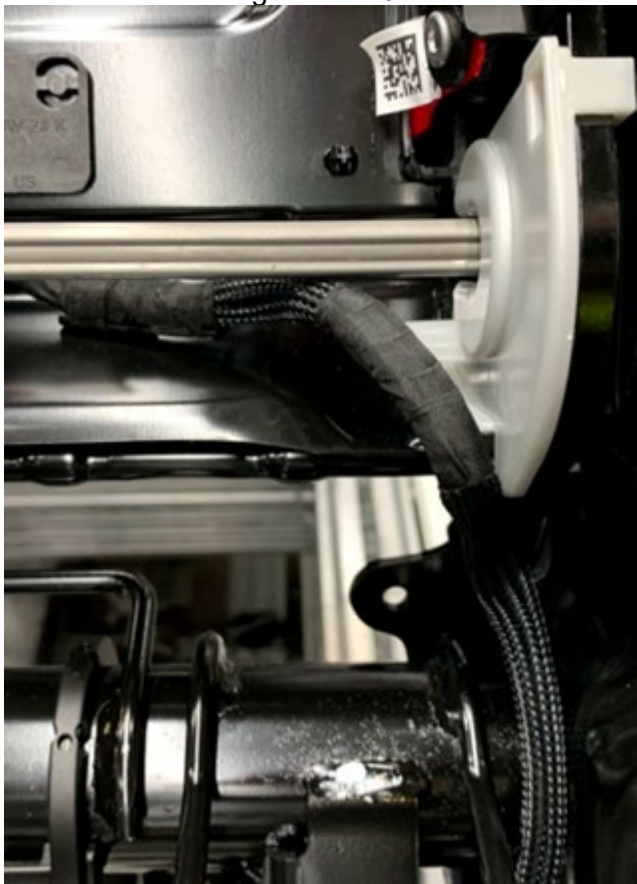
Passenger side 40% seat

Pinch protection plate

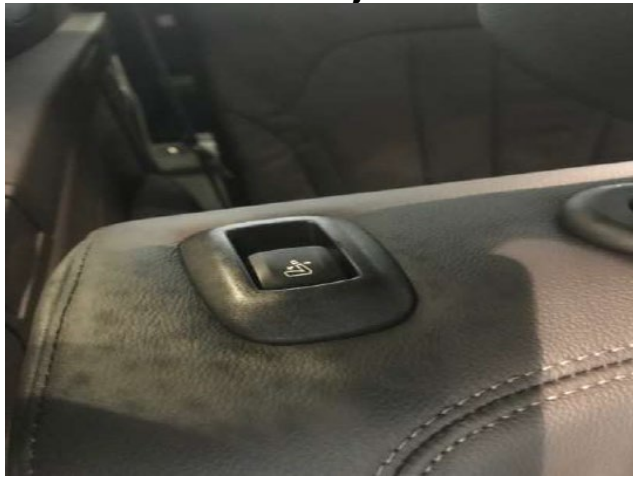
### Lift - Fold adjustment

This button is located on the 'shoulder' of the 2<sup>nd</sup> row seat and folds the seat down or lifts it back up.

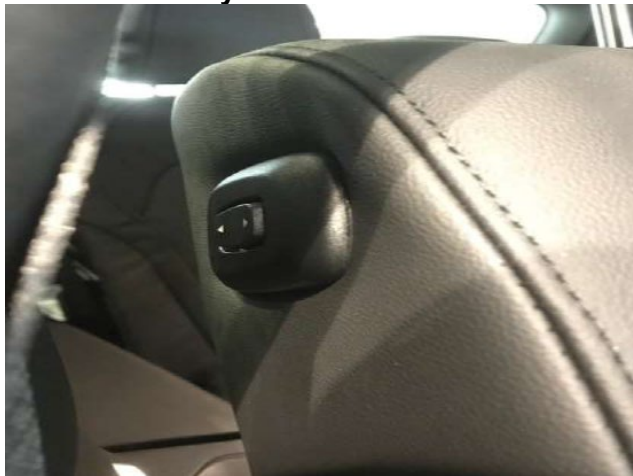
### Easy Access to 3<sup>rd</sup> row

This button is located on the side of the 2<sup>nd</sup> row seat and it allows easy access to the 3<sup>rd</sup> row seats.

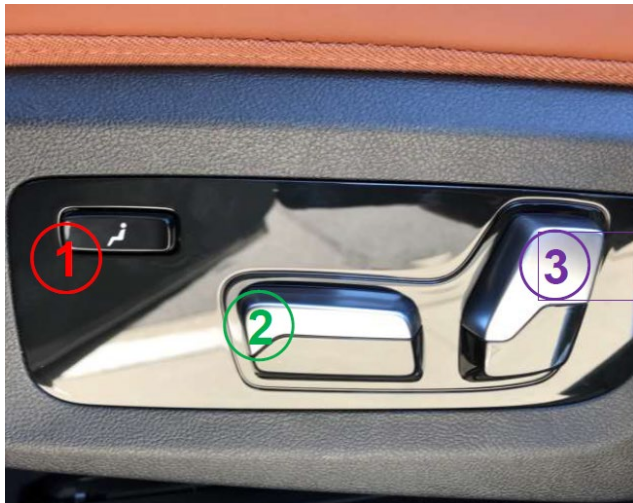
### 2<sup>nd</sup> row seat mounted switch block

These controls are identical on the side of the bench or captain seats.

On a bench seat, the middle section moves with the driver seat

- 2 Resets the 2<sup>nd</sup> row seat to its default position  
3 Seat Forward - Backward  
Seatback Forward - Backward

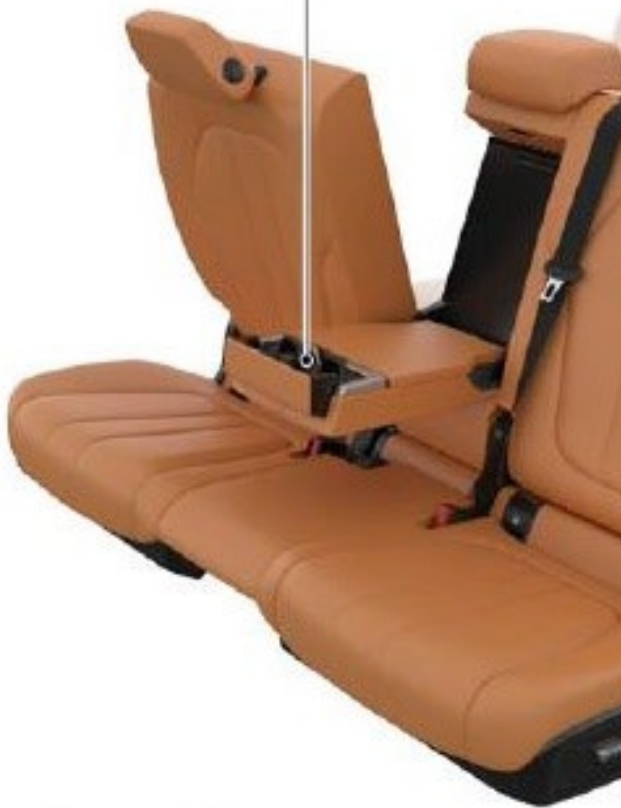
**Center 20% Seat section**

The armrest of the 60/40 seat can be folded down to access the cupholders.

The armrest position is not monitored.

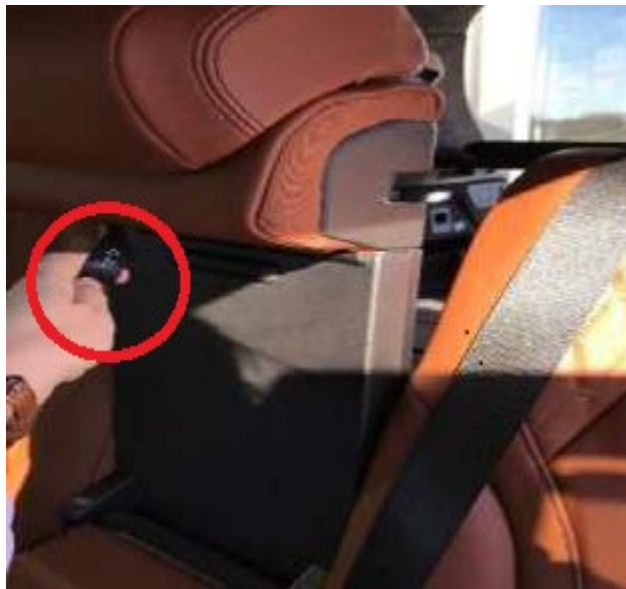
The center section (20%) of the seat can be folded down independently of the driver's 2<sup>nd</sup> row seat by pulling on the release (circled).

- **NOTE:** The center section (20%) is a monitored status. **If this is folded down, it can influence the front seat backrest position** if the vehicle thinks there will be interference between the seats.

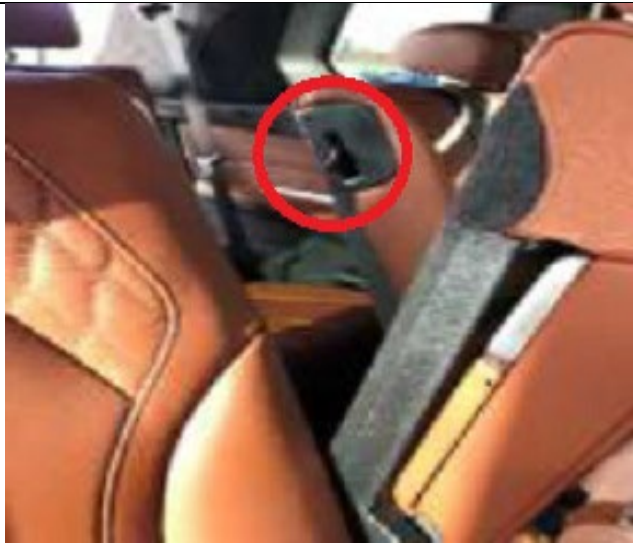
**Center 20% Seat section mounting pin**

The middle section of the seat is retained by a pin (circled) on the driver's 2<sup>nd</sup> row seat. This pin folds down - retracts into the seat once the middle section is folded

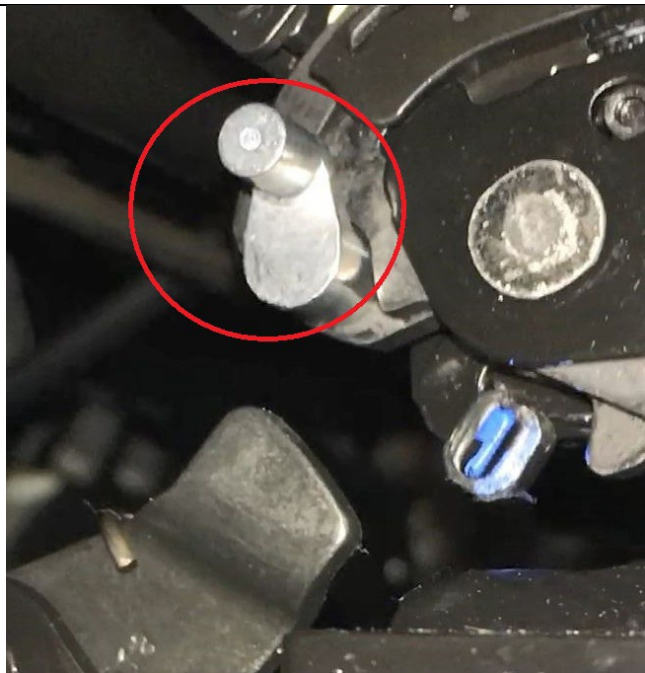
If this vehicle does have the washer as noted above or the washer is not needed by production

date, then see SI **B52 04 22** for instructions to modify this cam.

When this occurs a Check Control Message (CCM) “**Left rear seat back unlocked**” comes up in the display.

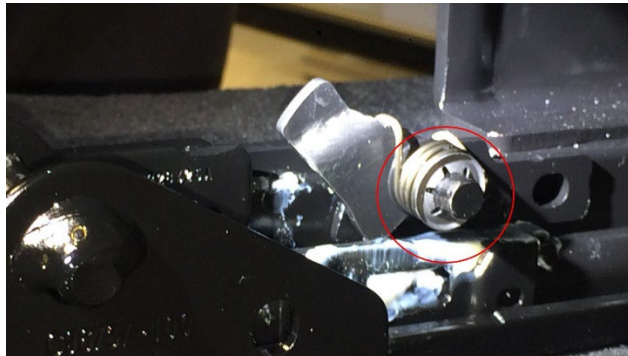
#### Cam Interlock on rail

The matched section of the cam interlock is located on the seat rail. This tab (shown raised) contacts the interlock when the seat is lowered to its normal seating position.

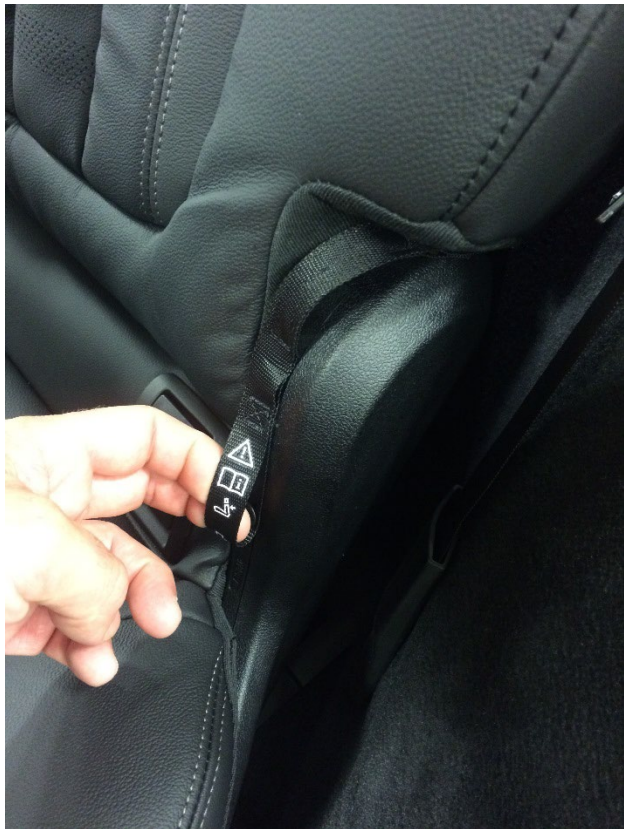
Seat Manual Release 1

The seat can be manually released in case of electrical failure to access the third row seats. This is located at the outer pivot point on each side of the 2<sup>nd</sup> row seat.

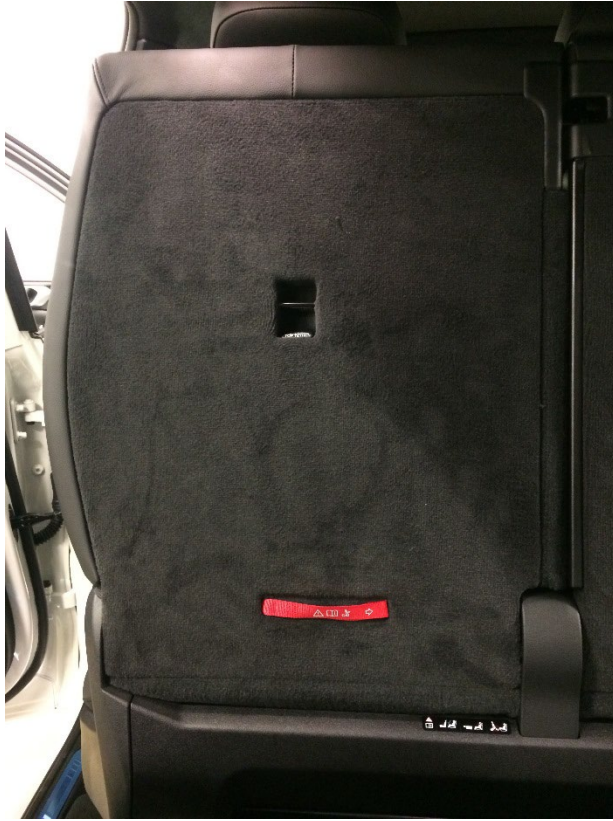
### Seat Manual Release 2

The seat release (red) is for the third row passenger to actuate, enabling exiting the vehicle in case of electrical failure.

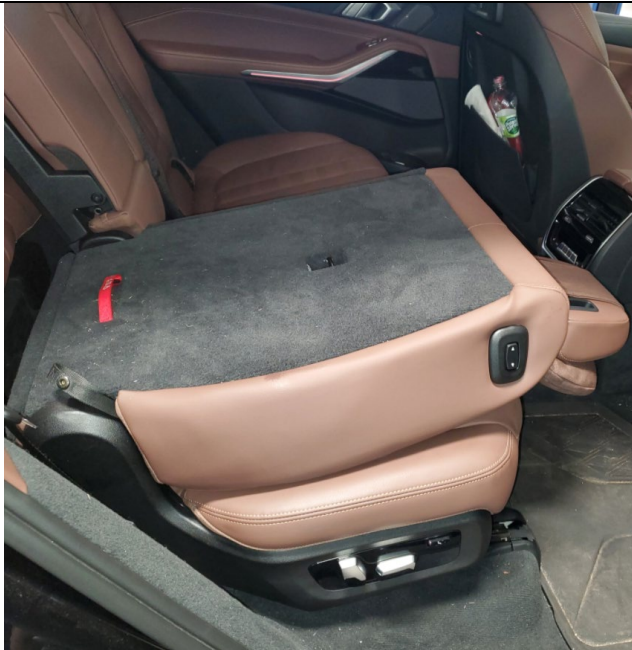
### REPLACEMENT SEAT COMES IN SHIPPING POSITION #1 / SEAT STUCK IN FOLDED POSITION

The second-row seat is shipped in a folded-flat position. When in this shipping position, the manual releases detailed above will not work. The manual release will only allow the seat to fold. To unfold the seat it must be either electrically (#1) or mechanically (#2) turned at the backrest pivot

Reference the attachment to SI B52 05 20 and power the seat backrest motor directly with a drill battery and connector (V cable 612 160) to open/unfold the backrest. Once the backrest has been powered open, the manual release cables will then allow the backrest to fold.

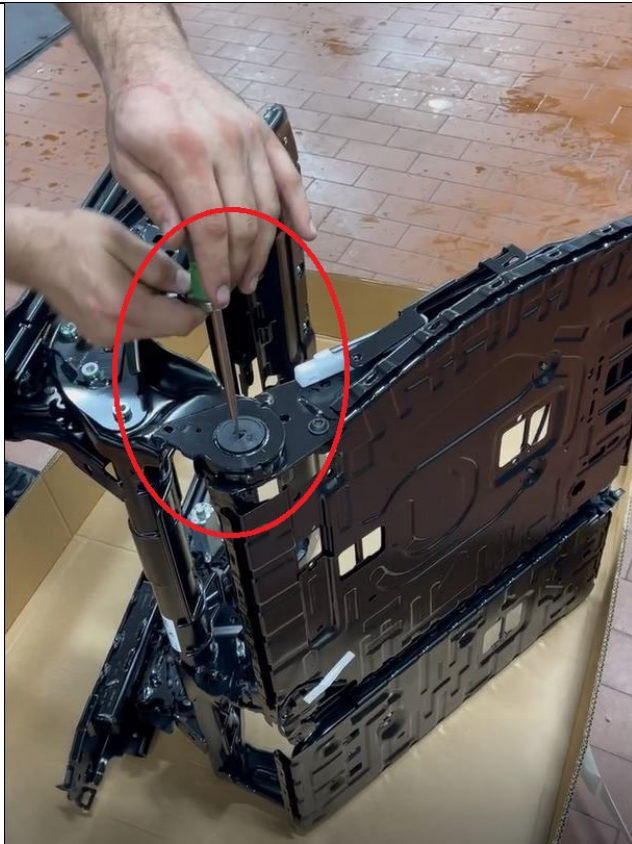
## REPLACEMENT SEAT COMES IN SHIPPING POSITION #2 / SEAT STUCK IN FOLDED POSITION

When in this shipping position the seat can also be unfolded by spinning the circled pivot by hand using a screwdriver.

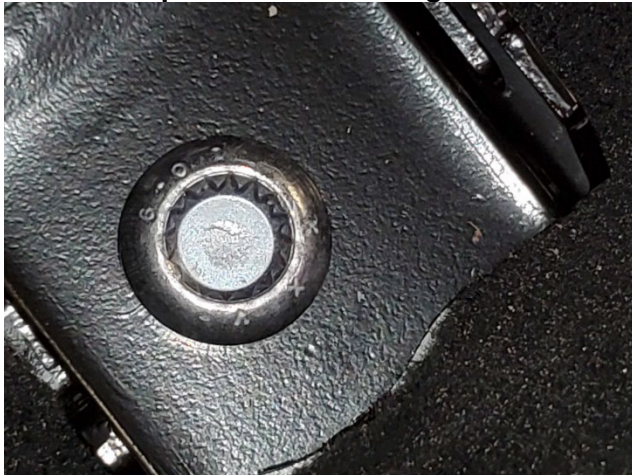
## 16 point Seat Mounting bolts

The seats are mounted with a new style 16 point internal bolt.

- Always replace the bolt after removal  
Torque to 42 Nm

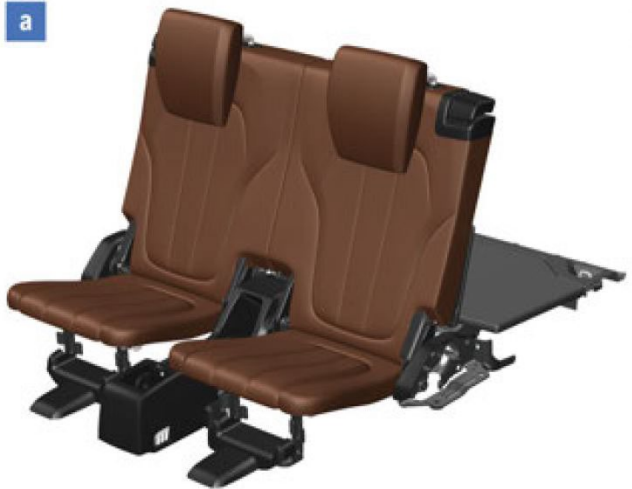
**Upright position**

A – Third Row Seats in upright position

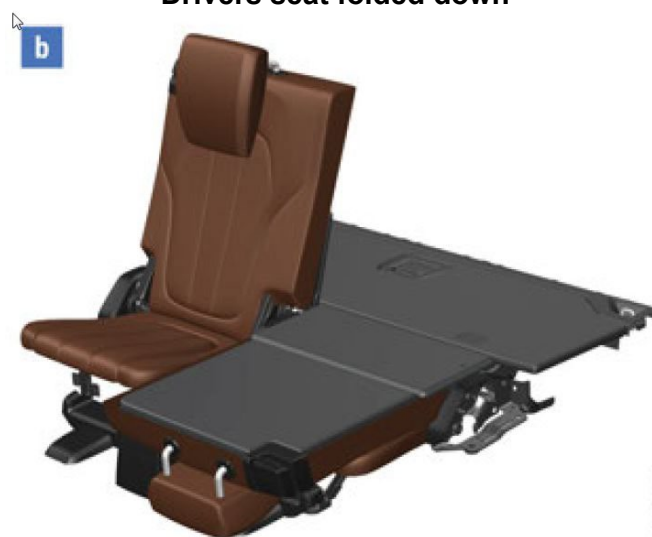
**Drivers seat folded down**

B – Third Row Seats with Drivers side folded down.

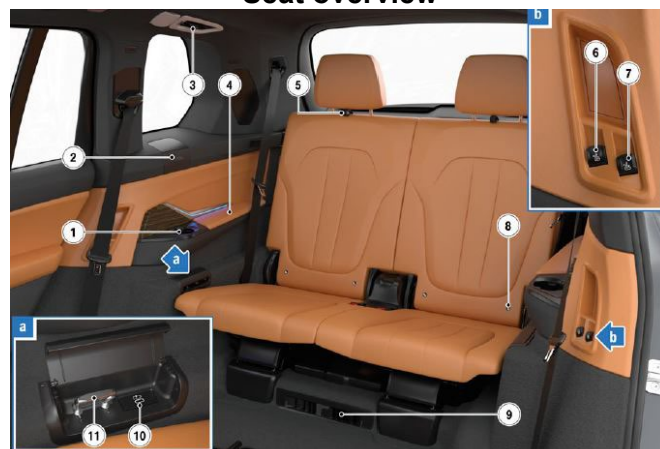
#### Seat overview

Index	Explanation
1	Cupholder
2	Mounting point for luggage compartment roller cover
3	Roof air vent
4	Armrest
5	Release loop for folding the backrest
6	Button for electrically folding the right-hand seat
7	Button for electrically folding the left-hand seat
8	ISOFIX
9	Footwell air outlet
10	Type C USB socket (option SA 4FL or SA 6FH)
11	Lashing hook

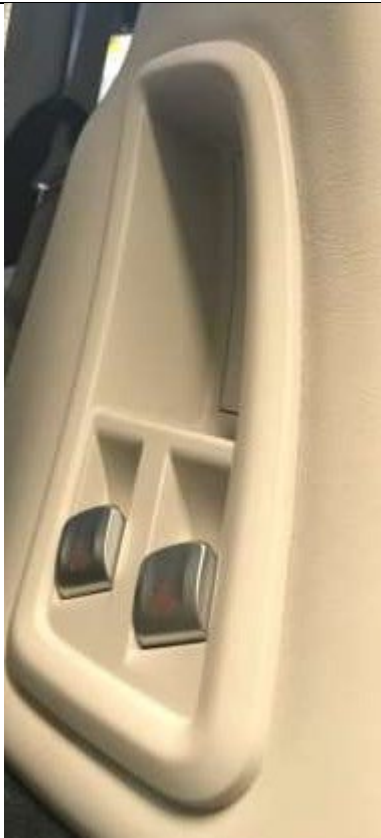
The buttons (**S311** and **S312**) to control the third row seats are located on the C-pillar.

- Pulling the button lowers the seatback

- Pushing the button raises the seatback
- The small recess above the buttons is there to assist in entering the 3<sup>rd</sup> row
- Wiring Schematics for these motors can be found under “Electric seats 6 seats”

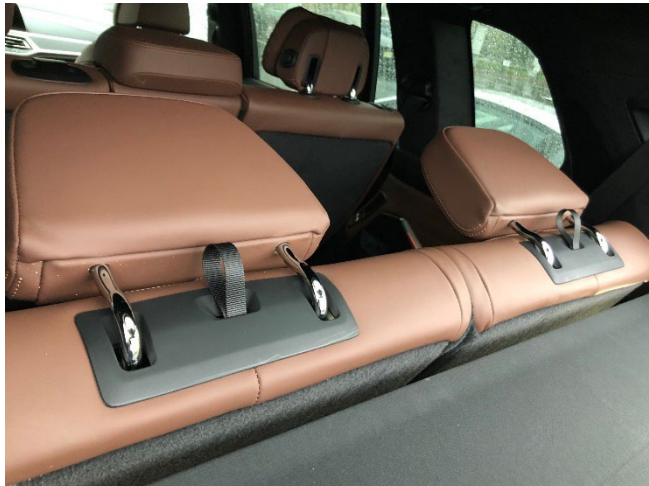
#### Headrest Manual Release

There is a manual pull release to fold the headrest(s) located under the headrest.

**NOTE:** To remove the rear seat headrest assembly, you must remove the headrest leather cover. **This cover will be destroyed during removal and will have to be replaced.**

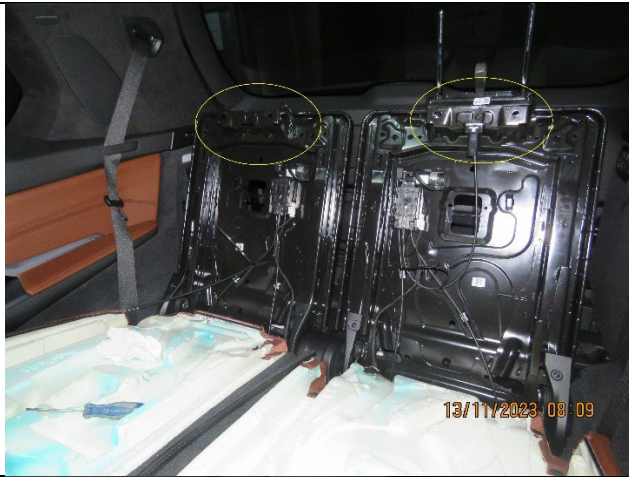
The metal bracket that holds the headrest assembly is welded to the seat backrest assembly.

If any of the welds did not penetrate well this bracket may make noise.

Replace seat frame assembly if necessary.

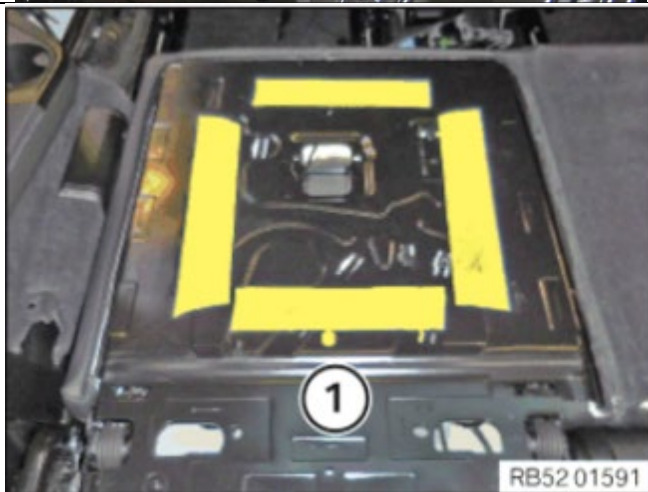
The rear panel of the third-row seat is additionally held in place with adhesive strips. Make sure to use the required adhesive tape when installing the rear panel on the backrest using P/N 83 19 0 445 309

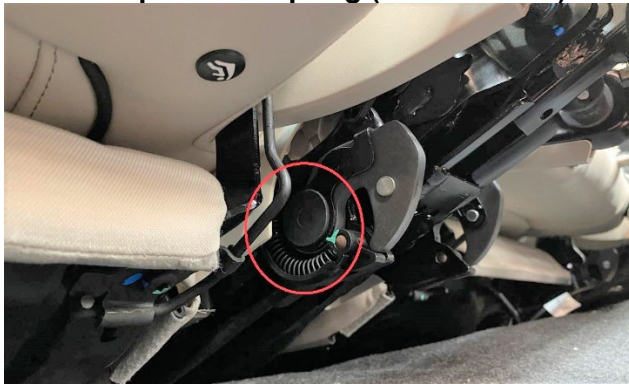
Compression springs are required for the electric fold function and to fully seat the latch assembly. An improperly positioned or missing compression spring prevents the seat backrest from locking completely.

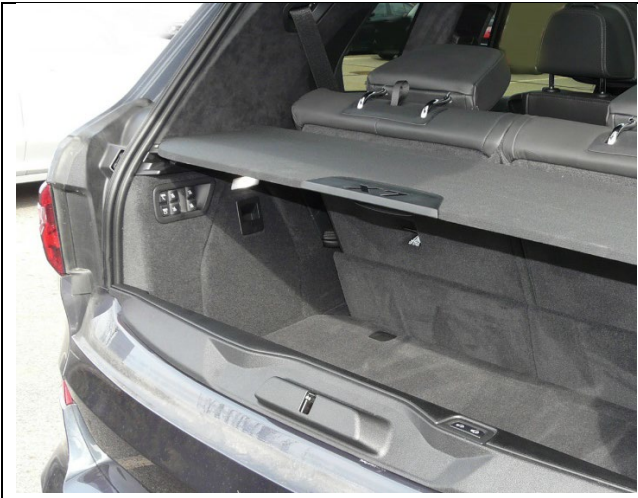
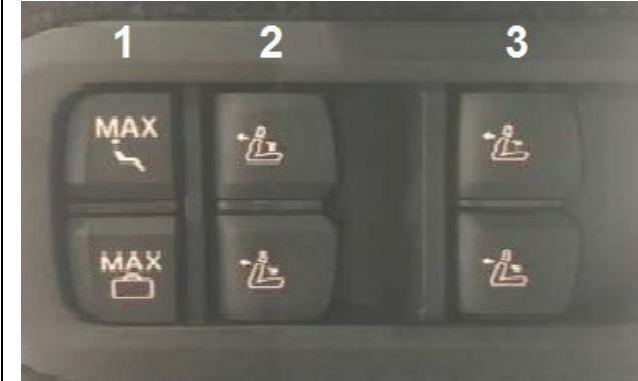
### D Pillar mounted switch block location

<ul style="list-style-type: none"> <li>Wiring Schematics for this switch block can be found under “Luggage Compartment Switch Block”</li> </ul> <p>There is a slight delay from when the buttons are pressed until the seats move. If a button is pressed before seat movement is finished it will stop the seats operation.</p>
<p><b>D Pillar mounted switch block</b></p>

<ol style="list-style-type: none"> <li><b>MAX Buttons</b> <ul style="list-style-type: none"> <li><b>Top</b> button – Moves all 4 seats to the maximum seating position. All seats move upright, 2<sup>nd</sup> row moves forward to allow max legroom for all passengers</li> <li><b>Bottom</b> button – Moves all 4 seats to the maximum cargo position. The third-row seats fold flat. The second-row seats operation will vary depending upon options. 60/40 Bench Seat will fold flat. Captains Seats will move forward but don't fold flat</li> </ul> </li> <li>These buttons are for the 3<sup>rd</sup> row seats. <ul style="list-style-type: none"> <li>Push to fold seats down; headrest will fold down</li> <li>Pull to raise seats up; headrest will not return to up position. They must be manually moved by hand to the up position.</li> </ul> </li> <li>These buttons are for the 2<sup>nd</sup> row seats. <ul style="list-style-type: none"> <li>Push to fold seats down</li> <li>Pull to raise seats up</li> <li>The second-row seats operation will vary depending upon options:</li> <li>60/40 Bench Seat will fold flat</li> </ul> </li> </ol> <p><b>Captains Seats</b> will move forward but <b>don't fold flat</b></p>
