Technical product information

Topic	Bentayga rear brake noise/squeal - Repair method depending on the brake noise frequency (Iron brakes only)
Market area	Australia E04 Bentley rest Asia and Australia (6E04),China 796 VW Import Comp. Ltd (Vico), Beijing (6796),Germany E02 Bentley rest Europe (6E02),Japan E03 Bentley Japan (6E03),Korea, (South) E08 Bentley South Korea (6E08),United Arab Emirates E06 Bentley Middle East and Africa (6E06),United Kingdom E01 Bentley UK (6E01),United States E05 Bentley USA and rest America (6E05)
Brand	Bentley
Transaction No.	2071730/2
Level	EH
Status	Approval
Release date

Bentayga rear brake noise/squeal - Repair method depending on the brake noise frequency (Iron brakes only)

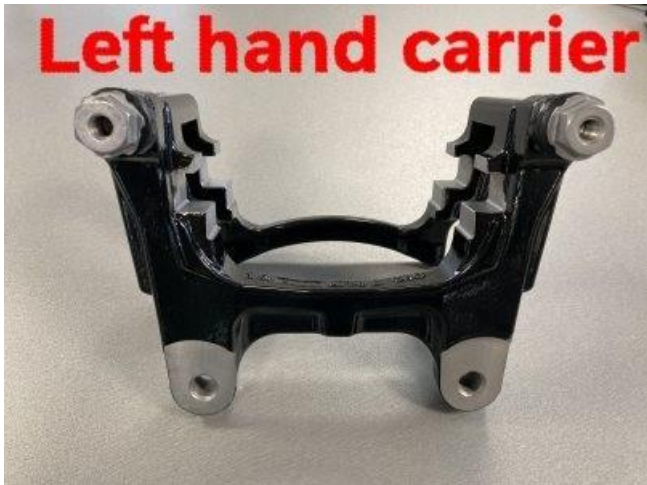
Figure 1 and Figure 2 - Left hand side

- 36A 698 425 - Left hand side
- 36A 698 426 - Right hand side

3) Referring to Rep.Gr 46 - Fit the left and right hand rear carriers as follows:

Hint: There are two colours available (red and black) for photographic purposes only, black carriers are shown as follows:

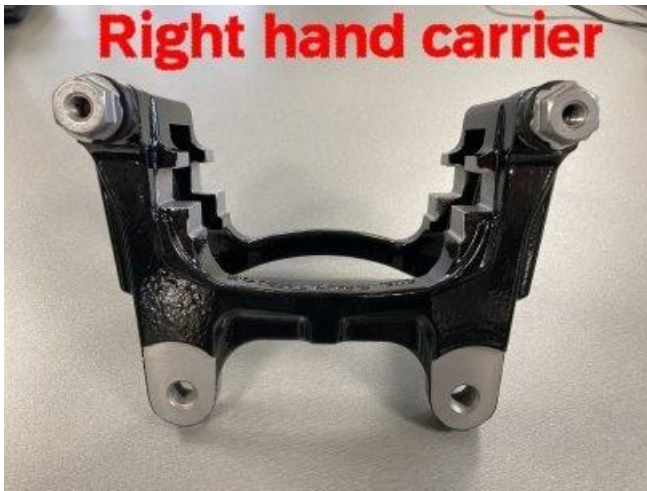
Figure 3 and Figure 4 - Right hand side
