TECHNICAL SERVICE BULLETIN

Classification: FE23-001A	Reference: NTB23-055A	Date: November 27, 2023
------------------------------	--------------------------	----------------------------

FUEL ODOR

APPLIED VEHICLES: 2021-2023 Rogue (T33)
APPLIED DATES: Built on or before July 27, 2023
APPLIED ENGINES: KR15DDT

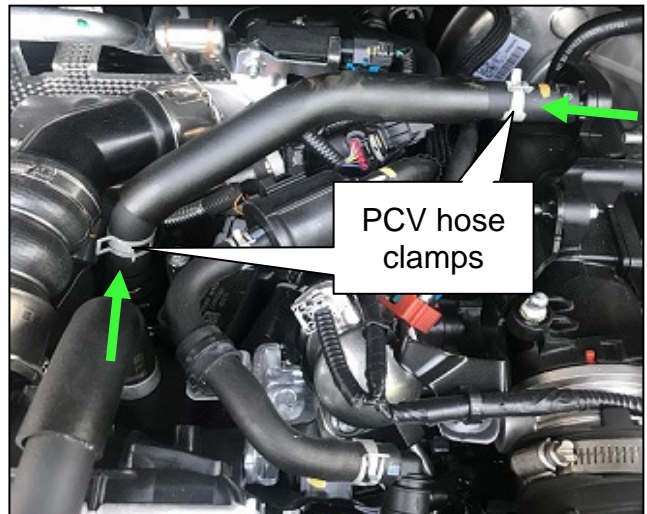
Figure 3

- c. Relocate the clamps that secure the PCV hose, to allow for PCV hose removal.

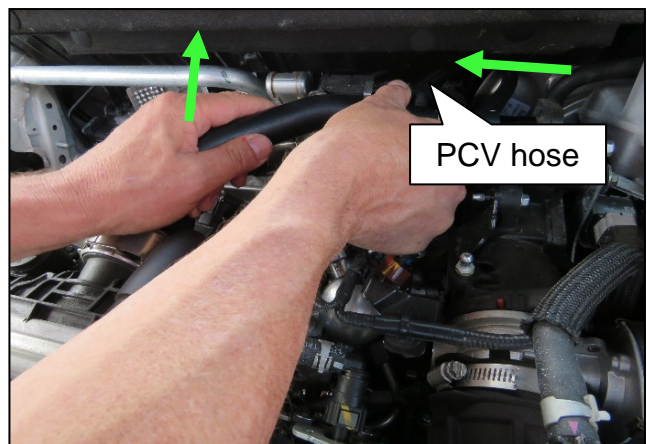
Figure 4

- d. Pull on the PCV hose in the directions shown in Figure 4, for PCV hose removal.

- e. Install the new PCV hose in the reverse order of removal.
- f. Reinstall the engine cover.
