Rear Spoiler Control Unit Replacement - Follow Procedure (134/23)

Model Line: **Panamera (971)**

Model Year: **As of 2017 up to 2020**

Concerns: **Control unit for rear spoiler**

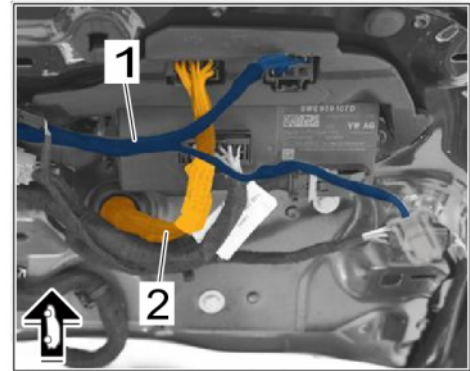
Affected rear lid wire harness and rear spoiler wire harness

- Replacing the previous rear spoiler control unit with a second-generation rear spoiler control unit on the Panamera
- Reworking rear lid ⇒ *Affected rear lid wire harness and rear spoiler wire harness -1-* wire harness
- Reworking rear spoiler ⇒ *Affected rear lid wire harness and rear spoiler wire harness -2-* wire harness
- Re-coding control unit for rear spoiler

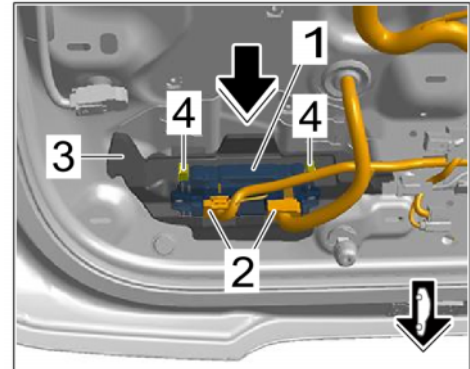
Control unit for rear spoiler

- 3 Position rear spoiler control unit ⇒ *Control unit for rear spoiler -1-* with rear spoiler control unit holder in rear lid and push in.
- 4 Position foam part ⇒ *Control unit for rear spoiler -3-*.
- 5 Determine further work procedure using the table.

- Work Procedure:
- 1 Remove previous control unit for rear spoiler.
⇒ *Workshop Manual '667419 Removing and installing control unit for rear spoiler'*
 - 2 Clip in **new** rear spoiler control unit with changed component version in **new** control unit holder.

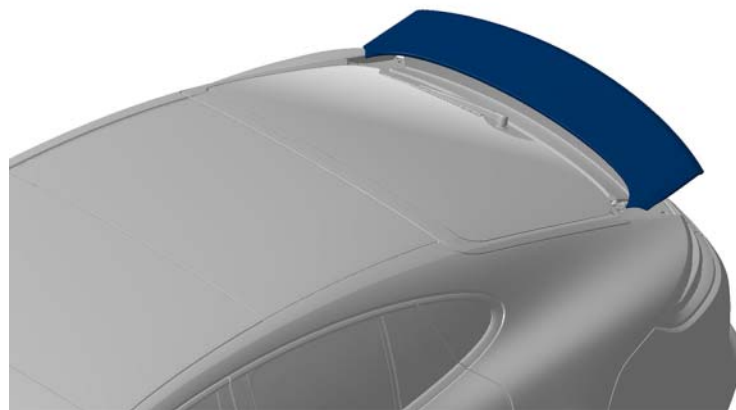
2D rear spoiler (*without lateral adjustment*)

This rework manual describes how to adapt the 2D rear spoiler of the Porsche Panamera and of the Porsche Panamera S.

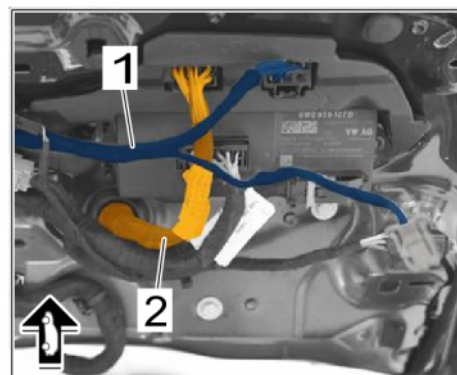
Affected rear lid wire harness and rear spoiler wire harness

- Work Procedure: 1 Remove the sheath of the rear lid wire harness installed in the vehicle ⇒ *Affected rear lid wire harness and rear spoiler wire harness -1-*, rear spoiler wire harness ⇒ *Affected rear lid wire harness and rear spoiler wire harness -2-* and the two rear lid wire harnesses (971998213H) and rear spoiler (971974224F) of the second generation Panamera from the affected plug connection on a length of approx. 200 mm/ 7.87 in.

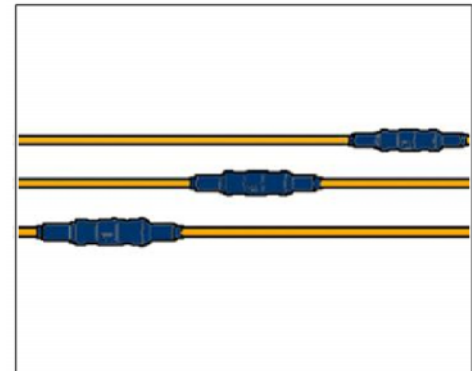
Arrangement of crimp connections

If more than one line needs to be repaired, the crimp connectors may not be directly next to each other. To ensure that the circumference of the wire harness is not too large, the crimp connectors must be offset.

2.3 In accordance with the following table, connect the new wire harness of the second-generation Panamera with the previous rear lid wire harness in the vehicle. Proceed with each line one-by-one as follows:

2.3.1 Slide shrink-fit hoses onto the electric lines.

2.3.2 Strip 10 mm/ 0.39 in of insulation off electrical lines.

2.3.3 Crimp electric lines with crimping pliers using crimping sleeves or a combination of crimp and shrink-fit hose.

2.3.4 Slide shrink-fit hose over the crimp connections and carefully shrink it to make it watertight using the hot air gun.

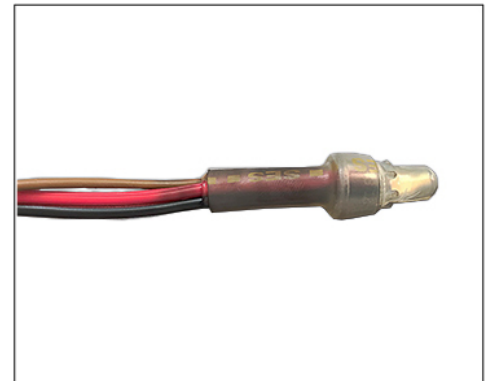
Insulated line (example illustration)

2.2.1 Disconnect electrical line PIN 1 (red / white, 0.5 mm) on the vehicle rear lid wire harness and wear it watertight using a shrink-fit hose. The electrical line is no longer required. → *Insulated line (example illustration)*

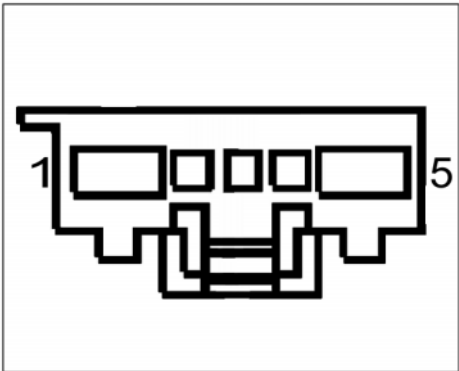
Pin assignment for electric rear lid push-on connector for Panamera G2 II

New rear lid wire harness for second-generation Panamera			Previous rear lid wire harness in the vehicle		
PIN	Cable cross-section in mm	Cable color	PIN	Cable cross-section in mm	Cable color
1	2.5	Red / Green	3	2.5	Red / Green
3	0.35	Brown / Red	2	0.35	Brown / Red

4	0.35	White / Brown	5	0.35	White / Brown
5	2.5	Brown	4	2.5	Brown

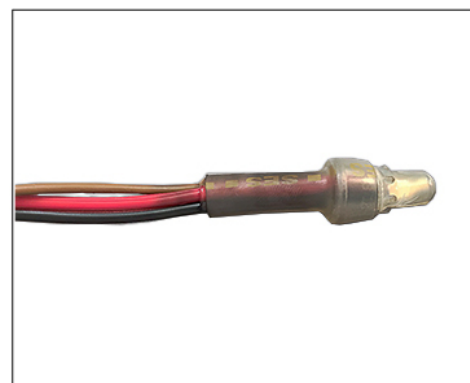
Insulated line (example illustration)

3.1.2 Disconnect electrical lines PIN 2 (brown / white, 0.5 mm), PIN 3 (brown / white, 0.5 mm), PIN 11 (brown, 1.0 mm) and PIN 12 (red / white, 1.0 mm) at the wire harness close to the plug connection and wear watertight using a shrink-fit hose. The electrical lines are no longer required. ⇒ *Insulated line (example illustration)*

3.2.1 Disconnect electrical lines PIN 3 (brown / white, 0.5 mm), PIN 8 (brown / white, 0.5 mm), PIN 9 (red / white, 1.0 mm) and PIN 10 (brown, 1.0 mm) on the vehicle-side rear spoiler wire harness and wear watertight individually using a shrink hose. The electrical lines are no longer required. ⇒ *Insulated line (example illustration)*

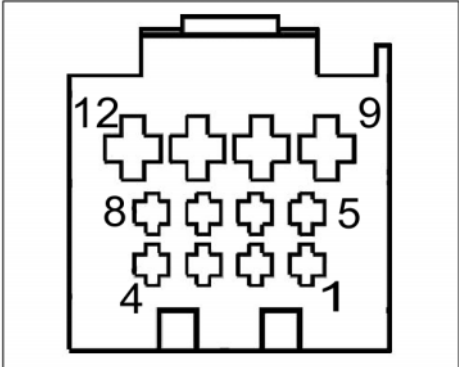
<p><i>Pin assignment for electric rear spoiler push-on connector for Panamera G2 II</i></p>

New rear spoiler wire harness for second-generation Panamera			Previous rear spoiler wire harness in the vehicle		
PIN	Cable cross-section in mm	Cable color	PIN	Cable cross-section in mm	Cable color
1	0.5	Brown	2	0.5	Brown
5	0.5	Red	5	0.5	Red
6	0.5	White	7	0.5	White
7	0.5	Black	4	0.5	Black

9	1.5	Red / White	1	1.5	Red / White
10	1.5	Brown	6	1.5	Brown

The splice connection (connection point of two black electrical lines to a brown electrical line) remains on the vehicle-side wire harness PIN 2 (brown, 0.5 mm) and is crimped on the **brown** electrical line PIN 1 (brown, 0.5 mm) with the **new** rear spoiler wire harness of the second generation Panamera.

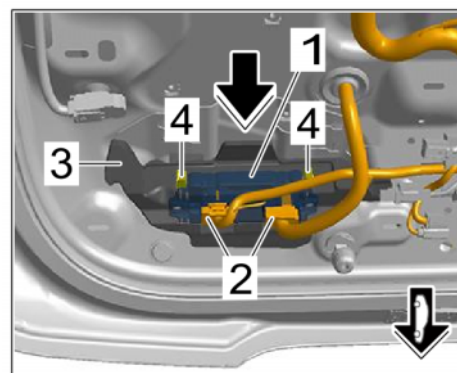
Control unit for rear spoiler

- 4 Wrap the reworked rear lid and rear spoiler wire harness with non-woven adhesive tape up to the respective plug connection.
- 5 Connect electric plug connection for rear spoiler control unit ⇒ *Control unit for rear spoiler -2-* until it locks perceptibly.
- 6 Continue with: ⇒ *Technical Information '667419 Follow-up actions'*

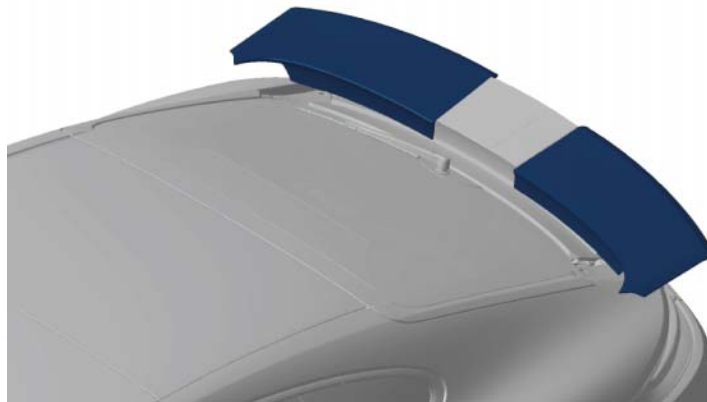
2D+ rear spoiler (*with lateral adjustment*)

This rework manual describes how to adapt the 2D+ rear spoiler of the Porsche Panamera GTS, Porsche Panamera Turbo and the Porsche Panamera S.

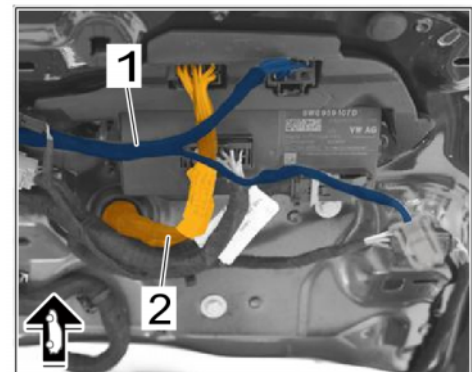
Affected rear lid wire harness and rear spoiler wire harness

- Work Procedure: 1 Remove the sheath of the rear lid wire harness installed in the vehicle ⇒ *Affected rear lid wire harness and rear spoiler wire harness -1-*, rear spoiler wire harness ⇒ *Affected rear lid wire harness and rear spoiler wire harness -2-* and the two rear lid wire harnesses (971998213H) and rear spoiler (971974224F) of the second generation Panamera from the affected plug connection on a length of approx. 200 mm/ 7.87 in.

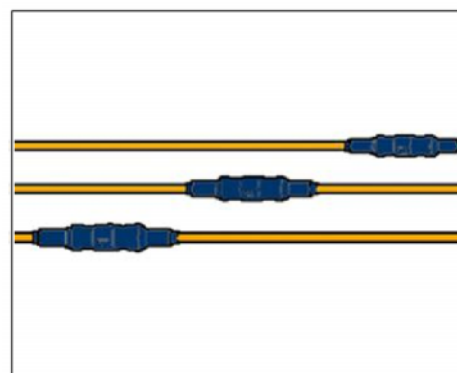
Arrangement of crimp connections

If more than one line needs to be repaired, the crimp connectors may not be directly next to each other. To ensure that the circumference of the wire harness is not too large, the crimp connectors must be offset.

- 2.3.3 Crimp electric lines with crimping pliers using crimping sleeves or a combination of crimp and shrink-fit hose.
- 2.3.4 Slide shrink-fit hose over the crimp connections and carefully shrink it to make it watertight using the hot air gun.

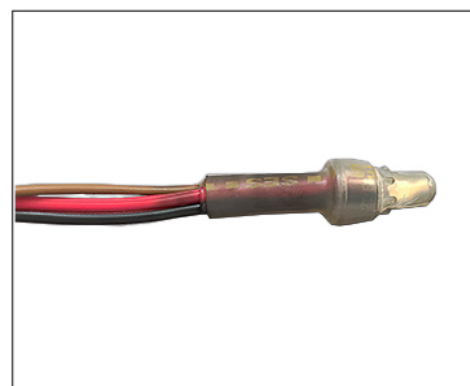
Insulated line (example illustration)

2.2.1 Disconnect electrical line PIN 1 (red / white, 0.5 mm) on the vehicle rear lid wire harness and wear it watertight using a shrink-fit hose. The electrical line is no longer required.

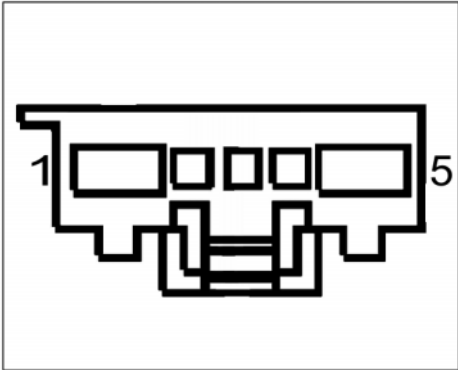
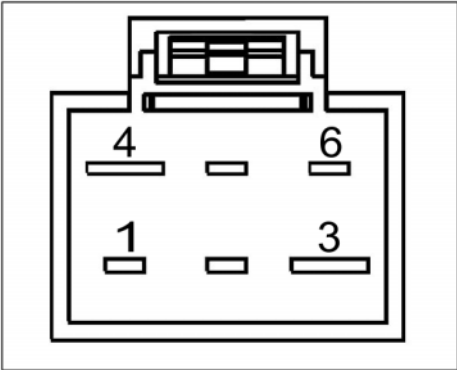
<p><i>Pin assignment for electric rear lid push-on connector for Panamera G2 II</i></p>	<p><i>Pin assignment for electric rear lid push-on connector for Panamera G2</i></p>

New rear lid wire harness for second-generation Panamera			Previous rear lid wire harness in the vehicle		
PIN	Cable cross-section in mm	Cable color	PIN	Cable cross-section in mm	Cable color
1	2.5	Red / Green	3	2.5	Red / Green
3	0.35	Brown / Red	2	0.35	Brown / Red
4	0.35	White / Brown	5	0.35	White / Brown
5	2.5	Brown	4	2.5	Brown

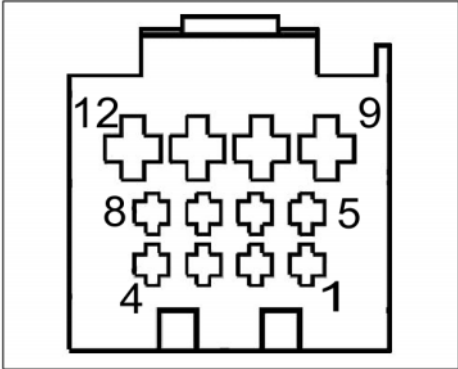
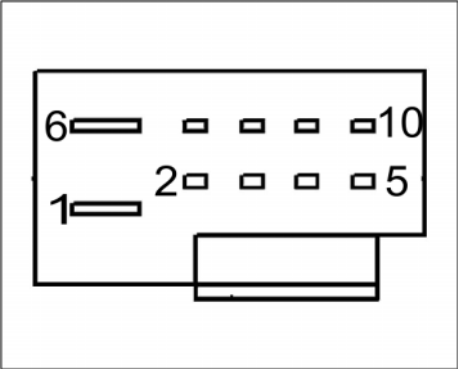
<p><i>Pin assignment for electric rear spoiler push-on connector for Panamera G2 II</i></p>	<p><i>Pin assignment for electric rear spoiler push-on connector for Panamera G2</i></p>

New rear spoiler wire harness for second-generation Panamera			Previous rear spoiler wire harness in the vehicle		
PIN	Cable cross-section in mm	Cable color	PIN	Cable cross-section in mm	Cable color
1	0.5	Brown	2	0.5	Brown
2	0.5	Brown / White	8	0.5	Brown / White
3	0.5	Brown / White	3	0.5	Brown / White
5	0.5	Red	5	0.5	Red
6	0.5	White	7	0.5	White
7	0.5	Black	4	0.5	Black
9	1.5	Red / White	1	1.5	Red / White
10	1.5	Brown	6	1.5	Brown

11	1	Brown	10	1	Brown
12	1	Red / White	9	1	Red / White

The splice connection (connection point of two black electrical lines to a brown electrical line) remains on the vehicle-side wire harness PIN 2 (brown, 0.5 mm) and is crimped on the **brown** electrical line PIN 1 (brown, 0.5 mm) with the **new** rear spoiler wire harness of the second generation Panamera.

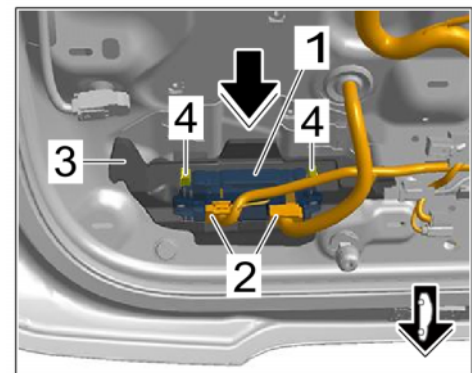
Control unit for rear spoiler

- 4 Wrap the reworked rear lid and rear spoiler wire harness with non-woven adhesive tape up to the respective plug connection.
- 5 Connect electric plug connection for rear spoiler control unit ⇒ *Control unit for rear spoiler -2-* until it locks perceptibly.
- 6 Continue with: ⇒ *Technical Information '667419 Follow-up actions'*

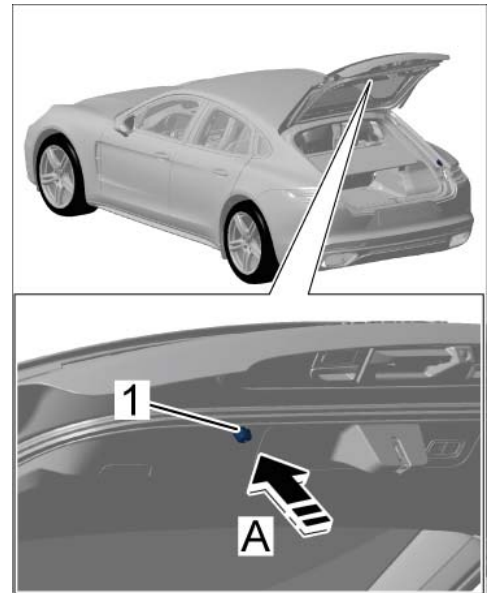
Adjuster

- 3.1 Loosen screw on adjusting elements ⇒ *Adjuster -1-* and press adjusting elements ⇒ *Adjuster -1-* in completely ⇒ *Adjuster -Arrow A-*.
- 3.2 Press adjusting elements ⇒ *Adjuster -1-* approx. 1 cm/ 0.39 in into the square opening.
- 3.3 Close the lid with your hand by applying slight pressure over the center (handle area) and then open it again.
- 3.4 Pull adjusting elements ⇒ *Adjuster -1-* out again by one notch ⇒ *Adjuster -Arrow A-*

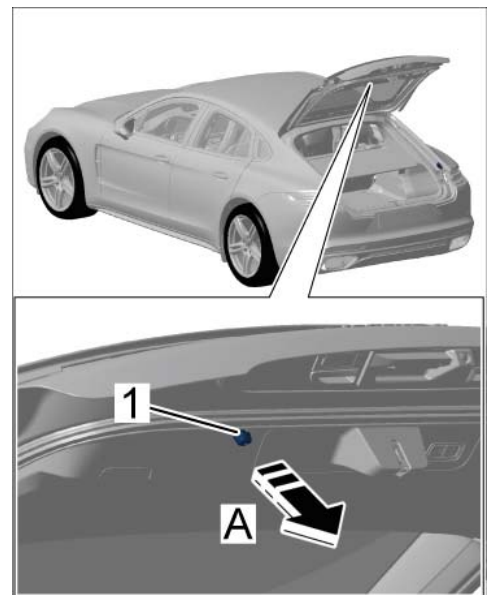
Rubber stops

- 4 Tighten screw on adjusting elements ⇒ *Rubber stops -1-*.
