<b>REFERENCE:</b>	<b>TSB:</b> 23-106-23 <b>GROUP:</b> 23 - Body	<b>Date:</b>	October 27, 2023	<b>REVISION:</b>	-
<b>VEHICLES AFFECTED:</b>	<b>2023 (BV) Jeep Renegade</b> This bulletin applies to vehicles built on or after August 30, 2023 (MDH 0830XX) and on and before September 13, 2023 (MDH 0913XX).			<b>MARKET APPLICABILITY:</b>	
				<input type="checkbox"/> NA	<input type="checkbox"/> CH
				<input checked="" type="checkbox"/> EE	<input checked="" type="checkbox"/> IAP
				<input type="checkbox"/> SA	<input checked="" type="checkbox"/> MEA
<b>CUSTOMER SYMPTOM:</b>	<b>Customer may experience one or more of the following:</b>				
	<ul style="list-style-type: none"> <li>Nameplate badge on front doors (left and right) not properly affixed.</li> <li>Possible detachment.</li> </ul>				
<b>CAUSE:</b>	Not properly applied at plant

This bulletin involves inspecting the nameplate badges (left and right) for proper adherence and replacing the badge(s), if necessary.

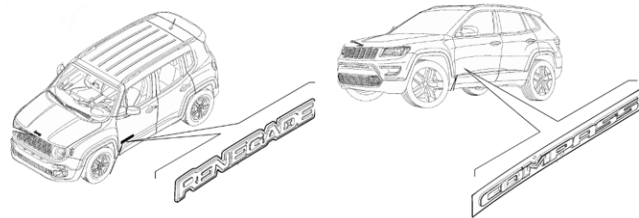
**Fig. 1**

1. Check the adhesion of both of the left and the right side nameplate badges. Are the nameplate badges loose?
  - NO>>> This bulletin has been completed. Use Inspect LOP (23-03-08-9E) to close this active RSU.
  - YES>>> Proceed to [Step 1](#) of the Repair Procedure.

**NOTE: Perform the check on both sides of the vehicle [Fig. 1](#).**

Left Side Badge Locations

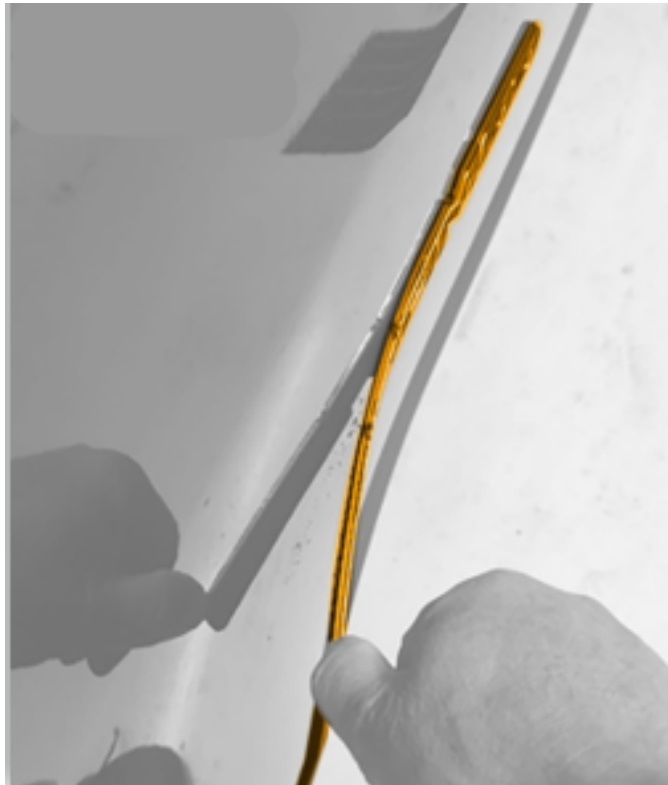
**Fig. 2**

**NOTE: If the nameplate badge partially or completely detaches, the badge is NON compliant [Fig. 2](#).**

Nameplate Badge Adherence Check

2. If both nameplate badges (left and right) do not detach partially or completely, the badge is compliant. Return the vehicle back to the customer.

1. Apply a length of masking tape on the body, parallel to the top edge of the nameplate to use as a guide, if necessary.

2. Using Special Tool C-4755 or equivalent, carefully remove the nameplate badge from the body panel, as necessary.
3. Clean adhesive residue from body with MOPAR® Super Kleen solvent or equivalent.

5. Remove the protective covering from the back of the new nameplate badge and position the nameplate badge onto the body using the previously installed guide tape.

**NOTE: To ensure proper name plate or decal adhesion, apply consistent and uniform pressure of approximately 40 psi over the entire surface of each name plate or decal.**

6. Install the new nameplate badge onto the body.
7. Repeat for opposite side, if necessary.
