Technical Service Bulletin

87 Air conditioning does not cool
87 23 65 2072351/1 December 13, 2023.

Model(s)	Year	VIN Range	Vehicle-Specific Equipment
Q4 e-tron RWD	2023 – 2024	All	Not Applicable
Q4 e-tron quattro, and Q4 Sportback e-tron	2024

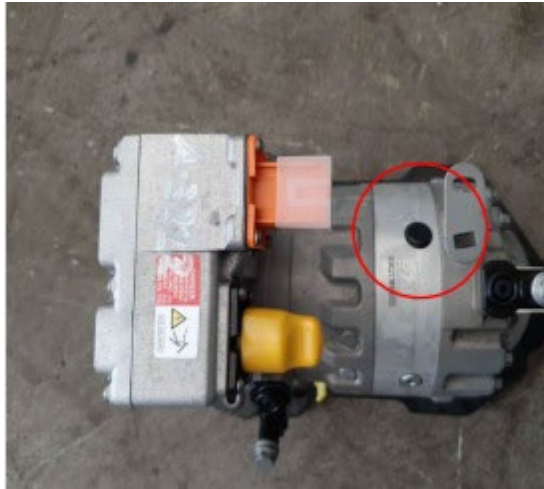
1. A common area where a refrigerant leak may be discovered is at the air conditioning compressor, specifically at the pressure relief valve. Figure 1 illustrates the location of the pressure relief valve. The leak here is likely to be rapid and the approved diagnostic methods should quickly confirm a leak in this area of the compressor.

Figure 1. Pressure relief valve on the air conditioning compressor.

3. In cases where a leak is diagnosed at the pressure relief valve the air conditioning compressor must be replaced. Ensure that the correct amount of refrigerant oil in the total refrigerant circuit is restored after compressor replacement.

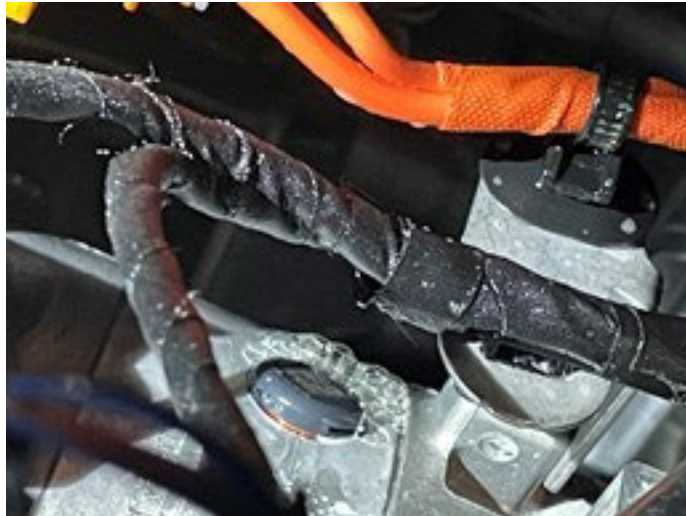
2. Figure 2 shows a close-up view of an active leak at the compressor pressure relief valve using a diagnostic method with compressed nitrogen and the application of a soap and water solution.

Figure 2. Active compressor pressure relief valve leak.
