HYUNDAI Technical Service Bulletin

23-BD-016H

PALISADE (LX2)

TAILGATE LATCH REPLACEMENT & TRIM REWORK
FOR TOW HITCH INSTALLATION

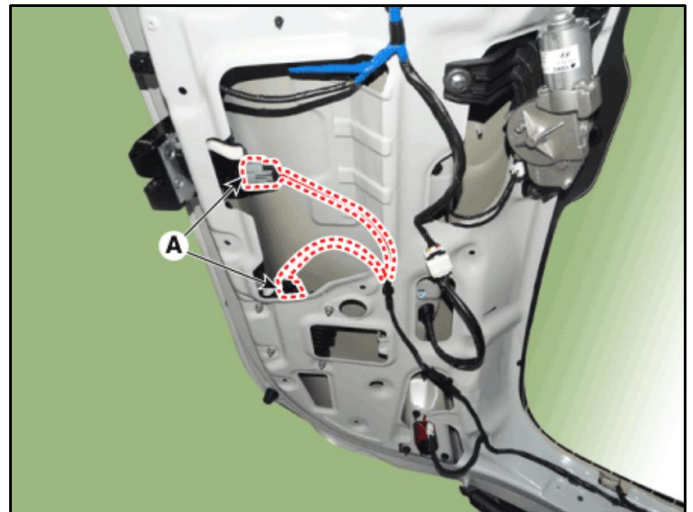
1. Remove the power tailgate latch assembly.

- **Body Electrical > Power Tailgate Module > Power Tailgate Latch > Repair procedures**

Use a trim removal tool to prevent damaging trim or components.

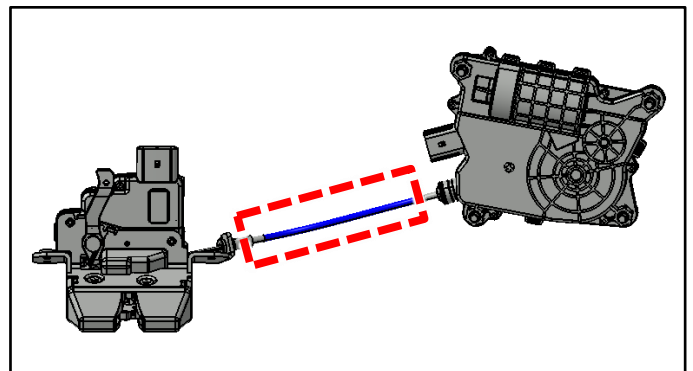
2. Install the new part (81800-S8100).

Confirm the new part has a blue cable before installation.

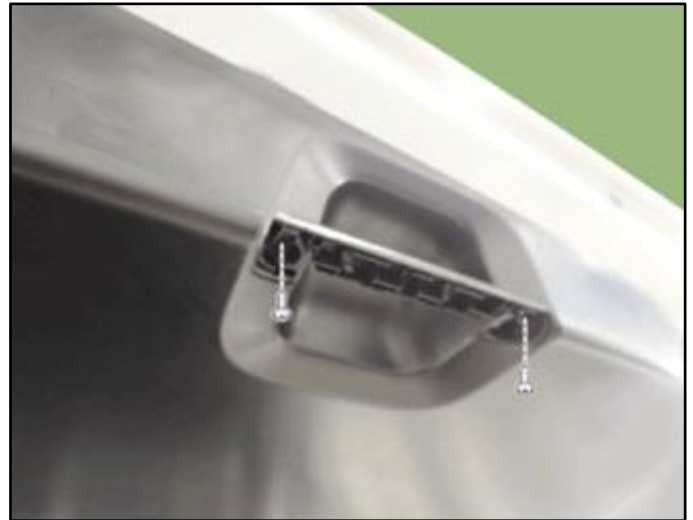
1. Remove the tailgate latch assembly.

- **Body (Interior and Exterior) > Tailgate > Tailgate Trim > Repair procedures**

Use a trim removal tool to prevent damaging trim or components.

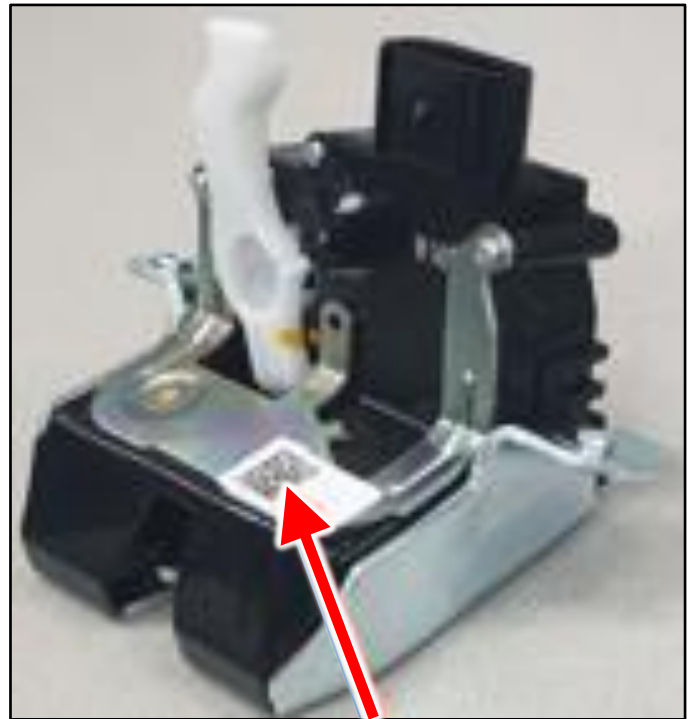
2. Install the new part (81800-S8000).

Confirm the new part number on the label indicated by the red arrow.

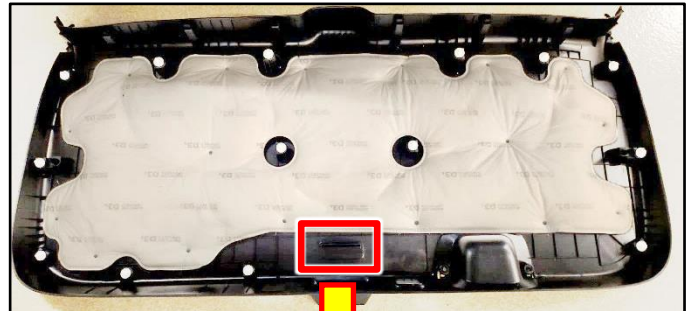
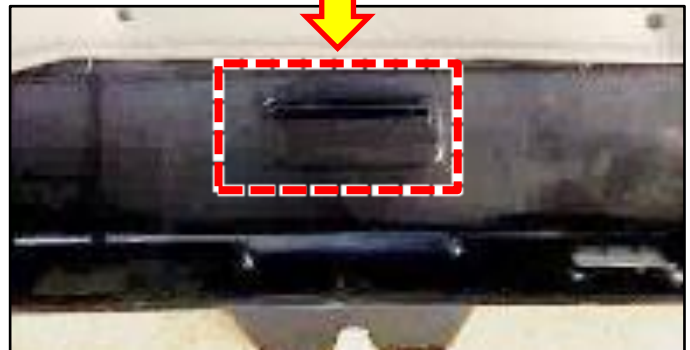
1. Locate the emergency release slot on the backside of the tailgate trim.

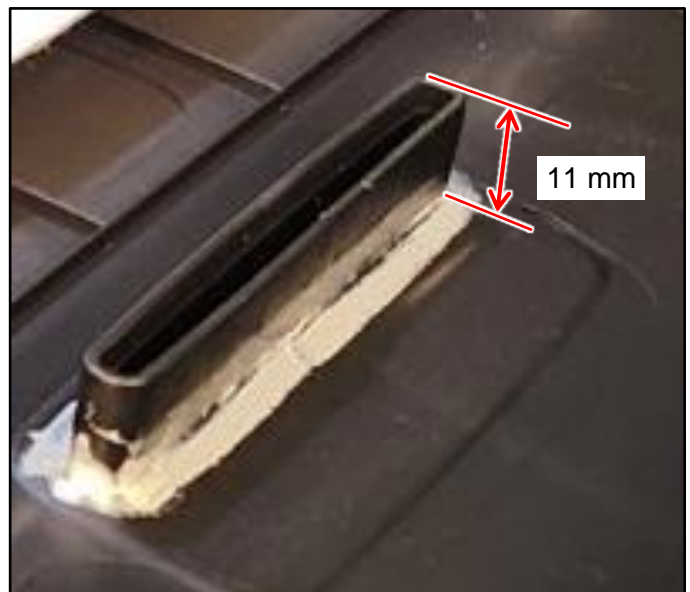
2. Measure 11 mm (7/16 inch) down from the top of the protrusion, and mark the area to be cut using a white marker.

Cutting off more than 11 mm (7/16 inch) may result in poor appearance (fragments and/or burrs) when the tailgate trim is reinstalled.

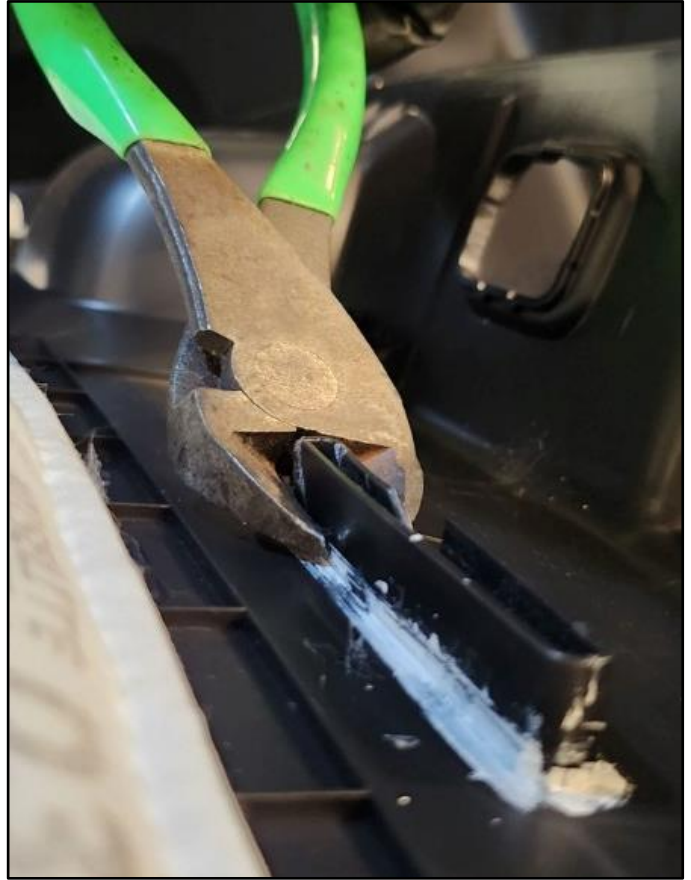
- Using cutting pliers or a hand saw, cut off 11 mm (7/16 in) from the top of the protrusion.

Be careful not to cut off too much from the protrusion.

Cutting off more than 11 mm (7/16 inch) may result in poor appearance (fragments and/or burrs) when the tailgate trim is reinstalled.

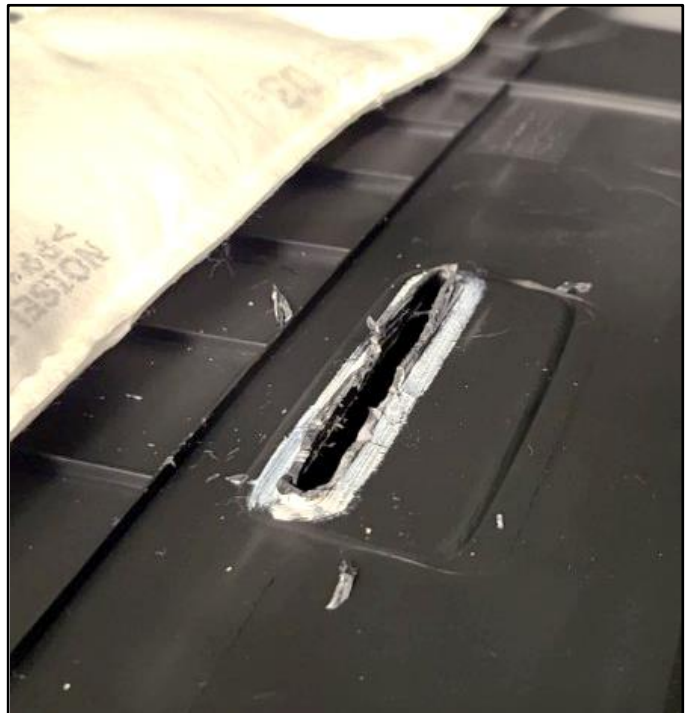
- Use sand paper to remove any remaining sharp edges or burrs after cutting off the protrusion.

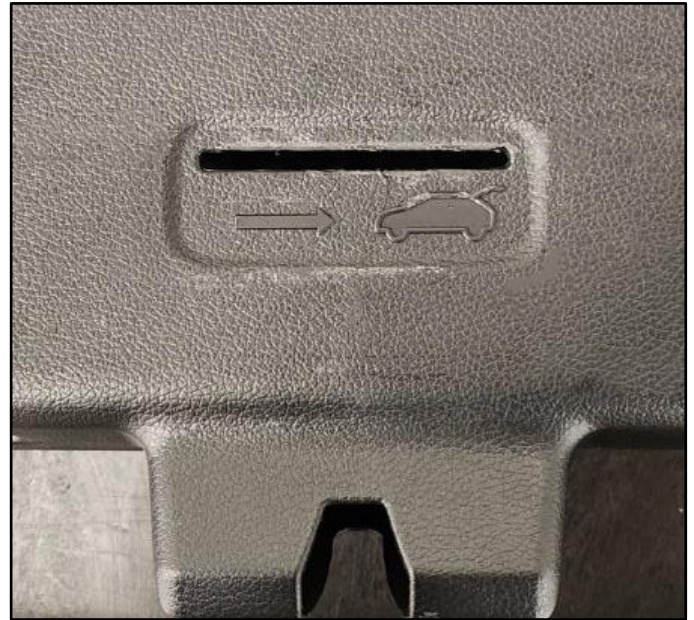
5. Inspect the opposite surface of the tailgate trim to ensure no damage or scratches are visible.

Carefully reach in the emergency release slot to verify the customer will not injure their hands while using this function.

Use sand paper to smooth out any remaining sharp edges or burrs if needed.
