HYUNDAI Technical Service Bulletin

GROUP CAMPAIGN	NUMBER 23-01-094H
DATE DECEMBER 2023	MODEL(S) ELANTRA (AD/ADA)

SUBJECT: HEAD LAMP HIGH BEAM REPAIR (SERVICE CAMPAIGN T5G)

Description: This bulletin describes the procedure to repair a head lamp that has an inoperable high beam function.

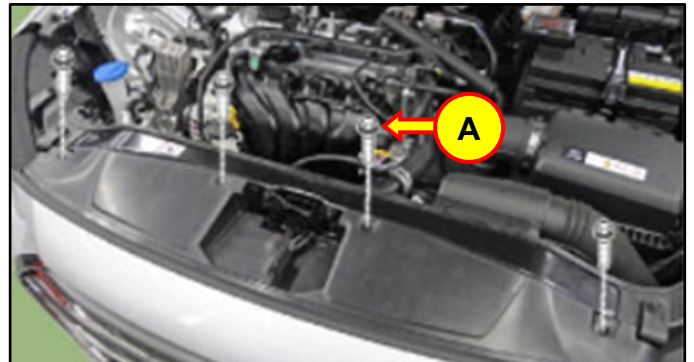
1. Loosen the front upper bumper mounting screws and clips (A).

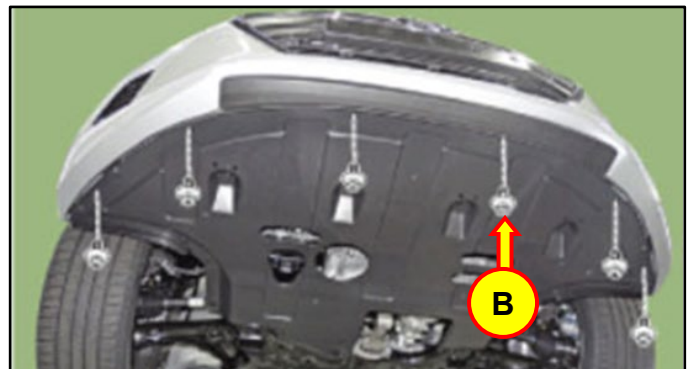
2. Remove the front lower bumper mounting clips (B).

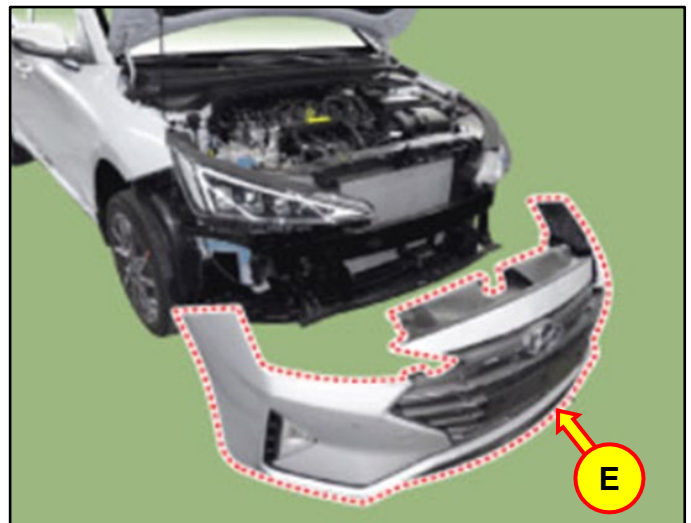
5. Remove the front bumper cover (E).

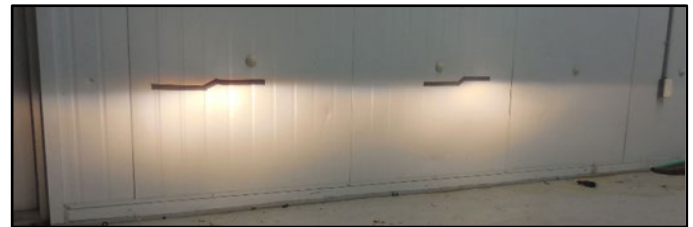
7. Turn on the head lamps.

Mark the height of the head lamp illumination.

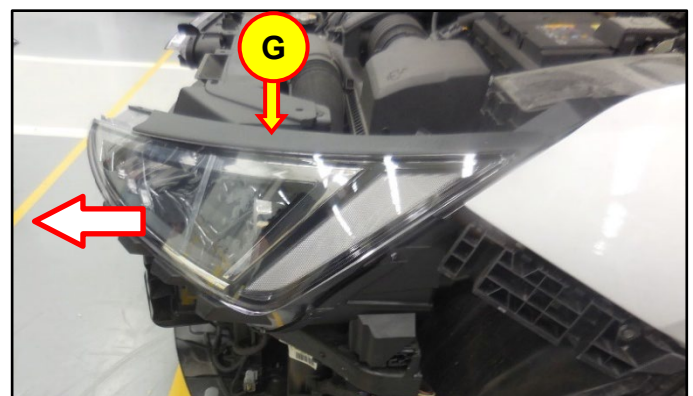
10. Remove the affected head lamp(s) (G).

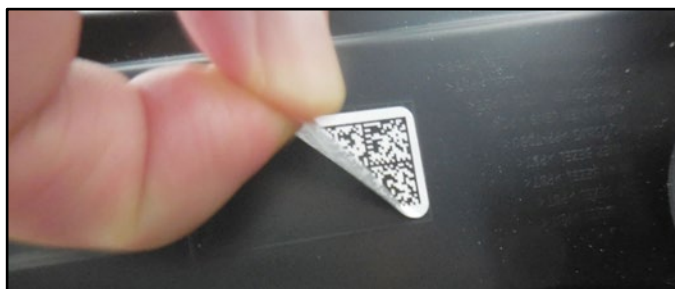
2. Remove the label.

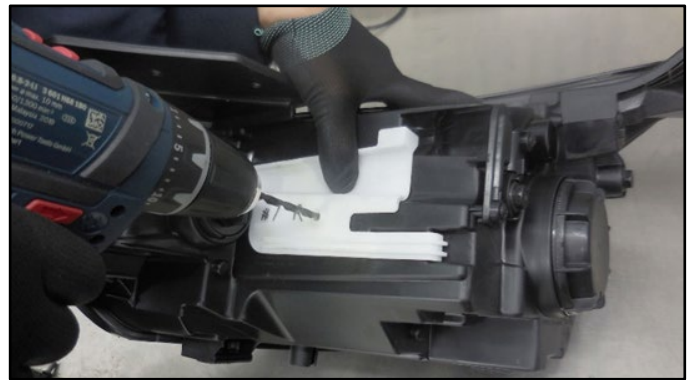
5. Slowly drill a pilot hole using the smaller drill bit 5 mm (13/64 inch).

Do not drill past a depth of 15 mm (9/16 inch).

Hold the head lamp firmly while drilling to prevent movement.

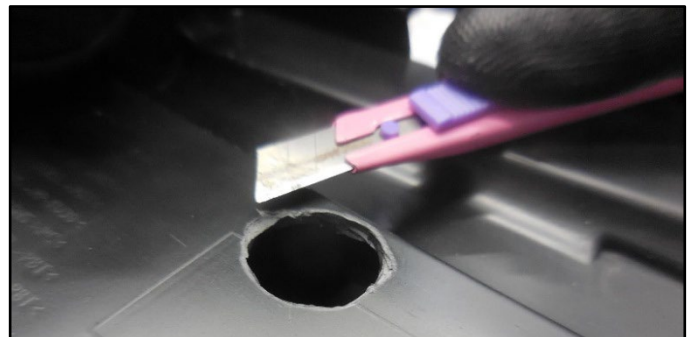
7. Remove the remaining debris around the hole to ensure a smooth surface.

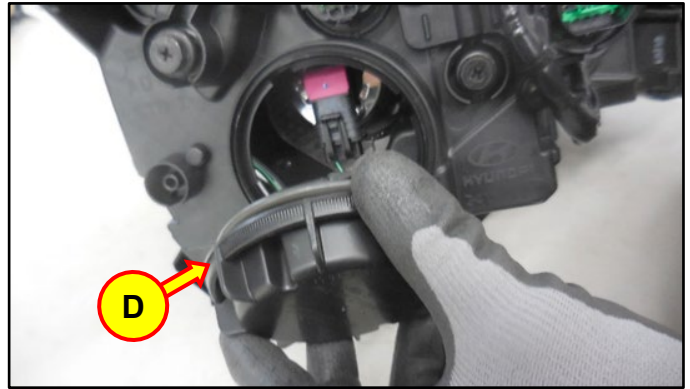
8. Remove the head lamp dust cover (D).

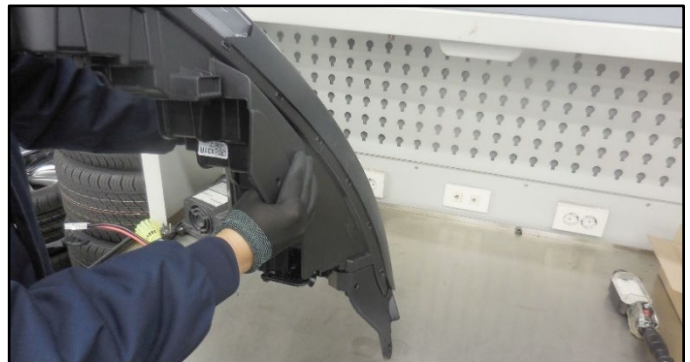
9. Shake the head lamp to remove the debris through the dust cover opening.

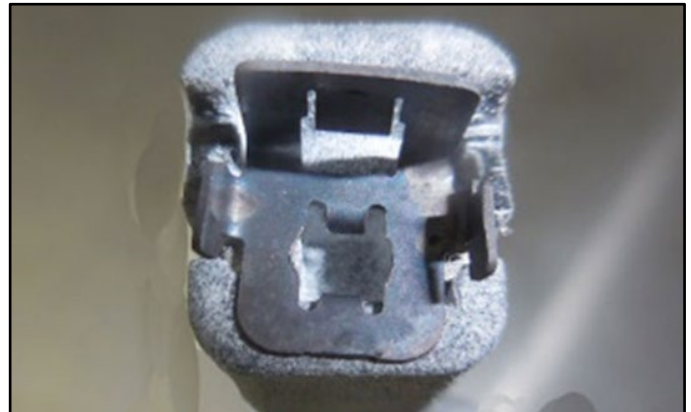
- Install the clip (G) onto the clip installation tool (H).

Verify that the clip is fully seated and held in place by the magnets on the clip installation tool.

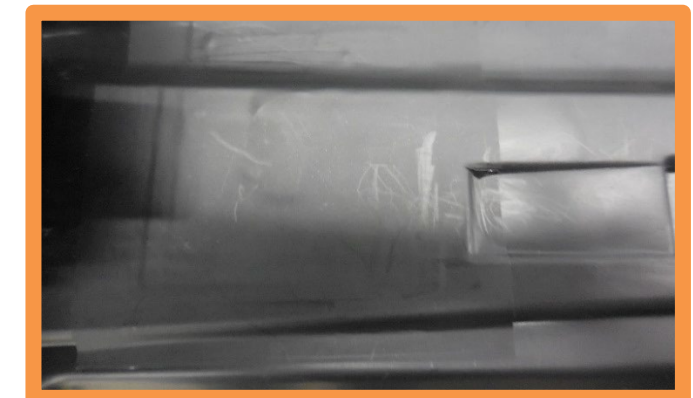
Using STUI, take a photo of the completed tape application with the last 6 digits of the VIN and the date of repair on a piece of paper.

Upload the photo to STUI.
