Technical Service Bulletin

GROUP ENGINE MECHANICAL	NUMBER 23-EM-009H
DATE DECEMBER 2023	MODEL(S) SONATA HYBRID (DN8 HEV)

SUBJECT: EHR'S COOLANT LEAK REPAIR

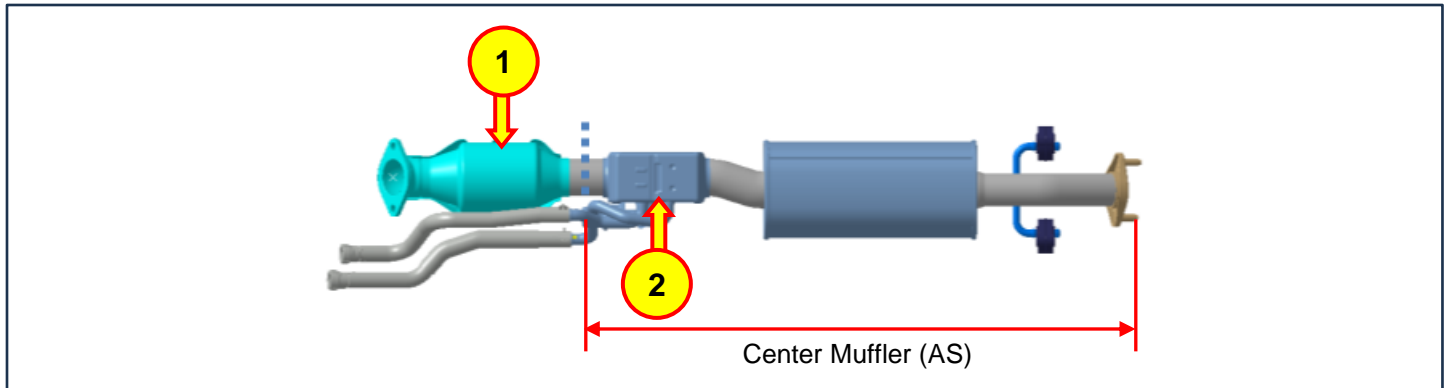
Remove the center muffler. After cutting the pipe, reuse the catalyst (1), replace the center muffler with one that has an improved EHRS (2). Tighten the clamp and install it on the vehicle.

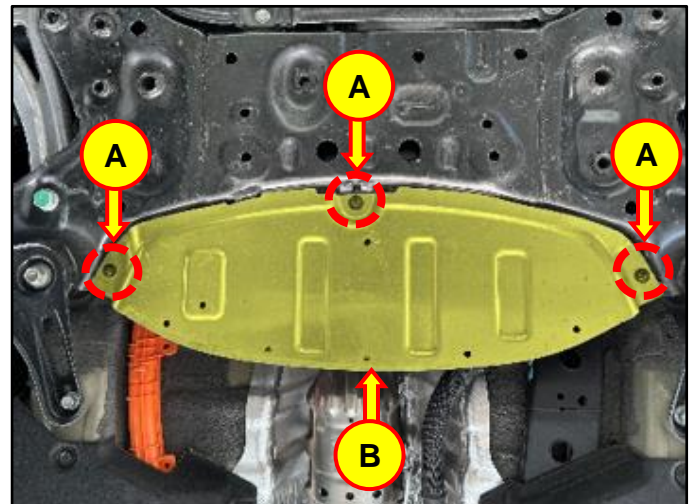
1. Raise the vehicle on a lift.
2. Loosen the three (3) bolts (A) and remove the front muffler heat protector (B).

lb-ft	8.0
lb-in	95
N.m	10.8

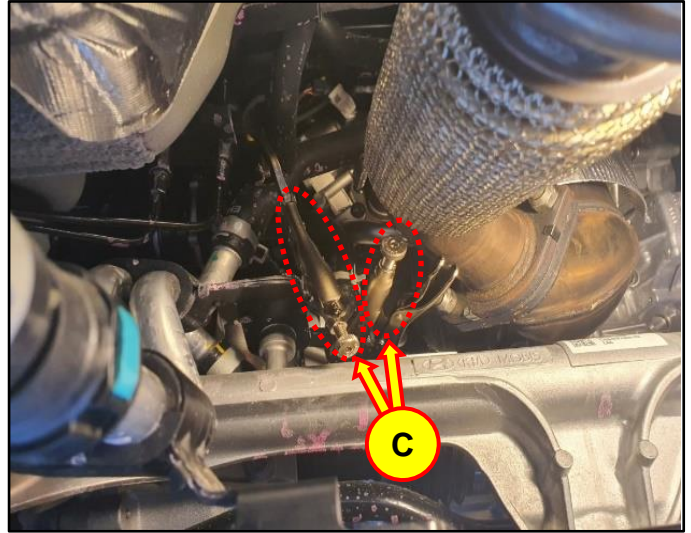
To prevent excess coolant loss, pinch off the ends of the hoses with pliers (C).

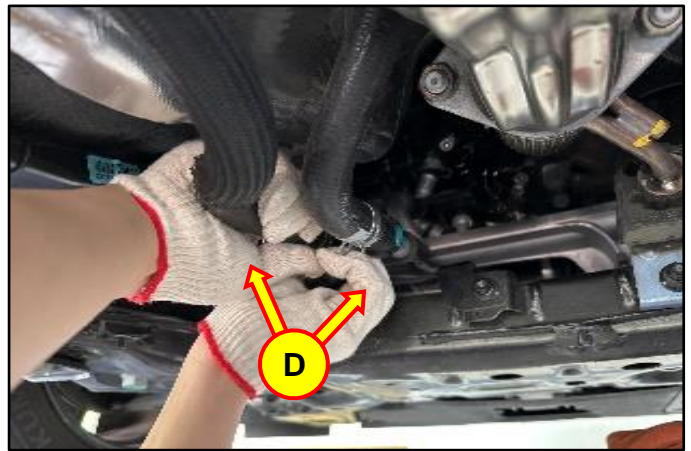
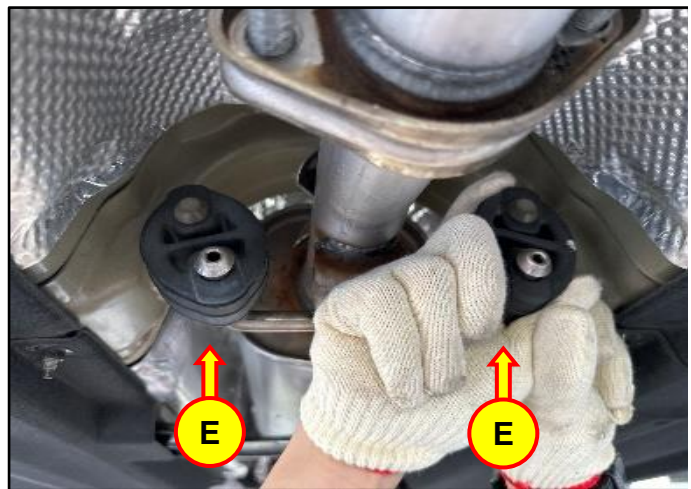
3. Remove the two (2) quick connectors (D) and the two (2) hangers (E) from the center muffler and exhaust heat recovery system (EHRS).

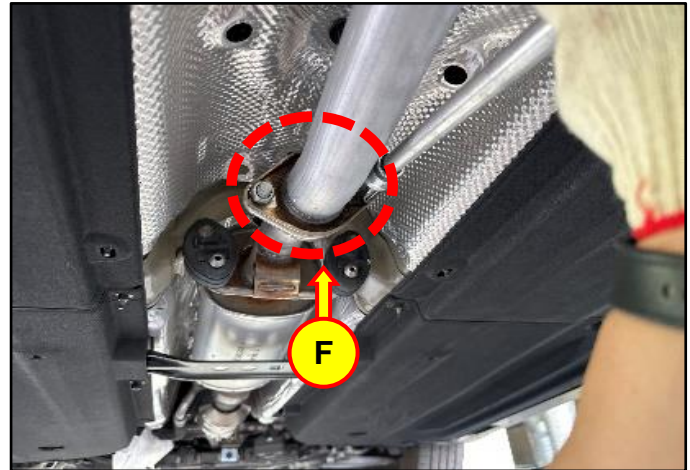
- Remove the four (4) bolts for the front and rear center muffler. (F).

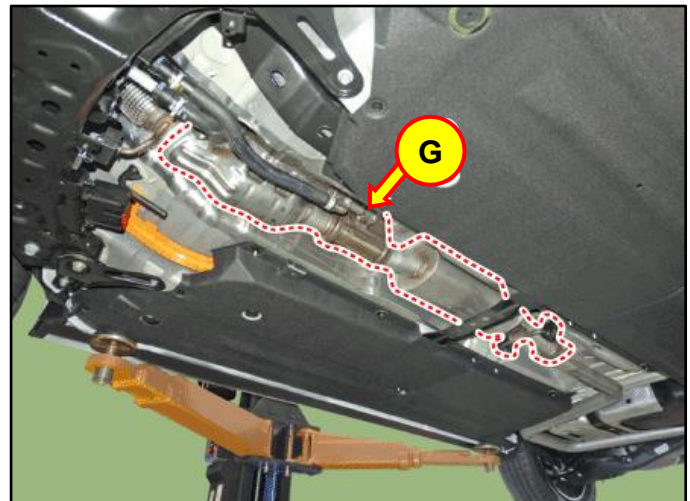
- Remove the center muffler & exhaust heat recovery system (EHRS) (G).

Center Muffler & Catalyst (M10):

lb-ft	18
N.m	25

Center Muffler & Catalyst (M12):

lb-ft	36
N.m	49

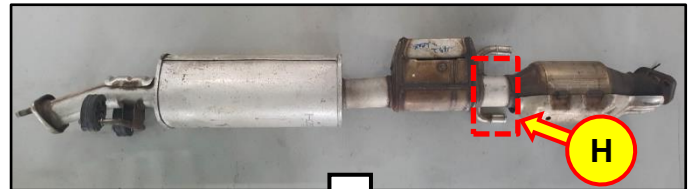
- Before cutting the center muffler, mark the cutting area (H).

- Cutting area: **42 ± 1 mm** from the end of the weld, as shown

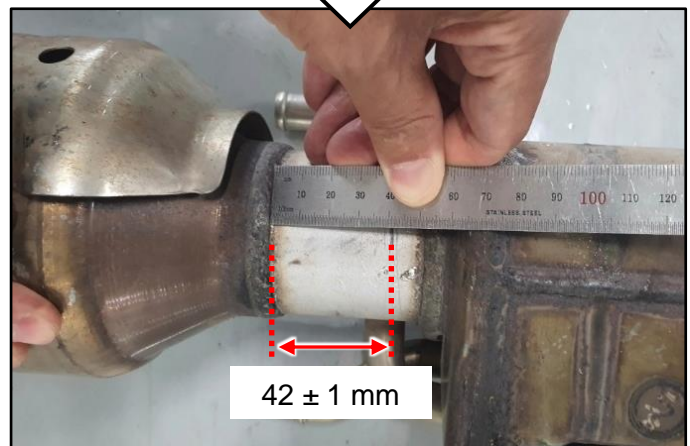
Before cutting the pipe, be sure to measure and mark all the way around the pipe to ensure a vertical cut.

Use a hacksaw, chain pipe cutter, or a commercially available pipe cutter that is in good shape and can cut at a right angle cleanly and accurately.

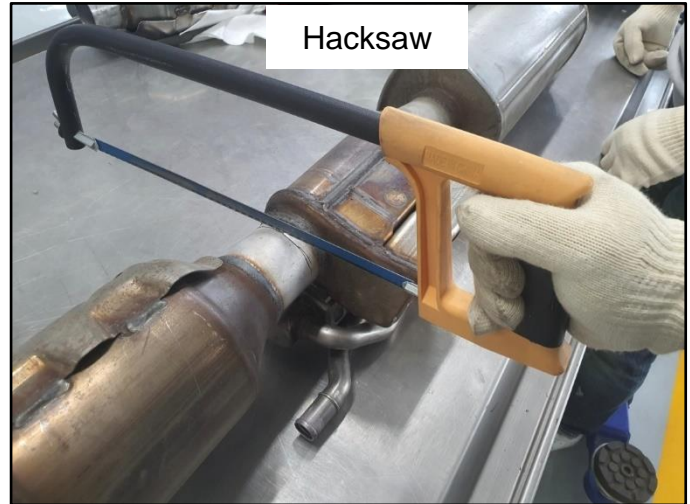
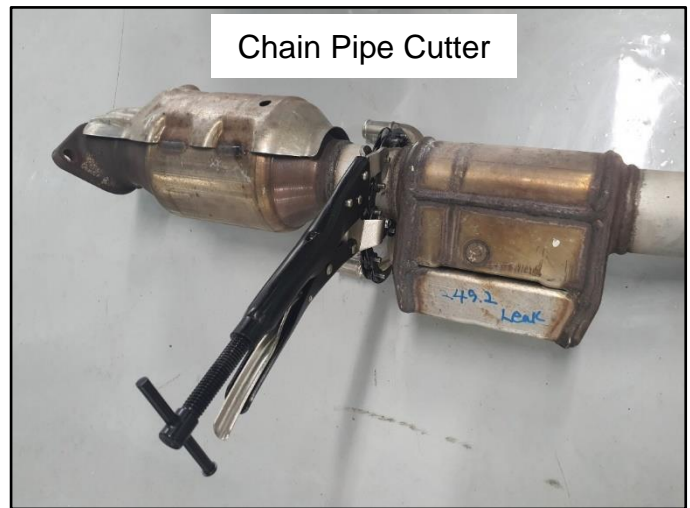
7. Use a hacksaw, chain pipe cutter, or a commercially available pipe cutter to cut the pipe where marked.

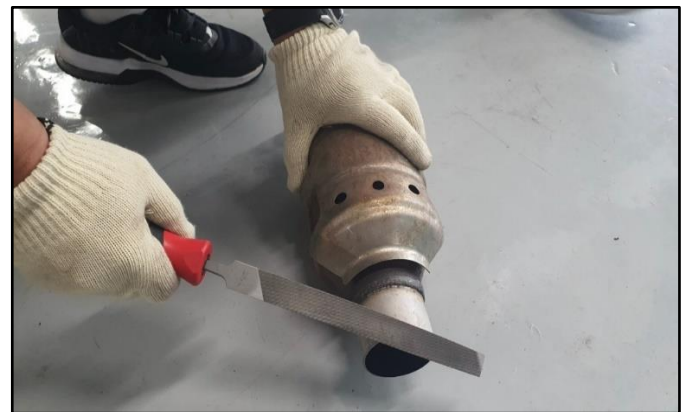
8. Remove any foreign substances, burrs, welding spatter, rust, and rough edges with a file or similar tool. Be sure to remove any debris that may have fallen into the catalyst.

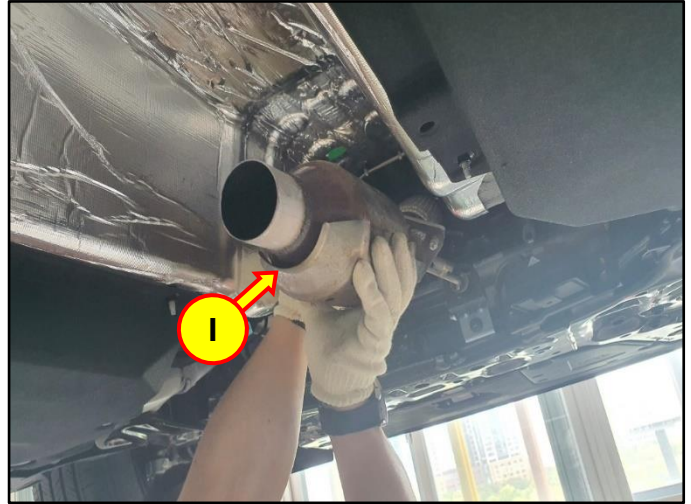
9. Place the cut catalyst (I) on the vehicle.

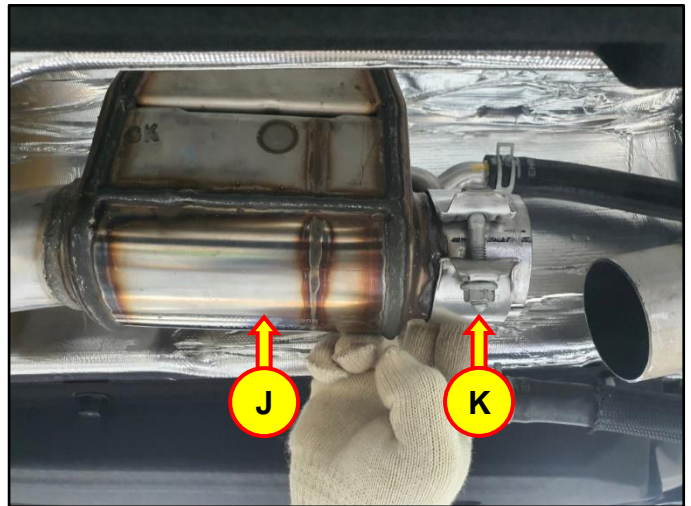
10. Place the supplied center muffler (J) and clamp (K) on the vehicle.

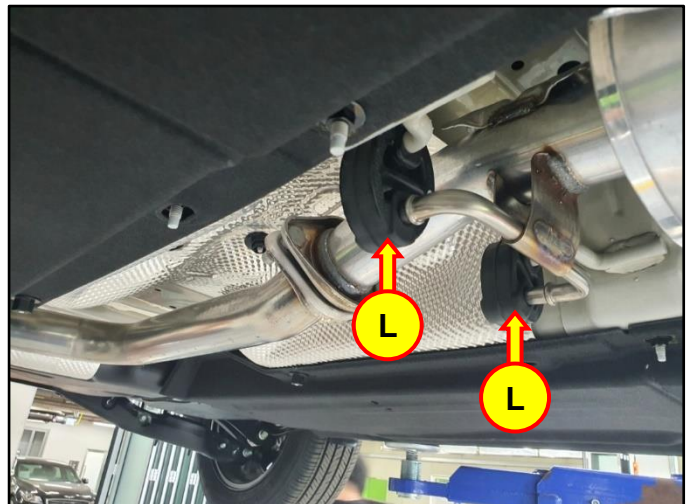
11. Install the two (2) hangers (L) to the body and temporarily fasten the nuts to the flange.

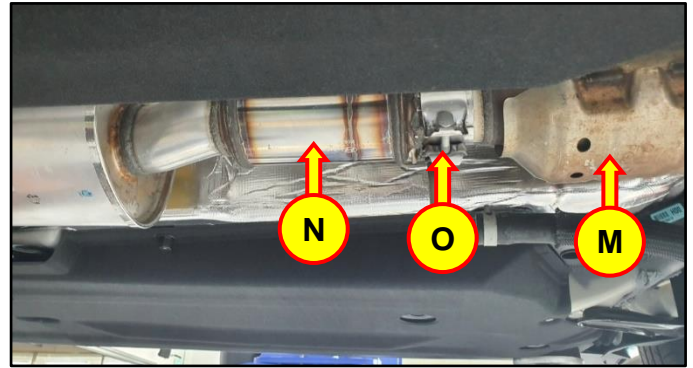
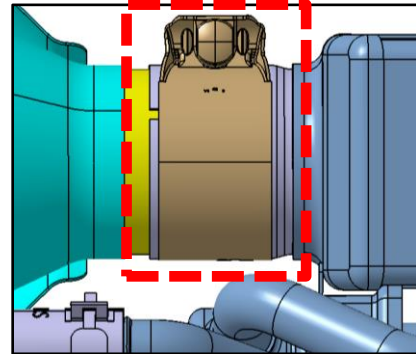
12. Combine the catalyst (M) and center muffler (N) and then tighten the clamp (O) temporarily.

Fully fasten the nuts to the flange.

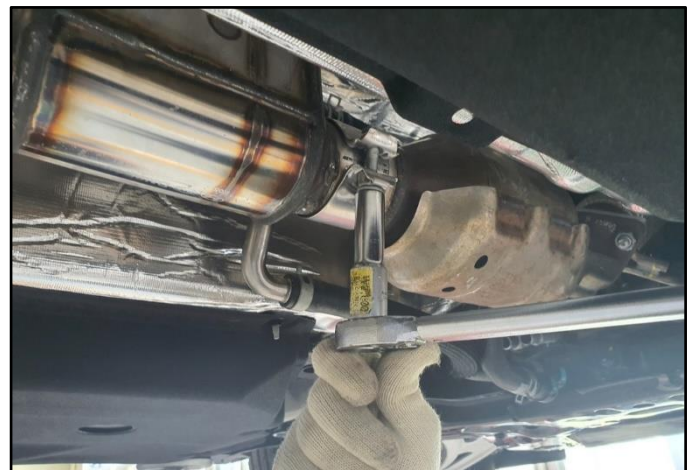
13. Ensure that the center muffler is mounted horizontally, then fully tighten the clamp.

lb-ft	20
N.m	28

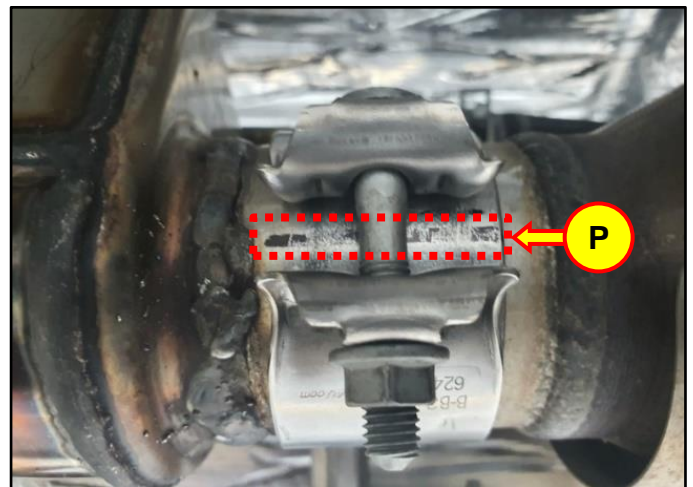
Tighten the clamp so that the line (P) is centered in the clamp as shown.

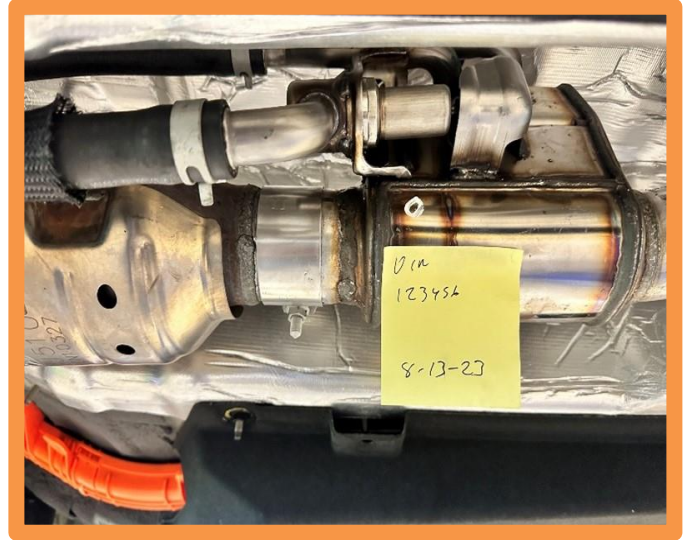
Using STUI, take a photo of the new EHRS and clamp installed on the vehicle, with the last 6 digits of the VIN and the date of repair on a piece of paper.

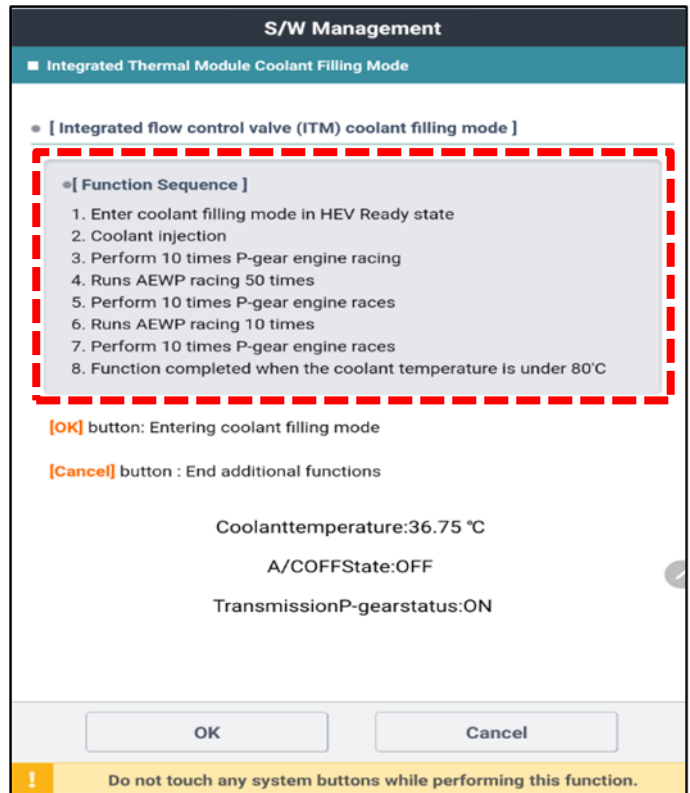
16. Fill the radiator with about 1 L of coolant.

Be sure to follow the **NEW** ITM Coolant Filling Mode procedure. Failure to do so may result in air pockets and overheating of engine. Refer to TSB 23-HC-002H.
