## Technical Service Bulletin

| GROUP<br><b>CAMPAIGN</b> | NUMBER<br><b>23-01-076H-2</b> |
| DATE<br><b>December 2023</b> | MODEL(S)<br><b>Santa Fe (CM)</b> |

**SUBJECT:** CYLINDER HEAD COVER OIL LEAK REPAIR  
WITH OIL PROTECTOR INSTALL AND ALTERNATOR VOLTAGE TEST  
(SERVICE CAMPAIGN 976)

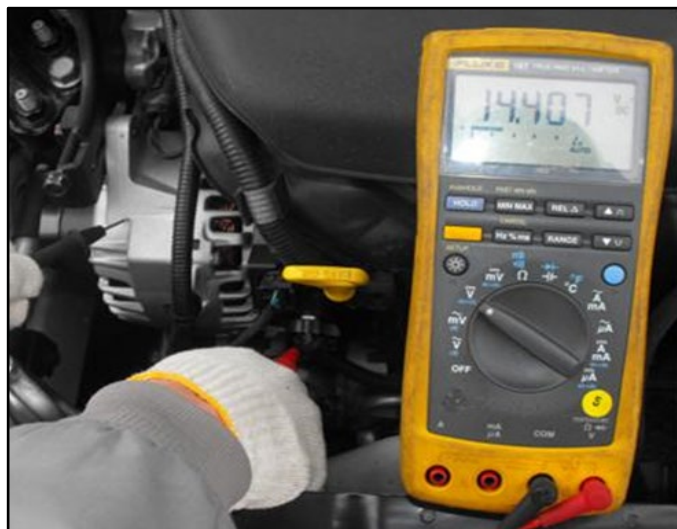
#### **Voltage Test of Alternator**

- Using a multimeter, connect the positive lead of the meter to the B+ terminal (A) of the alternator. Connect the negative lead to a ground, (not the alternator housing). Use the test method written to the left to determine alternator replacement.

- With the engine running at idle and the headlamps switched on, with no other loads switched on, measure the voltage at B+ terminal of the alternator. In the condition above, **the alternator should be generating 14 volts or higher.**

If the reading is lower than 14 volts, the alternator may need to be replaced if the T-joint inspection also does not pass.

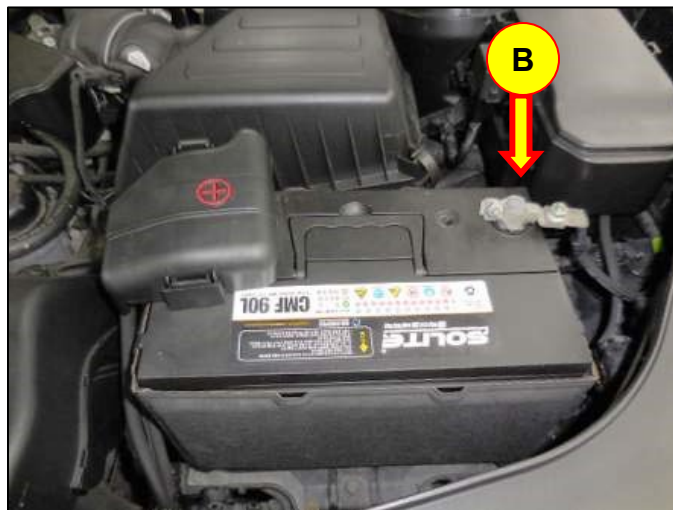
3. Make note of customer radio presets and disconnect the battery (B).

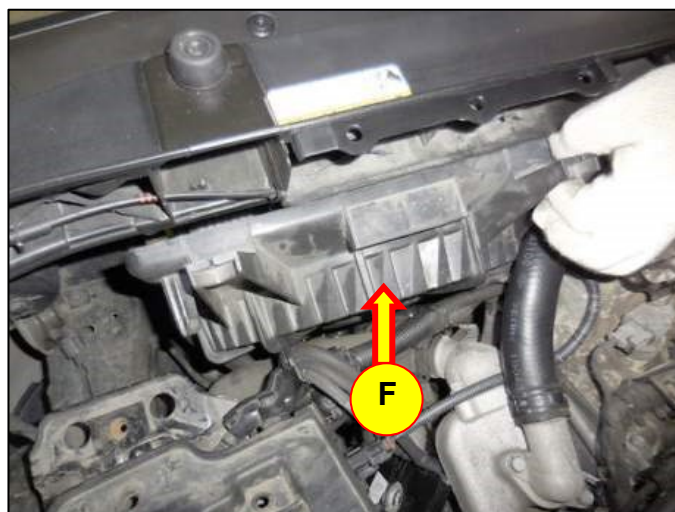
7. Remove the LH fan shroud (F).

***Carefully remove the LH fan shroud (F)  
so that it does not damage any  
surrounding parts.***

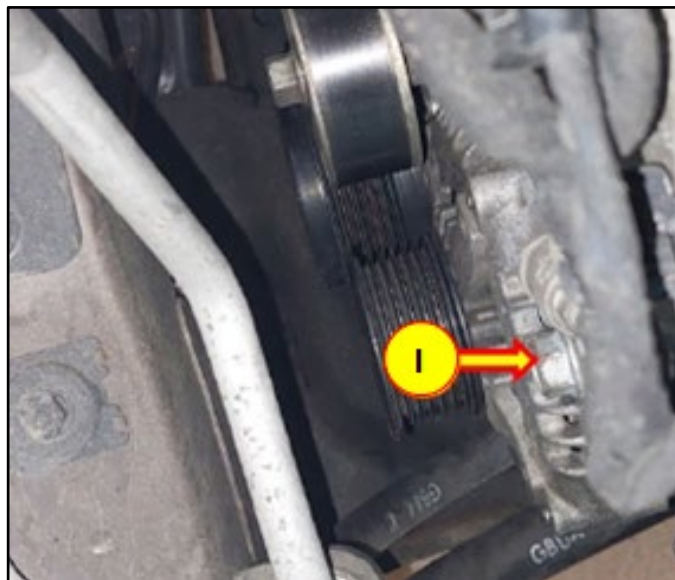
10. Remove the alternator upper mounting bolt (I).

***Tightening torque specification:  
22 lb-ft (29.8 Nm)***

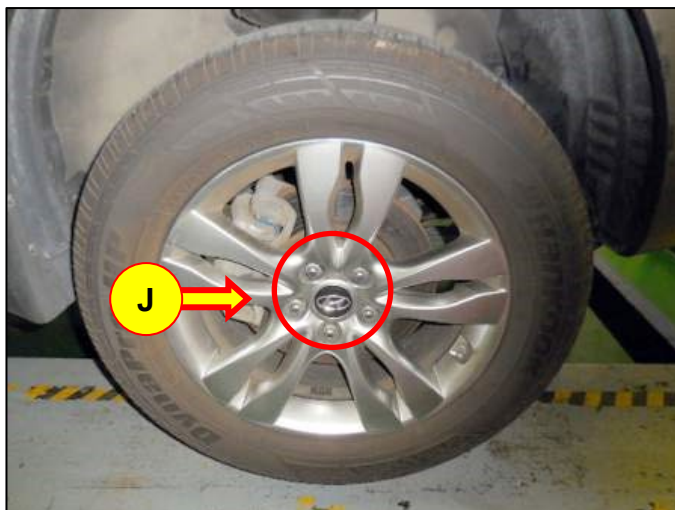
11. Remove the RH wheel and tire by loosening the 5 wheel nuts (J).

***Tightening torque specification:  
75 lb-ft (101.7 Nm)***

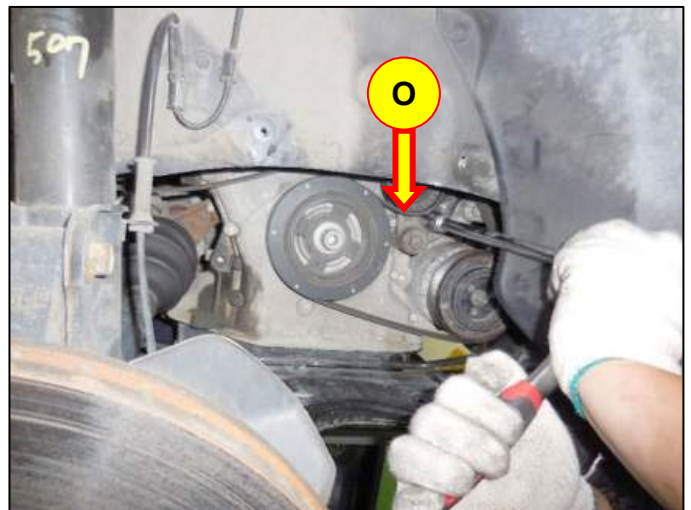
16. Remove the drive belt after relaxing the belt tension by rotating the tensioner pivot bolt (O).

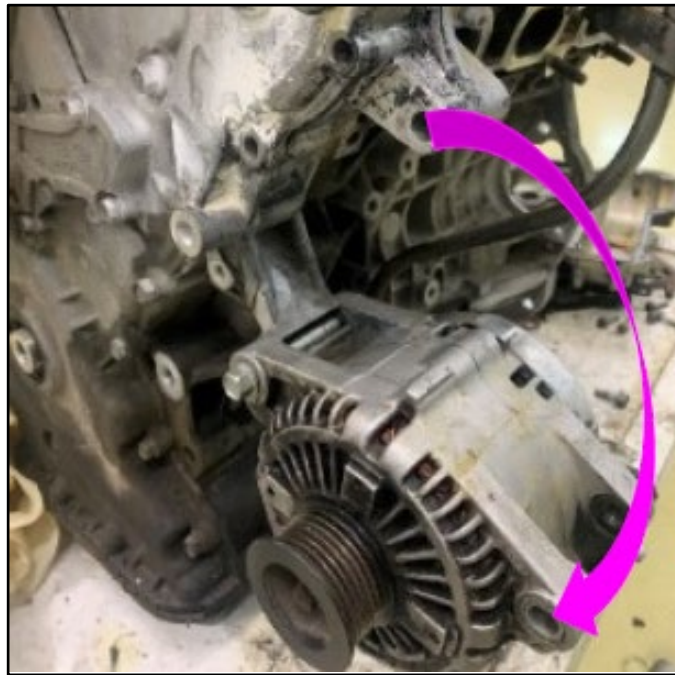
18. Rotate the alternator towards the front of the vehicle (Q).

***If the alternator voltage check and t-joint inspection both do not pass, replace the alternator.***

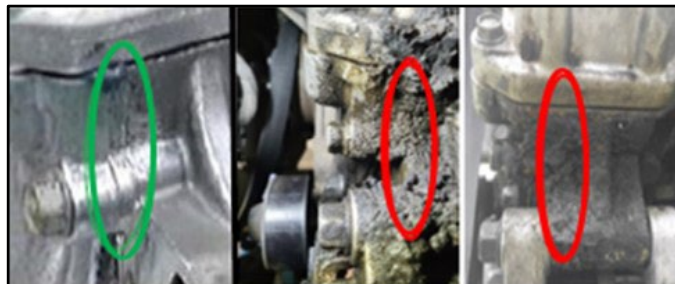
19. Inspect the T-Joint area for oil leak. Any oil leakage requires the replacement of the head cover gasket.

**PASS**

**NO PASS**

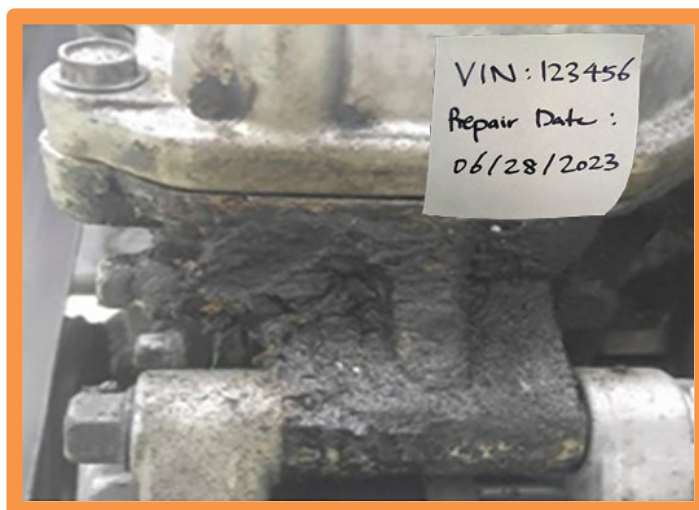
**Using STUI, photograph the T-joint area. Include in the photo a piece of paper containing the last 6 digits of the VIN, and the date of the repair. Ensure the photo is in focus and captures the T-joint. Upload the photo to STUI.**

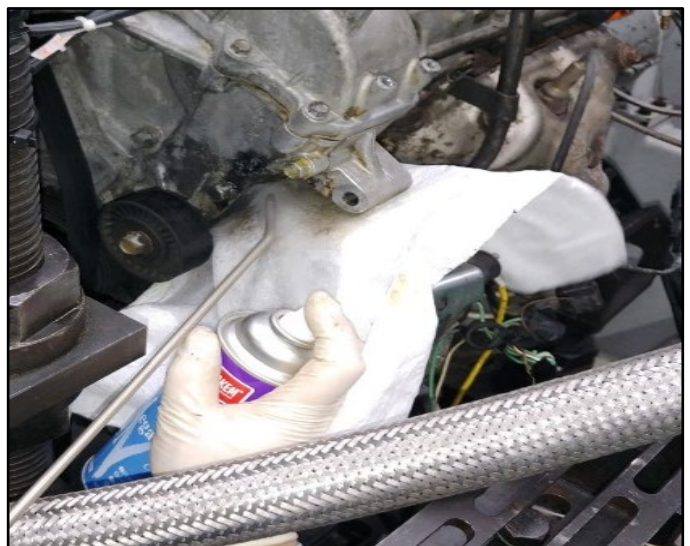
23. Spray the area using cleaner (Threebond 2706) and an air gun at the same time to remove oil and foreign matter.

***Air gun pneumatic pressure: 14-28psi (1-2 bar). Cover exhaust manifold to prevent cleaner from coming in contact.***

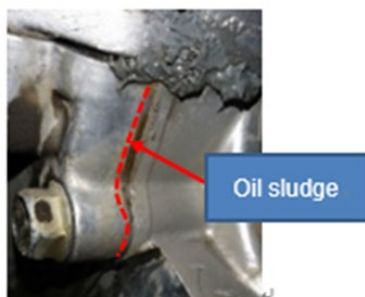
24. The oil protector will be sealed to the engine at this point. It is crucial that this area is free from oil and contaminants.
- (T) Area : Head, Head Cover, Chain Cover, and Block.

After cleaning the T-joint of the head cover, scrub with a clean cloth and clean it with a Threebond 2706 if the oil sludge remains between the chain cover and gap in the head.

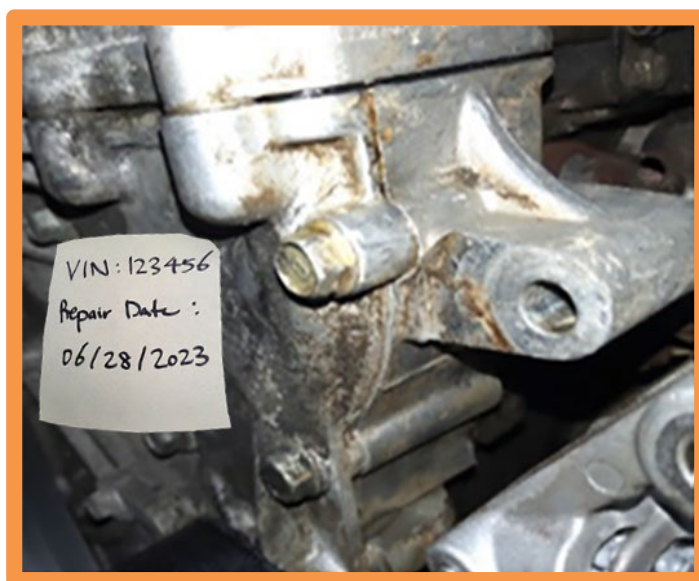
Using STUI, photograph the T-joint area. Include in the photo a piece of paper containing the last 6 digits of the VIN, and the date of the repair. Ensure the photo is in focus and captures the T-joint. Upload the photo to STUI.

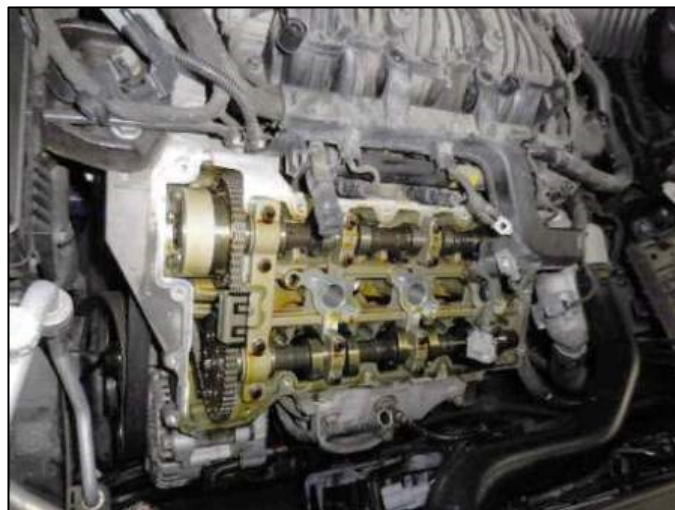
***Carefully remove the cylinder head cover to avoid any dirt/debris falling into the engine. Debris falling into the cylinder head can result in engine damage.***

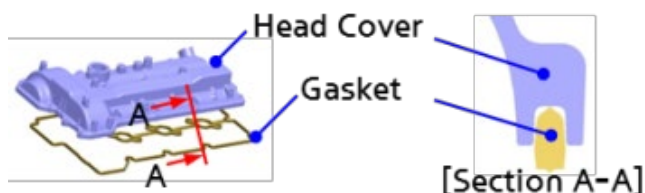
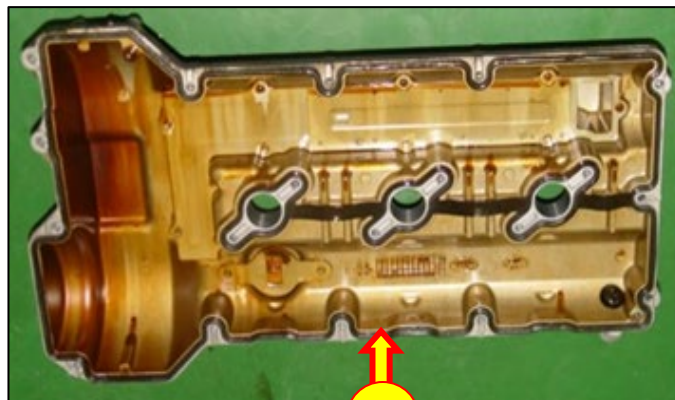
**Gasket Installing Groove (Cleaning area)**

40. Install the new cylinder head cover gasket (Q).

*Before installing the new gasket (Q), clean the gasket installing groove with a Threebond 2706 and a clean lint-free shop towel.*

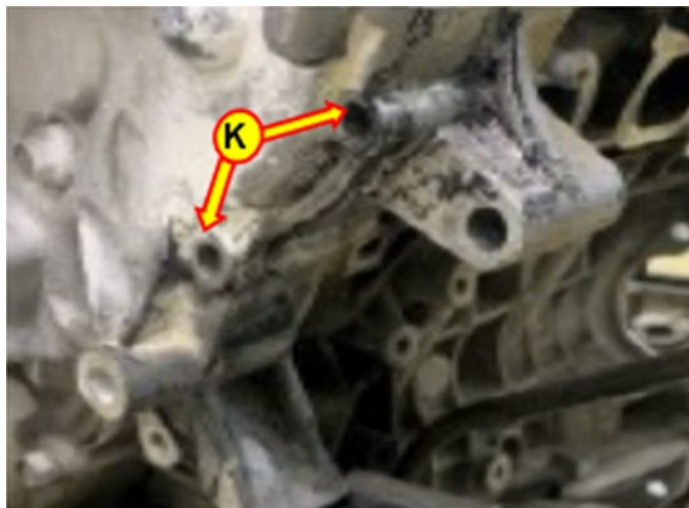
42. Remove (two) chain cover bolts shown here (K).

When removing the two chain cover bolts it is possible for retained oil to come out. If oil escapes through bolt holes, clean thoroughly with Threebond 2706.

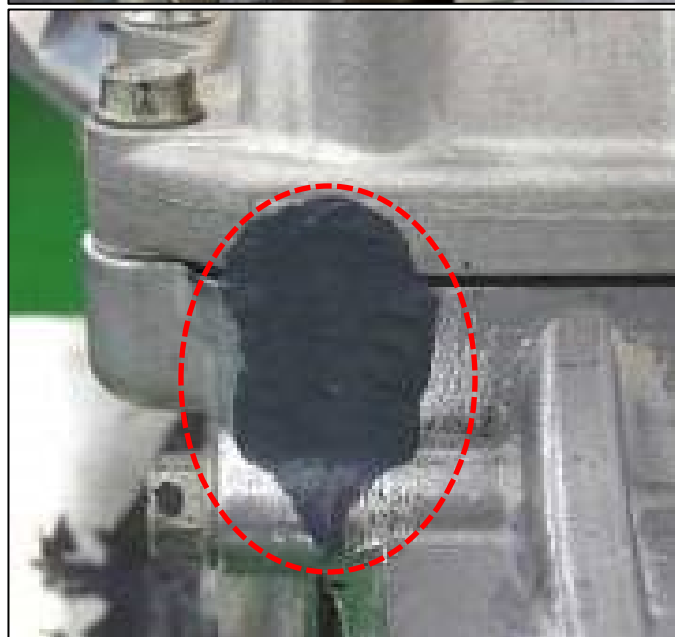
43. Apply liquid RTV gasket onto the outer surface of the “T” joints (S) of the cylinder head and cover.
- Apply the liquid RTV gasket in a line at least 30 mm long, following the green bold line as shown in the picture on the right and below.

- Within several minutes before the liquid RTV gasket begins to harden, spread the gasket evenly as shown in the picture on the right.

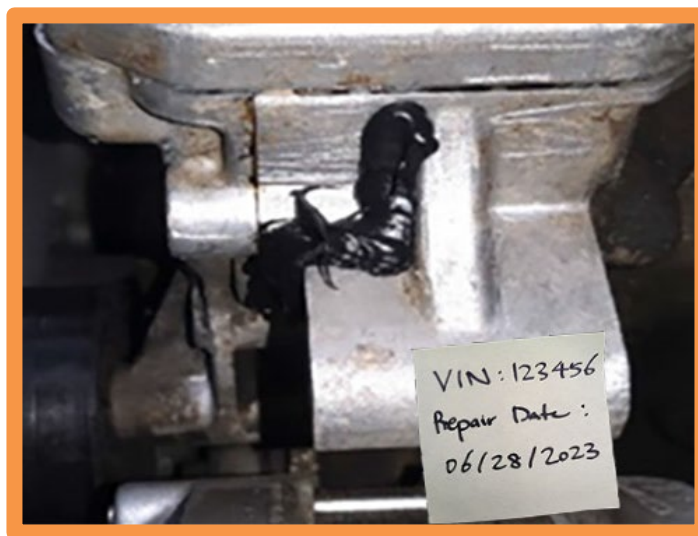
Using STUI, photograph the T-joint area. Include in the photo a piece of paper containing the last 6 digits of the VIN, and the date of the repair. Ensure the photo is in focus and captures the T-joint. Upload the photo to STUI.

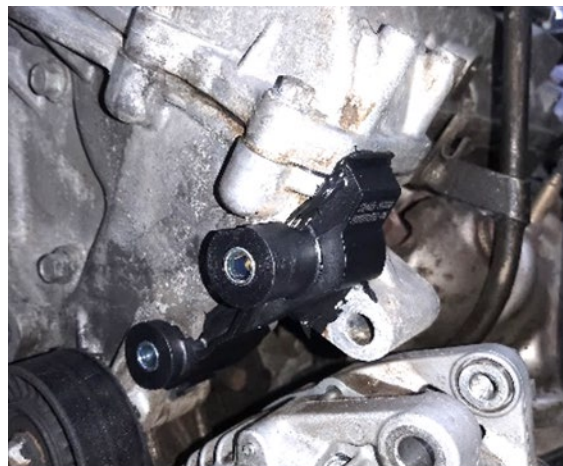
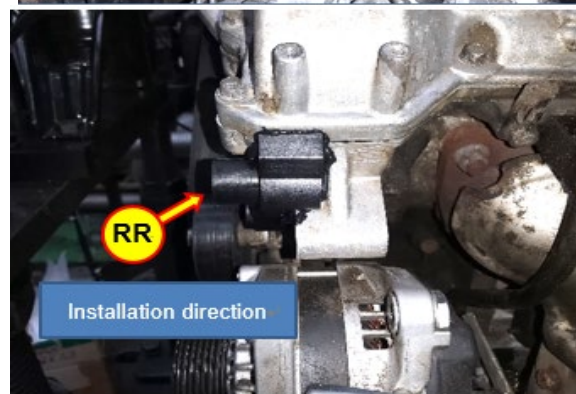
47. Place oil protector in place.
- 1.) Install oil protector to the timing chain cover in the indicated angle pictured in (RR).
  - 2.) Be careful not to contact surrounding parts.

***If the sealant is heavily smeared on the surrounding parts, remove the oil protector, thoroughly clean the sealant from surrounding areas and clean the oil protector. Go back to 41 and repeat.***

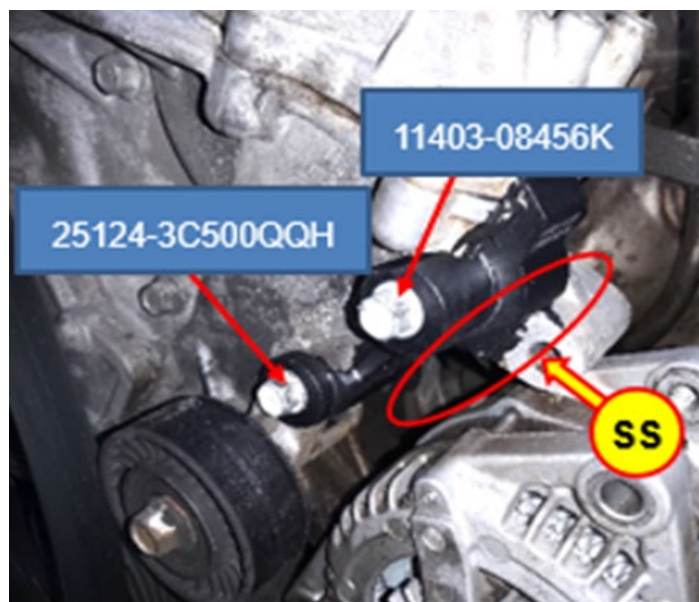
49. Remove sealant from the alternator mount (SS).
